ANALYSIS OF THE POST-MORTEM EVENTS AT THE TLS

K. H. Hu, Y. R. Pan, Y. T. Chang, P. C. Chiu, Jenny Chen, C. H. Kuo, K.T. Hsu, Y.H. Lin,
NSRRC, Hsinchu 30076, Taiwan

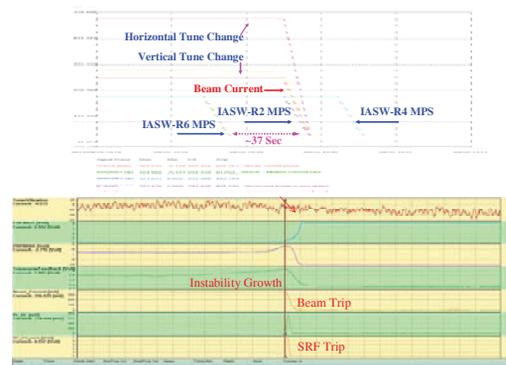
The trip resulted from the superconducting wiggler IASW-R6 main power supply itself rather than real quench of the coil was easily determined because coil current dropped to zero first. The beam loss induced quench of the SID. Fig. 1 shows the tune change induced the instability growth, the beam loss induce the SRF interlock active caused beam trip. After check over interlock message, it was found out power supply water flow meter fail caused power supply internal interlock active. After replace of spare main power supply, this error was cleared.

Figure 1: The beam trip caused by IASW-R6 main power supply failed.

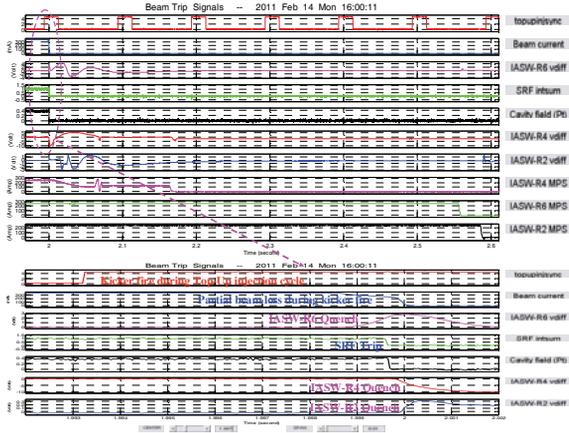
Scenario of a partial beam loss event is shown in Fig. 2, the partial beam loss induced the SRF interlock active caused beam trips during top-up injection period and the coil quench of the IASW-R6 was clearly observed, the beam trip induce IASW-R2 and IASW-R4 coil quench.

Figure 2: The partial beam loss during Top-Up injection cycle induce SRF trip caused super-conducting insertion device quench.

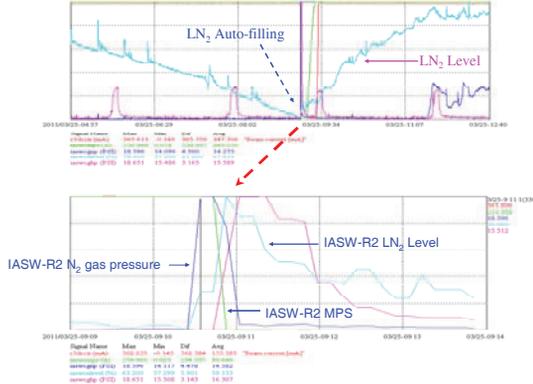
In the Fig. 3, the N₂ gas pressure over pre-defined trip threshold during LN₂ auto-filling period activate IASW-R4 interlock logic to trip main power supply which cause tune change, then partial beam loss happened caused SRF interlock active to trip beam induce IASW-R2 and IASW-R6 quench is shown in Fig. 4.

Figure 3: Too large N₂ pressure during LN₂ auto-filling period caused IASW-R4 interlock active.

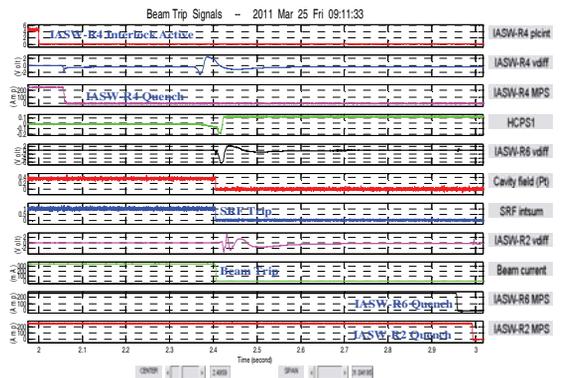
Figure 4: The IASW-R4 interlock active trip main power supply, then tune change caused beam loss and SRF trip.

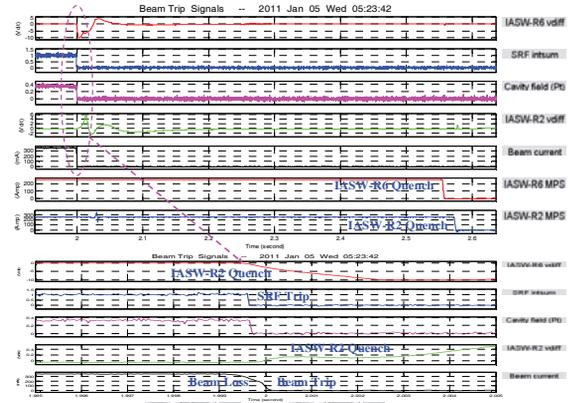
The dipole power supply fault caused the SRF interlock active to trip beam, and then the beam trip induce IASW-R6 and IASW-R2 coil quench. The dipole power supply trip hang caused beam loss and SRF trip is shown in Fig. 5. The dipole power supply trip can induce orbit change and beam intensity decay. The horizontal position of BPM fast access data and the sum signal of BPM turn-by-turn data is shown in Fig. 6.

Figure 5: The dipole power supply fault caused the SRF interlock active to trip beam, and then the beam trip induce IASW-R6 and IASW-R2 coil quench.

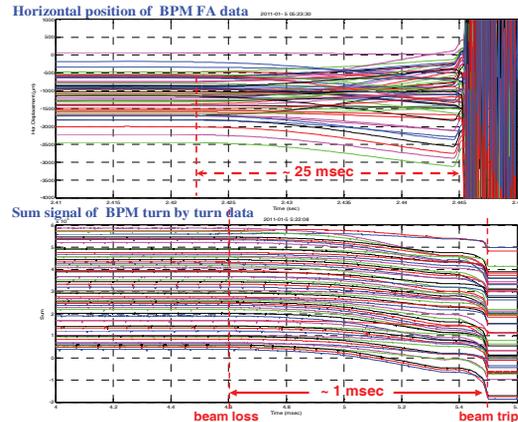
Figure 6: The dipole power supply trip can induce orbit change and beam intensity decay. The horizontal position of BPM fast access data and the sum signal of BPM turn-by-turn data are clearly observed.

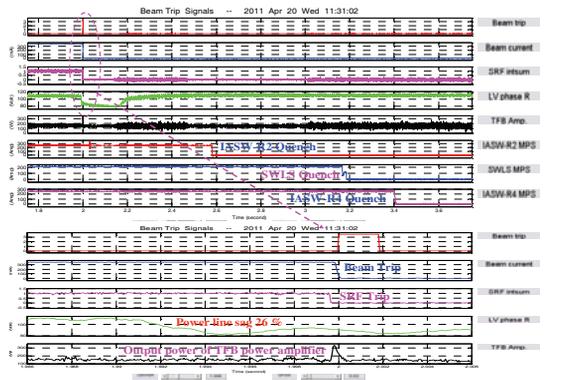
Too large voltage sag of the power line caused problem also. This power line sag caused fault is shown in Fig. 7 for about 26% line voltage sag within 12 power line cycles (~200 msec) caused the SRF and the SWLS - the IASW-R2 and the IASW-R4 three SID trip simultaneously. The superconducting wavelength shifter (SWLS) is cooled by a cryo-cololer. Limited cooling power of the SWLS led more than two hours recovery time. To eliminate such kind of events, a dedicated UPS for all SID was installed.

Figure 7: The stored beam current drop to zero due to power line sag. Severe trip due to power line voltage sag. Near 26% lines voltage drop caused SRF system interlock active and beam trip, the beam trip induce SWLS · IASW-R2 and IASW-R4 devices trip simultaneously.

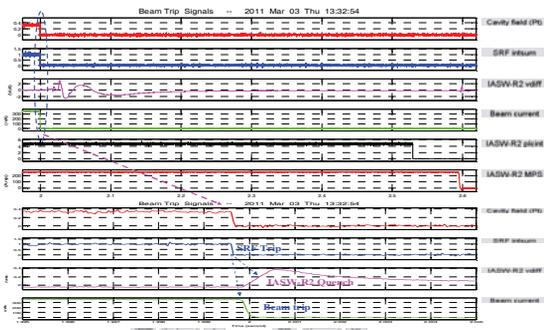
The earthquake induce SRF interlock active caused the beam trip and the IASW-R2 quench. The earthquake caused beam trip is shown in Fig. 8. The orbit change and beam current from 362 mA drop to 0 mA caused sum signal drop of the BPM during the SRF trip. The orbit change and sum signal of the BPM are show in Fig. 9.

Figure 8: Earthquake induced SRF interlock activate which caused the beam trip and the IASW-R2 quench.

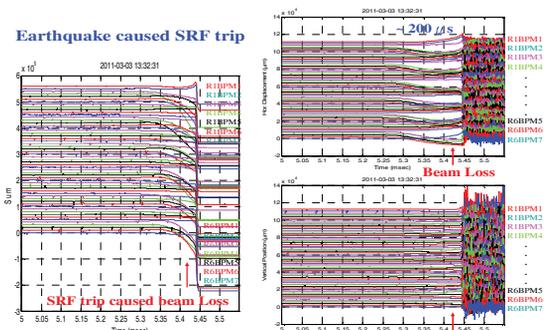
Figure 9: Earthquake caused beam trip, the orbit change and beam intensity from the BPM are clearly observed.

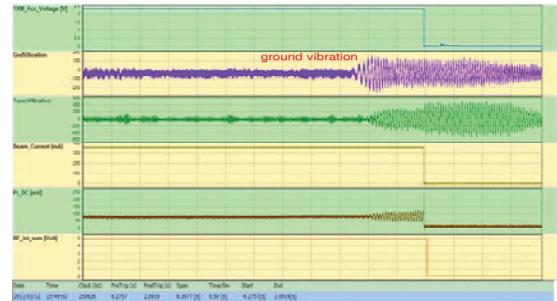
The ground vibration caused by the pile-sinking of the TPS civil construction caused the SRF trip is shown in Fig. 10, the transmitter trip of the SRF system and the SRF interlock active caused the beam trip and the IASW-

Figure 10: The ground vibration caused by the pile-sinking of the TPS civil construction caused the SRF system trip.

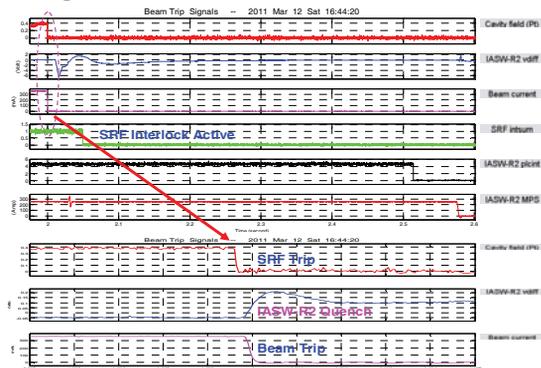
R2 quench as show in Fig. 11. The ground vibration of the TPS civil construction caused the transmitter trip of the SRF system and the SRF interlock active caused the beam trip and the IASW-R2 quench.

Figure 11: The SRF transmitter trip and the SRF interlock active caused the beam trip and the IASW-R2 quench.
