TROUBLESHOOTING STATUS FOR THE ALS IN-VACUUM INSERTION DEVICE*

A. Madur, S. Marks, S. Prestemon, D. Robin, T. Scarvie, R. Schlueter, C. Steier,
LBNL, Berkeley, CA 94720, USA

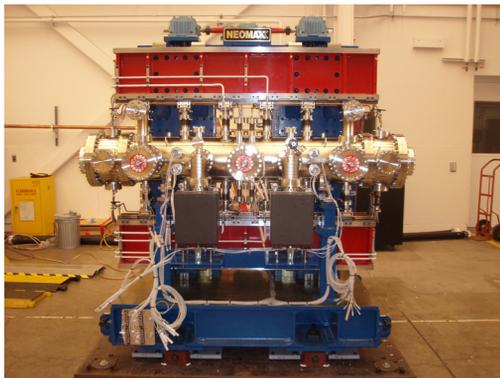
Figure 1: ALS In-Vacuum Insertion Device

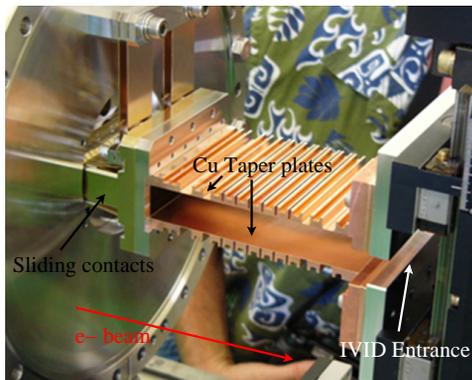
The magnetic structure is located within the vacuum chamber and a 110 μ m thick Cu-Ni conductive foil is installed over both magnetic structures (top and bottom) to ensure the conductive continuity of the image currents. This conductive foil is 110 mm wide and covers the magnets over the whole length (1.5 m). The Cu-Ni foil was obtained from a 60 μ m thick sheet of copper, plated with nickel (50 μ m). The magnetic properties of the nickel are used to ensure adhesion of the foil to the magnets; this provides the heat conduction path for foil cooling. At both ends, the foils are clamped to the water-cooled transition taper plates made of OFHC copper (Oxygen-Free High Conductivity). These taper plates along with the sliding contacts ensure the transition between the fixed gap vacuum chamber and the undulator varying gap for the continuity of the image currents. Figure 2 shows the transition we just described.

Figure 2: Transition parts between vacuum chamber flange and IVID gap (from left to right) - Cooling lines are not shown on this picture
