PERFORMANCE OF THE LHC MAGNET SYSTEM

V. Parma, L. Rossi, CERN, Geneva 23, 1211 Switzerland

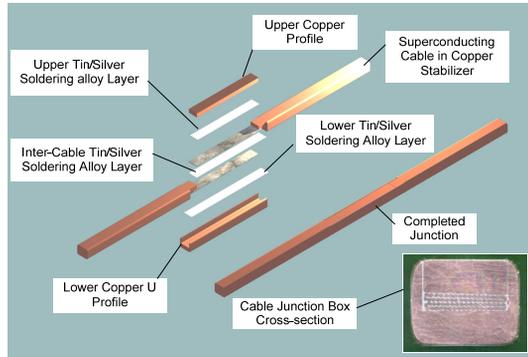
Figure 2: Schematic of a 13 kA connection.

The dipole circuit interconnection had a defective joint between superconducting cables. A schematic of the 13 kA interconnection is shown in Fig. 2. The technology is soft soldering based on tin-silver alloy, used both to splice the superconducting cable and to connect the copper stabilizer to the cable joint and to the stabilizing copper of the bus bar. When finished the connection looks like a perfect reconstitution of the bus bars system that run along the whole length of the magnet system.

The splice between superconducting cables is specified to be below $0.6 \text{ n}\Omega$ and the actual results on sample witness showed an average of $0.2 \text{ n}\Omega$ with a variance of less than 0.1Ω . The one that failed was later evaluated to be around $220 \text{ n}\Omega$. Unfortunately the quench detection system of the bus bar was not sensitive enough to detect the $\sim 2 \text{ mV}$ voltage of the resistive zone, its protection being ensured for the entire length of the bus and correspondingly set to a 1 V threshold.

It was found that data of temperature sensors placed in the magnet indicated, during the plateau of current at 7 kA done in the previous days, a small but very clear temperature gradient with a difference of up to 40 mK - a clear sign of the existence of an abnormal dissipation of $10.7 \pm 2.1 \text{ W}$, corresponding to a resistance of $180\text{--}260 \text{ n}\Omega$. A thermo-electrical model was then able to simulate a thermal runaway of the normal zone in the splice at 8.7 kA , by making the hypothesis of a resistance of $220 \text{ n}\Omega$ and no contact between cable and stabilizer at the joint and also of a longitudinal gap in the stabilizer. This discontinuity is very important as it impedes current sharing among cable and stabilizer. The time constant of the current decay in the bus bar is 104 s , while the copper of the cable is sized to withstand in resistive state a discharge time of 1 s , (what we have in a single magnet). If the above mentioned conditions are present together, the joint cannot sustain the discharge and melts away.

A longitudinal gap, either total or partial, were reported to be not infrequent in the interconnection works, so a very bad splice is likely to be without protection.

- Implementation of a new QDS on the bus bars and interconnection line, with a sensitivity threshold of 0.3 mV . In steady state, a $10 \mu\text{V}$ sensitivity level is

possible, enabling to detect a bad splice with $R > 10 \text{ n}\Omega$, well below the runaway threshold, now estimated to be beyond $50 \text{ n}\Omega$. The new QDS will also detect symmetric quenches. The present magnet QDS will be used in such a way as to also detect bad splices inside magnets: it has been found that three magnets, (two in the LHC and 1 in reserve), have defective internal splices of 100, 50 and 25 $\text{n}\Omega$. In the first and third cases, it was confirmed on opening that such a high value of splice resistance is due to absence of solder. As we could only test half of the machine we can expect to detect more cases when the LHC is cooled down. Internal splices are covered by the QDS and protected by the bypass diode.
