RECENT RESULT OF CAVITY INSPECTION FOR THE SUPERCONDUCTING CAVITIES AT KEK-STF

K. Watanabe[#], H. Hayano, E. Kako, S. Noguchi, T. Shishido, Y. Yamamoto, KEK, Ibaraki, Japan
 Y. Iwashita, Kyoto ICR, Uji, Kyoto, Japan

Abstract

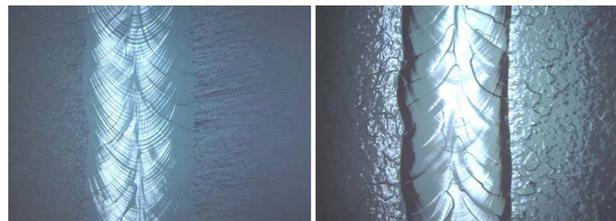
The images of the inner surface in comparison with as received and after EP-1 process for MHI-05 are shown in Figure 2.

Figure 2: Images of the MHI-05 at “As received (left) and after EP-1 process (right)”.

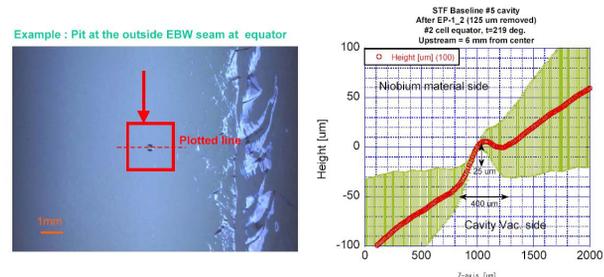
Figure 3: Example of image and shape of the suspicious spot at outside weld area measured by after EP-1 process.

The two types suspicious spots were found at outside of weld area in the inspection C) for MHI-05 and MHI-06. Then surface gradient measurement, shape analysis and marking of these spots were done. Figure 3 is image and shape of a pit type suspicious spot. The location and size of the observed suspicious spots at outside weld area is summarised in Table 1. The diameter and depth of the pit

type spots were 200 ~ 500 μm diameter and 10 ~ 30 μm depth. The diameter and height of the bump type spot were 800 μm diameter and 50 μm height.

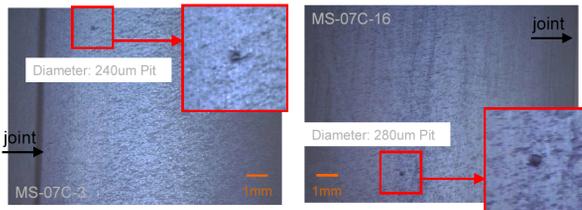
The inspection of three dumbbells for MHI-07 cavity was carried out to search that “When were suspicious spots made?”. The setup of the inspection is shown in Figure 4. The result of this inspection is shown in Figure 5. The spots were observed on the surface even in the dumbbells stage. The spots do not occur in neither the surface treatment nor EBW process. The locations of the spots were within 15 mm from a joint point of equator.

Figure 5: Observed the suspicious spots in the stage of the Dumbbells (before EBW)

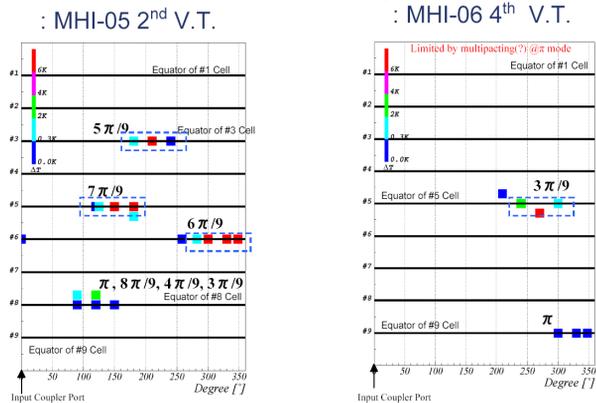
2009 [3], [4]. The heating locations of both cavities detected by T-map at high field are shown in Figure 6. The heating location detected by T-map, the cause of limitation and result of the inner surface inspection are summarised in Table 2. In the first V.T. of MHI-05 and MHI-06, the reason of limitation for the cavity performance was field emission. In the second V.T. of MHI-05, the heating locations at high field were #3 cell equator, #5 cell equator and #6 cell equator. In the fourth V.T. of MHI-06, the heating locations at high field were #5 cell equator. The heating of the suspicious spots (see Table 1.) of both cavities were not detected by T-map at ~ 39.9 MV/m in the pass-band measurement. The observed suspicious spots in MHI-05 and MHI-06 are not reason of

Figure 6: Heating location detected by T-map in V.T. (heating location at high field is indicated with blue dotted line-box)

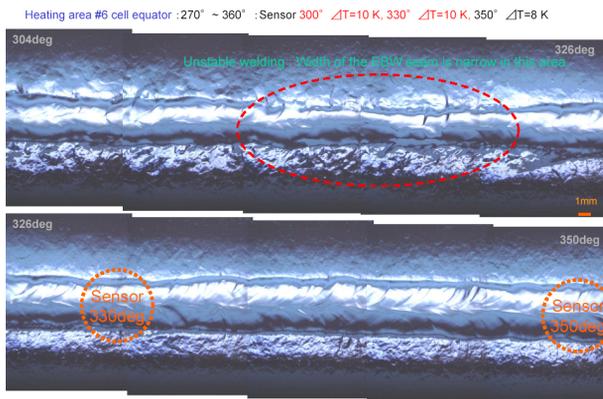
Figure 7 and Figure 8 are example of the inner surface inspection of MHI-05 at heating location in comparison with after V.T. and as received. One of the conditions of heating location was non-uniform EBW seam area (Non-uniform means narrow seam area at equator). The EBW seams of the heating locations detected by T-map at high field were similar condition. The result why heating happens in these non-uniform EBW seam area is not yet understood. The inspection for heating area found at pi-mode between 30 mm from the joint of the equator were

Figure 7: The images of the EBW seam in cell #6 equator (angle: 304 to 350 degree) of MHI-05 (Condition is after V.T.). The heating was occurred at 32.9 MV/m in $6\pi/9$ mode. The orange circle is the location of thermo-sensor. Red dotted line-circle is non-uniform EBW seam area.

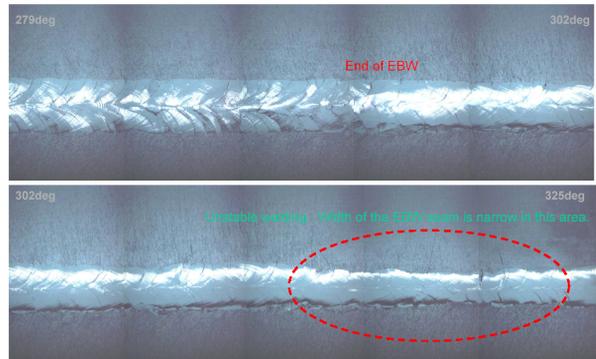
#6 equator, 279 ~ 325 degree. Condition : As received.

Figure 8: The images of the EBW seam in cell #6 equator (angle: 279 to 325 degree) of the MHI-05. (Condition is “As received”.) Red dotted line-circle is non-uniform EBW seam area.

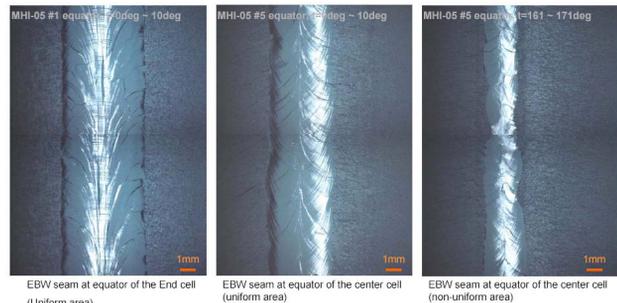
The EBW seam of MHI-05 and MHI-06 had both of the uniform area and the non-uniform area at around the EBW seam of the equators (see Figure 9 a). The non-uniform area of EBW seam has a possibility for a reason of the limitation to achieve a high accelerating gradient.

Possible reason of the non-uniform EBW seam is seemed as the material thickness error of the equator joint. EBW parameters were studied for fabricated new MHI cavities (MHI-07, MHI-08 and MHI-09) [1] to obtain a good and uniform EBW seam.

(a) EBW seam of MHI-05: as received

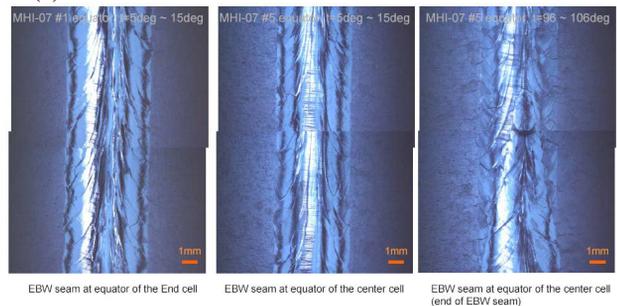
As a result, the EBW seams of MHI-07, MHI-08 and MHI-09 are improved (see Figure 9 b) by the new EBW parameter. The qualities of EBW seam for three cavities are the same. Figure 9 (a) and (b) are the images of the typical EBW seams in comparison with previous MHI-05 and improved MHI-07.

(b) EBW seam of MHI-07: as received
