# IMPEDANCE MEASUREMENTS OF MA LOADED RF CAVITIES IN J-PARC SYNCHROTRONS

M. Nomura\*, A. Schnase, F. Tamura, M. Yamamoto, K. Hasegawa, T. Shimada, H. Suzuki, JAEA/J-PARC, Tokai-mura, Ibaraki, Japan  
E. Ezura, C. Ohmori, K. Hara, A. Takagi, M. Toda, M. Yoshii, KEK/J-PARC, Tsukuba, Ibaraki, Japan

Eleven RF cavities have been installed in the J-PARC RCS. We have been measuring the impedance of each RF cavity after installation. The RF cavity 7 showed an impedance reduction. We disassembled the cavity 7 and checked the cores in it. We found buckling in eleven cores in the cavity 7. The buckling of one of the cores was very severe. We found that the impedance reduction of cavity 7 was caused by this core's buckling.

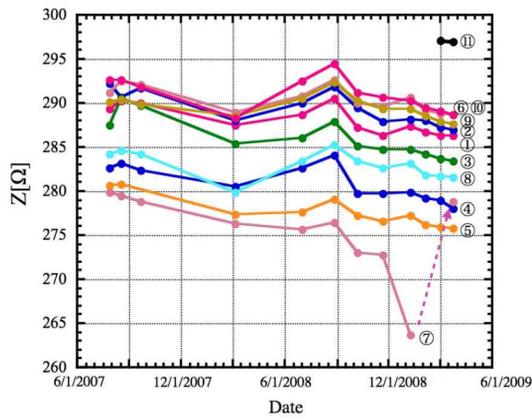
To check the MA core conditions, we have been measuring the impedance of each RF cavity in the RCS at the shutdown periods after installation. The impedance measurement results are shown in Fig. 2. All cavity impedance values show long-term fluctuations. We think that these fluctuations are related to the temperature of the cooling water. To understand the relationship between cavity impedance and temperature of cooling water, we assumed that the cooling water temperature dependence of each RF cavity impedance was the same and then we averaged over all RF cavity impedances except cavity 7, because the impedance of cavity 7 is different from the other cavities. We show the average of the cavity impedance and cooling water temperature in Fig. 3. In Fig. 3, we fitted roughly the impedance line to temperature at the first half year by adjusting the ratio of  $\Delta Z/\Delta T$ . The ratio of  $\Delta Z/\Delta T$  is 0.18 [ $\Omega/\text{deg.}$ ].

Figure 2: Real value of RCS RF cavity impedance. The vertical axis shows the cavity impedance at the resonance and the horizontal axis shows the date. The circled number in the figure means cavity number. The dotted arrow line shows the impedance change after core replacement.

We replaced three buckled cores in the cavity 7 with new ones. Impedance of cavity 7 was back to the initial value. See Fig. 2.

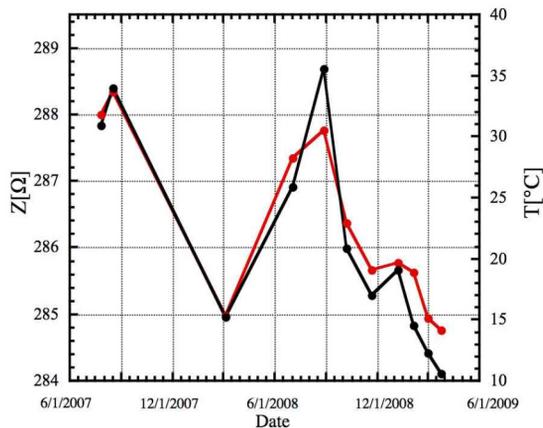
Fig. 3 shows clearly that the cavity impedance strongly depends on the temperature of cooling water. The mechanism of the temperature dependence is not clear yet. It seems to be caused by the temperature dependence of the dielectric constant of water and the thermal expansion of the cores. In Fig. 3, the difference between the cavity impedance and the cooling water temperature is very small after 18 month operation. This means the total cavity impedance is not reduced so much in this 18 month operation.

Figure 3: Average of the cavity impedance and temperature of cooling water. The black and red lines show the average of the cavity impedance and temperature of cooling water, respectively.

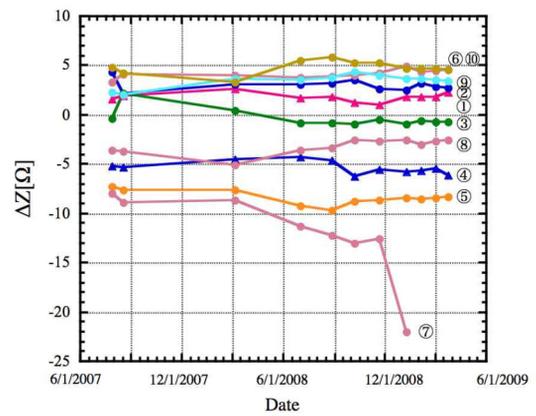
We show the difference of impedance between each cavity and the average in Fig. 4. Fig. 4 shows clearly that the cavity 7 impedance is different from the other cavities. The impedance of cavity 7 had been decreasing slowly until December 2008 and after that the RF cavity 7 showed rapid reduction in impedance.

Figure 4: Difference of impedance between each cavity and average. The  $\Delta Z$  means the difference of impedance between each cavity and average.

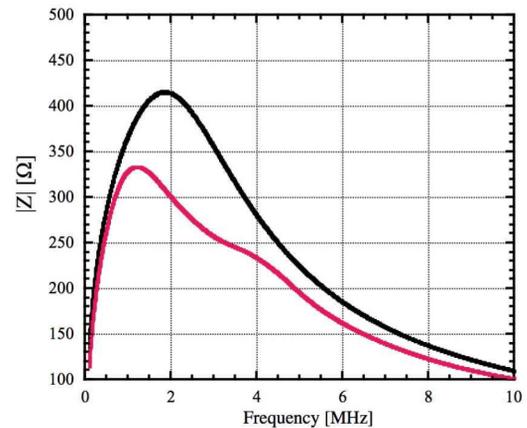
Just after this rapid reduction, we measured the impedance of all six water tanks of the cavity 7 and we found that the impedance of water tank 6 was drastically changed. The impedance data of water tank 6 is shown in Fig. 5. It shows at least one of the MA cores in the water tank 6 was damaged.

Figure 5: Impedance of water tank 6. The black and red lines show the impedance at the installation time and on January 2009, respectively.

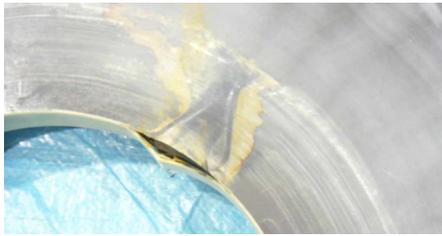
We disassembled the cavity 7 and found buckling in the MA cores in the cavity 7. The number of the buckled cores is eleven out of a total of eighteen. We show the typical core with buckling in Fig. 6. Fig. 6 shows that the FRP inner ring was broken and the fiber sheet on the core surface was stripped off by buckling. The most severe buckled core with serial number NGT06199 was located at the accelerating gap side of water tank 6. Fig. 7 shows the picture of buckling of NGT06199. In Fig. 7, the buckling part hit a column of the FRP inner wall of the water tank and then ribbons were ripped. The close-up picture of the buckling is shown in Fig. 8. It is clear that there is tear in the core.

Figure 6: Typical example of buckling.

In this section, we discuss the relationship between the core winding, coating and buckling. We summarized the core position of the water tank, winding, coating and buckling in Table 1. In this cavity, three different winding schemes were used and buckling was observed for all cases. We think core winding doesn't relate to the occurrence of buckling. However, there is an obvious difference in the coating process. The buckling happened in eleven cores within low viscosity epoxy immersion but no buckling happened in cores without low viscosity one. In cores within low viscosity epoxy resin, the large linear expansion coefficient of epoxy seems to make buckling easy to happen. On the other hand, in cores without low viscosity one, there is a small space between the ribbons and we speculate that mechanical strength is not strong so that the stress caused from thermal expansion was released by core deformation. Another possible cause is imperfect hardening during coating process.

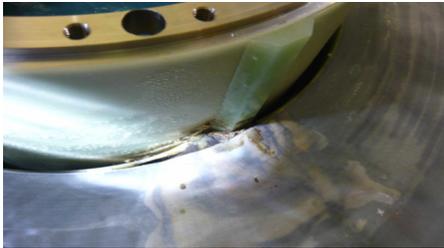
Figure 7: Buckled core NGT06199.

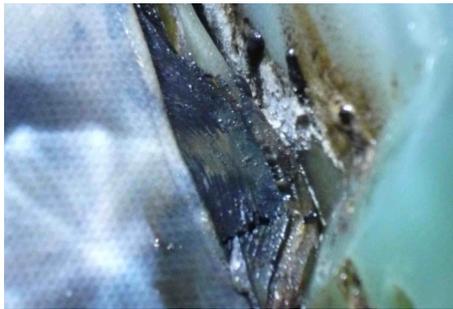
Figure 8: Close-up of buckling.

We measured the individual impedance of all eighteen cores in the cavity 7. We observed the impedance reduction of NGT06199 in the water tank 6. This reduction was caused by the tear in the core. See Fig. 8. We show the impedance data of NGT06199 in Fig. 9. We found that the rapid reduction in impedance of cavity 7 was caused by this core's buckling. About the other cores, we observed little reduction in impedance.

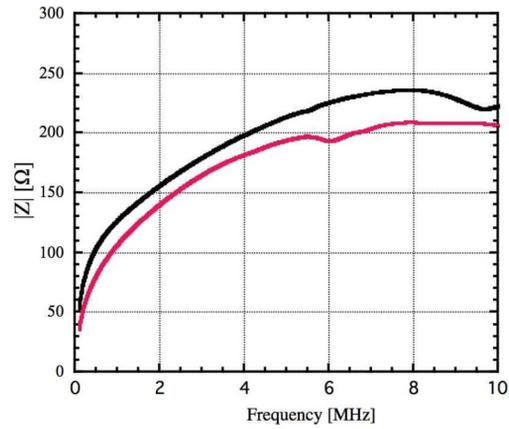
Figure 9: Impedance of core NGT06199. The black and red lines show the impedance at the installation time and on January 2009, respectively.
