Performance of the LHC magnet system

Vittorio Parma, Lucio Rossi CERN, Technology Dept.

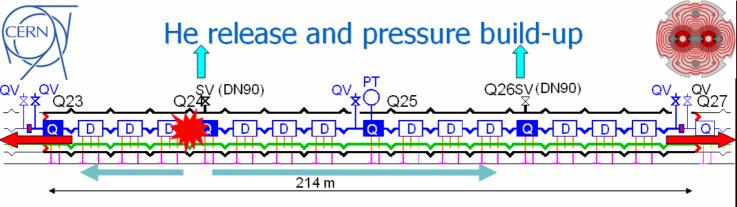
19th September 2008: ...an electrical arc in sect.3-4...

Sect.3-4 incident:

- Cryostat internal pressure estimate: 8 bar
- He mass flow estimate ~20 kg/s! (helium on electrical arc)

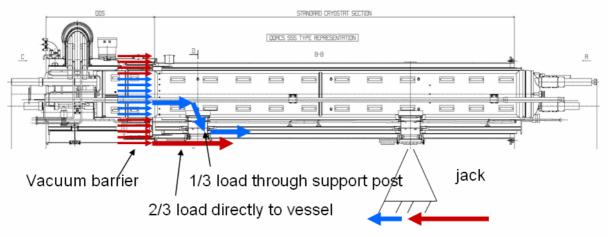
Pressure forces on SSS with vacuum barrier

- 3 SSS with vac. barrier uprooted and longitudinally displaced
- Floor break at jack fixations
- MLI damage, soot
- Bellows damage (CM and beam vacuum lines)
- → Can be mitigated (not eliminated!) by <u>limiting pressure rise</u> and <u>reinforcing jack fixations</u> to ground

Vacuum design forces:

- $\Delta p = 1.5$ bars across vac. Barrier \rightarrow 120 kN (40 kN through support post, 80 kN through Vacuum Barrier)
- •120 kN taken by 1 jack fixed to ground

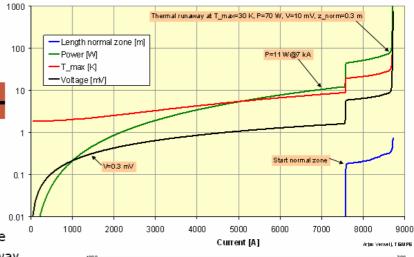
A resistive joint of about 220 $n\Omega$ with bad electrical and thermal contacts with the stabilizer

- Simulations confirm this as possible cause
 - Initially slow, then fast thermal runaway
 - QPS threshold of 1V is too high
 - → sect.3-4 data fit reasonably well
 - Confirms that discontinuities in joint stabilizer are critical

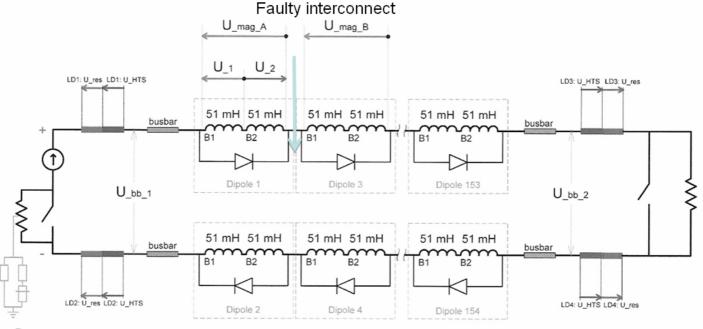
Protection of the dipole circuit in a sector

Threshold is **1V during 1 s**

Magnets $U_{res} = U_{_1} + U_{_2}$ Threshold is **100 mV during 10 ms**

New threshold of 0.3 mV being implemented in QPS consolidation
