## ANOMALOUS HIGH RADIATION BEAM ABORTS IN THE PEP-II B-FACTORY\*

M. Sullivan<sup>†</sup>, Y. Cai, S. DeBarger, F.-J. Decker, S. Ecklund, A. S. Fisher, S. Gierman, S. Heifets, R. Iverson, S. Metcalfe, A. Kulikov, N. Kurita, A. Novokhatski, J. Seeman, K. Sonnad, D. Teytelman, J. Turner, U. Wienands, D. Wright, Y. Yan, G. Yocky, SLAC, Menlo Park, CA 94025, USA

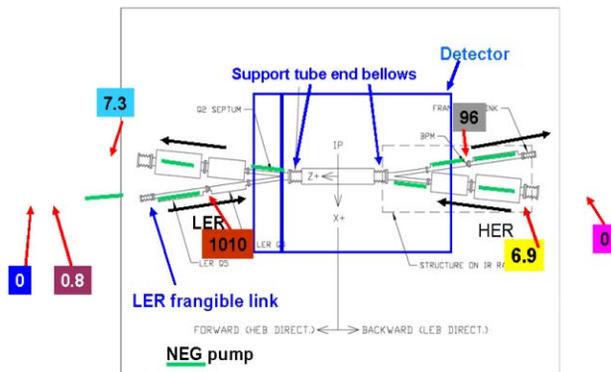
Figure 1: Layout of the Interaction Region. The numbers are typical peak pressure readings in nTorr for one of these fast pressure spike events. The green bars indicate the location of NEG pumps in this area. The layout is pictorial. The total z length of this region is about  $\pm 10$  m.

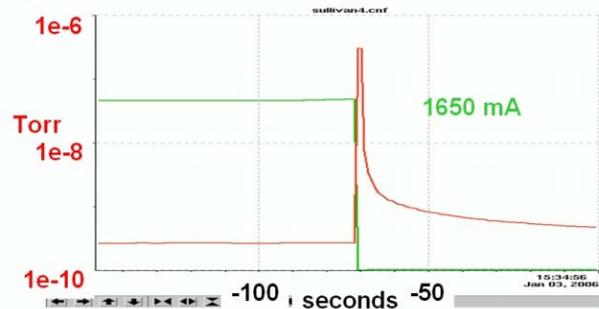
Figure 2: Time plot of a fast pressure spike and radiation abort event. The green curve is the LER beam current. The current was about 1.6 A when the spike occurred. No activity is seen before the spike. The red curve is the pressure seen from the vacuum gauge with the highest signal--about 5 m from the IP in the upstream LER beam pipe. The peak pressure for this event was about 300 nTorr. The pressure at this gauge returned to below 1 nTorr in less than 20 sec.

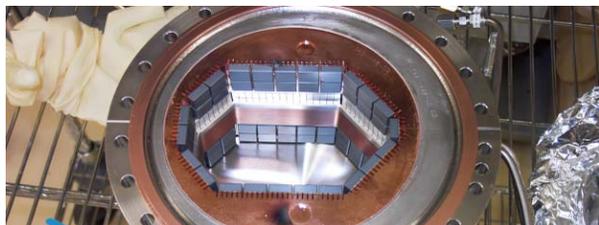
The pictures tell the story. Fig. 3 is a picture of the bellows section. A close look shows a small discoloration on the edge of the top row of tiles. Fig. 4 is a close-up of the damaged tile. The breakdown appears to start at the corner of the tile and then travel along the surface of the tile to the copper underneath the tile. Fig 5 is the RF seal that was next to the tile and figure 6 shows the new RF seal.

Figure 3: The entire bellows section. The LER beam is on the left side and the HER beam is on the right side. The damaged tile is a little closer to the LER than to the HER.

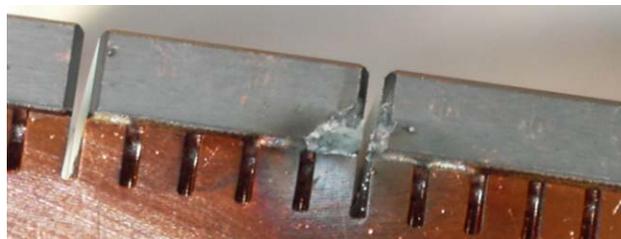
At about this time it became clear that there was a design flaw in how the RF seal works near the HOM tiles. The seal is supposed to electrically connect two vacuum pieces at flange joints so that the image current can easily flow along the inside surface of the chamber. The RF seals for the bellows section, however, were touching the HOM tiles instead of metal. The HOM tiles are essentially insulators, consisting of 60-40 composites of AlN and SiC. A damaged tile might be able to emit nitrogen gas. After designing and building a new set of RF seals we were ready to remove the bellows section.

Figure 4: A close-up of the damaged tile.

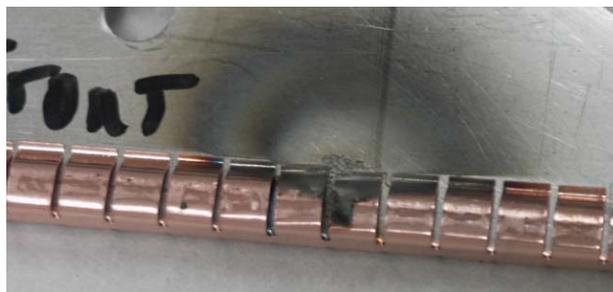
Figure 5: The RF seal that mated with the damaged tile. All of the discoloration was hidden behind the RF seal. We do not completely understand why the breakdown occurred at this location. There is a small dark spot on the third RF finger to the left of the discoloration that matches a small pit on the tile in Figure 4.
