INVESTIGATION ON MYSTERIOUS LONG-TERM ORBIT DRIFT AT NSLS-II*

Y. Hidaka[†], W. X. Cheng[‡], L. Doom, R. P. Fliller, G. Ganetis, J. Gosman, C. Hetzel, R. Hubbard, D. Padrazo Jr., B. Podobedov, J. Rose, T. Shaftan, S. Sharma, V. Smaluk, T. Tanabe, Y. Tian, G. Wang, C. Yu, Brookhaven National Laboratory, Upton, NY 11973 USA

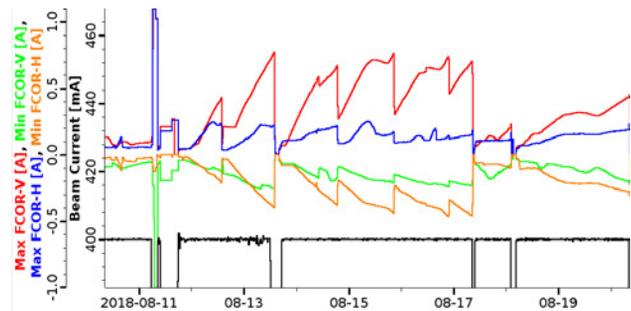
We noticed the first persistent orbit drift around the start of August 12, 2018, by the fact that the correction strengths of the fast correctors, which are automatically controlled by the fast orbit feedback (FOFB) system, were quickly accumulating. The fast correctors are rather weak, having the current range of +/-1 A with 12 urad/A. This forced us several times to run a shifting program that transfers the fast corrector correction strengths to the slow correctors, shown as the sawtooth behaviors of the maximum and minimum fast corrector strength history in Fig. 1. After about a week, the accumulation speed tapered down. The correction was always the strongest around Cell 4 (C04) straight section,

Figure 1: 10-day history of fast corrector max/min current, starting from August 10, 2018, before the shutdown.

and orbit analyses indicated a potential kick source around the same region. Since the readback for the insertion device (ID) orbit correctors for C04 ID was known to be unreliable, we decided to upgrade the power supply interface during the machine Fall shutdown starting on Aug. 20, 2018, to determine whether one of the ID correctors is the culprit if the same trend returns.

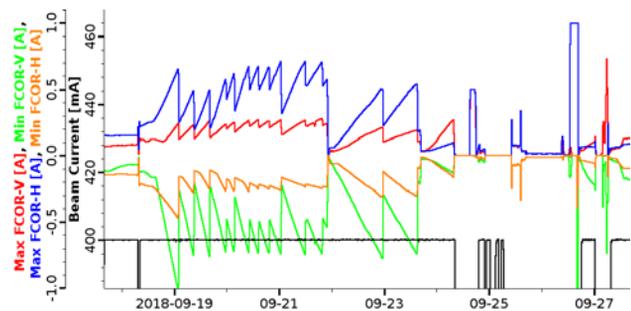
Figure 2: 10-day history of fast corrector max/min current, starting from September 17, 2018, after the shutdown.

When we came back from the shutdown on Sept. 17, 2018, the orbit was stable for one day, until a similar drift reappeared, as shown in Fig. 2. The strength accumulation was even faster than before, requiring more frequent fast-to-slow-corrector shifting operations.

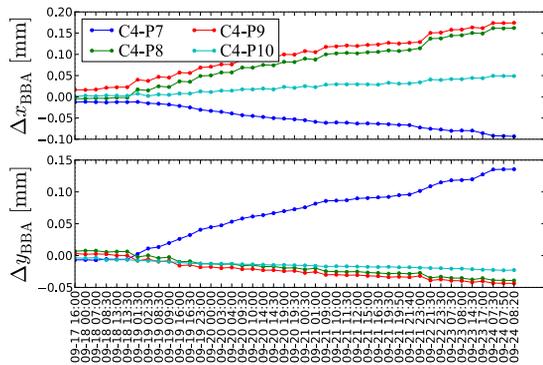
During the course of the investigation, as shown in Fig. 3, we realized that our so-called ID BPM beam-based alignment (BBA) values were drifting by more than 150 um within a week, our administrative threshold value for resetting the ID BPM BBA values. We will discuss more about ID BPM BBA values later, but these values are supposed to be constant over a long duration and the basis of our active interlock system for equipment protection [2]. Hence, it was deemed too risky to continue operation of C04 ID without knowing why these values were varying this much.

Figure 3: History of C04 ID BPM BBA deviation.

The drifting of the C04 ID BPM BBA values shown in Fig. 3 can be also explained by this girder motion. The BBA values are defined such that, if added to the ID BPM raw position values, ID BPM positions will always lie on the straight orbit drawn between the position readings of the 2 nearest BPMs bounding the ID straight section. This definition corresponds to a special case of dynamically-bounded orbit (DBO) as defined in [3], where the orbit at the 2 bounding BPMs is adjusted to their quadrupole-scan-based BBA values and the IDs in this bounded region are all fully open.

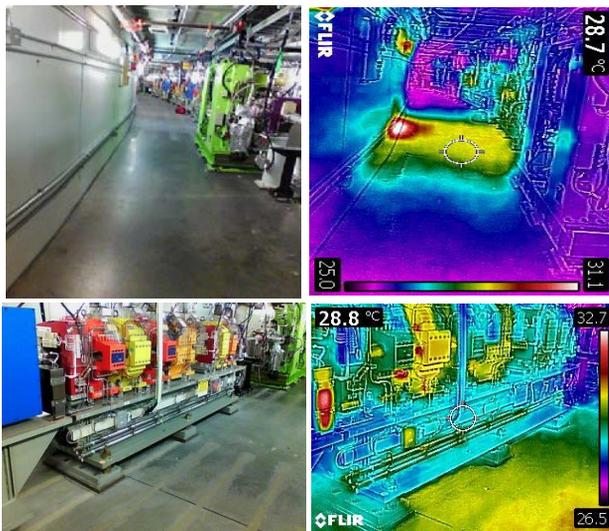
Figure 4: (Left) visible light and (right) infrared images of the section between C04 downstream bending magnet and C04 ID straight, right above the steam tunnel.

Finally, however, the girder alignment survey and thermal image scans of the C04 straight region on 09/26 revealed the root cause. As shown in Fig. 4, the floor temperature of C03 Girder 6, right next to and upstream of the

straight section, was locally elevated. The typical floor temperature in the storage ring tunnel is 25-26 °C, while the hottest area in front of the C03G6 girder was 34 °C (measured with a hand-held IR thermometer). Although not known to many people at the time, under this girder was a steam tunnel that brings in hot water for the whole facility. The visible light and infrared images of the tunnel are shown in Fig. 5. Utility Group found that the belt for an exhaust fan in the tunnel was broken and fixed it on Sept. 18. According to the history shown on Fig. 6, the tunnel temperature was hovering around 150 °F when discovered. After the fix, the temperature dropped quickly to 110 °F within a few hours. This sudden change in temperature apparently set off the ground motion. Table 1 shows the girder motion around this region on 9/25/2018, compared to the survey data during Fall 2016. The fiducials moved as much as by 270 μ m (H) and 330 μ m (V).

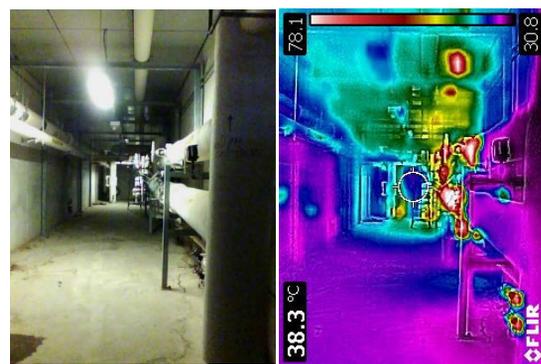
Figure 5: (Left) visible light and (right) infrared images of the steam tunnel below the C04 ID straight.

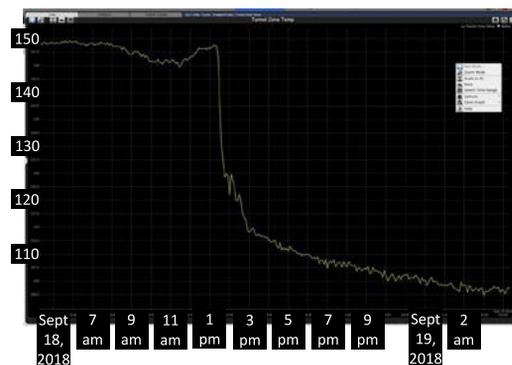
Figure 6: Steam tunnel temperature history on 09/18/2018 when the broken exhaust fan belt was found and fixed.

The timing of the temperature drop and the onset of the fast corrector accumulation trend exactly matched. Looking back further, there was a sharp temperature rise near the end of Aug. 11, as shown in Fig. 7. This was probably when the fan failed, and responsible for the fast corrector drift before the shutdown. Note that the amount of temperature jump is smaller in the August event than in the September event, which corroborates well with the accumulation speed difference. As Fig. 8 shows, the tunnel temperature was gradually increasing since April, yet there was no discernable fast corrector trend. From this, we can infer that the gradual temperature change does not cause a fast large floor motion, but sudden change does.

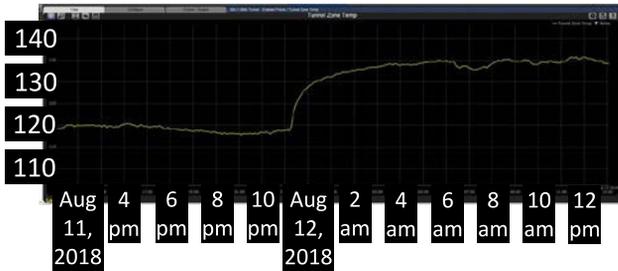
Figure 7: Steam tunnel temperature history in °F on 08/12 2018 when the exhaust fan belt apparently broke.

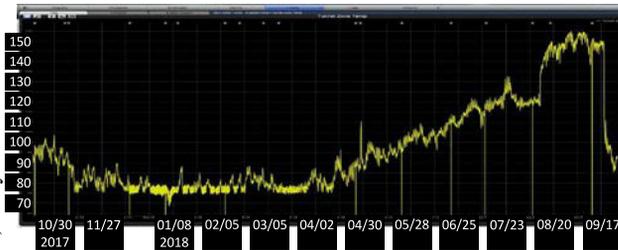
Figure 8: Steam tunnel temperature history in °F between October 2017 and September 2018

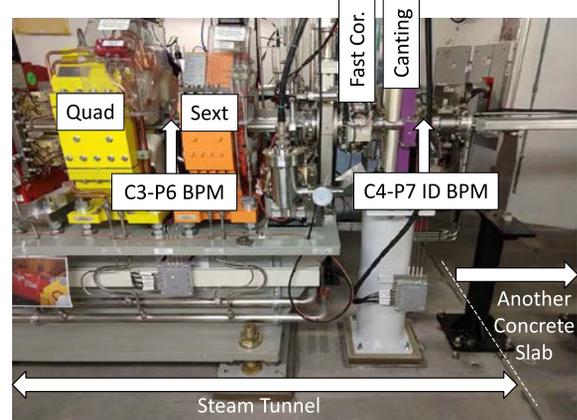
The most important characteristic of this orbit is that it stays constant as long as the 2 bounding BPMs and those within the bounded region, i.e., ID BPMs, are not physically moving and there is no change in transverse kicks within the bounded region. If the orbit is not constant as was the case in this incident, at least one BPM must be moving or the kick angle by one magnetic element must be changing. In this case, as Fig. 9 shows, one of the bounding BPMs (C3-P6) and one of the ID BPMs (C4-P7), located

right above the steam tunnel, must have been moving. The rest of the ID BPMs (C4-P8, C4-P9, C4-P10) are located on a different concrete slab to the right of the black seam (along the white dotted line). Using the unique characteristic of ID BPM BBA, combined with the reasonable assumption that C4-P9, C4-P10 and C4-P1 were much less affected by this thermal event, we can estimate the physical motion of C3-P6 and C4-P7 since the last ID BPM BBA update (within a week), by fitting a straight line to the 3 BPM positions, extending it to P6 and P7, and calculating deviations. The estimated result is shown in Fig. 10.

Figure 9: Relative positions of one ID BPM (C4-P7), one bounding BPM (C3-P6), different types of magnets, and the steam tunnel (extending beyond the left edge and separated by 635-mm-thick accelerator tunnel concrete floor). C04 ID is located on the right side of photo.

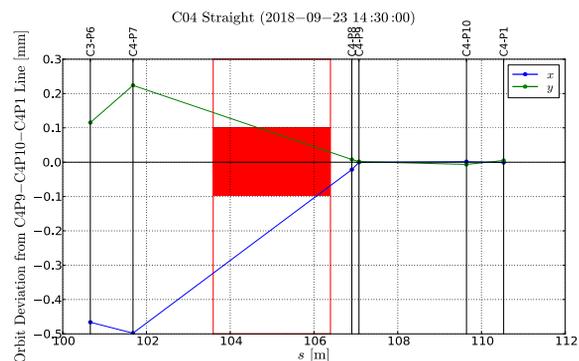
Figure 10: Estimated physical BPM motions for C3-P6 and C4-P7 assuming C4-P9, C4-P10 and C4-P1 were stable (C04 ID represented by red box).
