ALIGNMENT DESIGN AND STATUS OF TAIWAN PHOTON SOURCE

W.Y. Lai, C.J. Lin, P.S.D. Chuang, S.Y. Perng, M.L. Chen, H.S. Wang, C. W. Tsai, D. G. Huang, H.C. Ho, K.H. Hsu, C. K. Kuan, T.C. Tseng, J.R. Chen*

National Synchrotron Radiation Research Center, No 101, Hsin-Ann Road, Hsinchu 30076, Taiwan

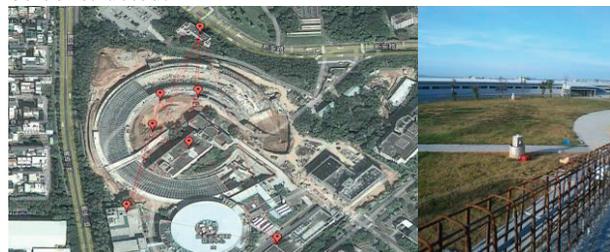
Figure 1: The photo of TPS building.

The network is the important foundation work to complete the alignment assignment of the TPS project. For stability reason, the TPS building is constructed half underground and has an outer wall blocking the measuring instrument from measuring one site to another directly. Thus, there are 8 fiducial points of global position system (GPS) set up around the building to confirm the location and the shape of TPS construction, as shown in Figure 1. By using these fiducial points of GPS, the primary fiducial points of survey network could be constructed.

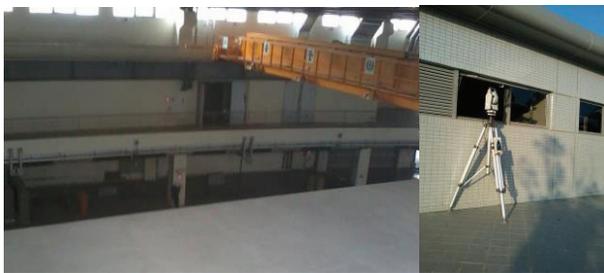
The coordinates of fiducial points is needed to be recorded as well as the current temperature. To construct the fiducial points of survey network, there are several windows installed on the inner wall in the TPS construction that are available for surveying through an outdoor laser tracker (AT401), as shown in Figure 3. It can provide the longer chord length to correct the error propagation from the imprecise geometry of the TPS ring.

Figure 3: The survey window of TPS.

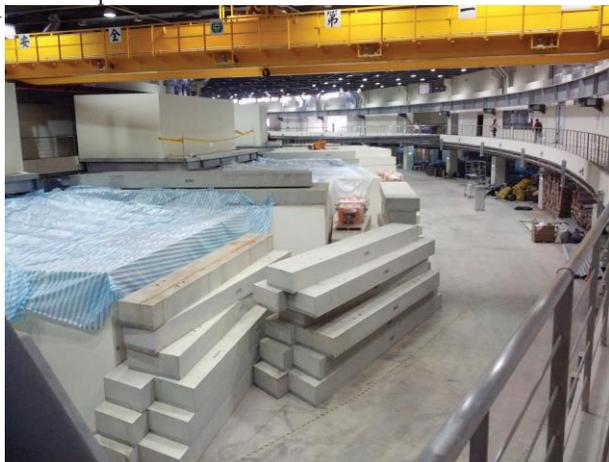
Figure 7: The state during installation and repair of the cement ceiling.

For the requirement of installation and repair of the cement ceiling, the cement ceiling were then removed and been placed on the experiment area from October 2013 to May 2014, as shown in Figure 7. That is the reason for the data of survey network to be incomplete for a long time. If the area of survey network is just in the storage ring area, the repeatability of the TPS survey network would be approximately 2 mm. Thus, the data of survey network was recorded again when the installation and recondition was completed.
