BEHAVIOR OF VACUUM PRESSURE IN TPS VACUUM SYSTEM

Abstract

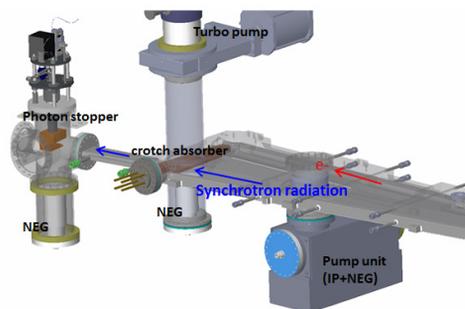
Figure 1: The geometric layout of bending chamber in arc section.

Aluminium alloy was chosen as the material of vacuum chamber because of its lower thermal outgassing rate and good experience in Taiwan Light Source at NSRRC in the past 20 years. For the arc sections, the triangularly shaped vacuum chambers were designed and Cu crotch absorbers located downstream intercepts more than 70 % of the synchrotron radiation from the bending magnet. Pumping unit combined sputtering ion pump (SIP) with non-evaporable getter pump (NEG) was design and located at the antechamber so as to decrease the pumping ports and produce a smooth vacuum surface with small impedance. Besides, near the crotch absorbers and photon stoppers, NEG pumps were also installed to enhance pumping speed. In addition, exhaust pumping systems with turbo-molecular pumps were used to remove large amount of

the photon stimulated desorption during machine commissioning. The geometric layout of bending chamber in arc section is shown in Figure1.

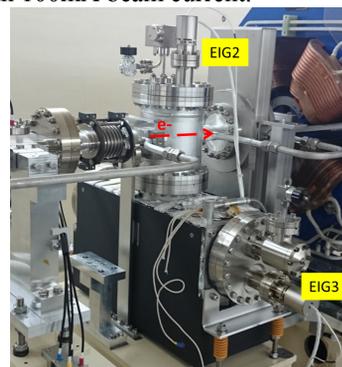
Figure 2: The location of EIG in storage ring.

Due to impedance issue and reducing the interference from scatter electron, EIG was installed into pumping unit shown as EIG3 in Figure 2. In straight section, another one was installed near the orbit of electron beam, especially in out-of-vacuum insertion device which has no space to install. The reading of EIGs in different location was summarized in table1. In static pressure, the readings were similar; a 1.5x difference was found in dynamic condition with 100mA beam current.

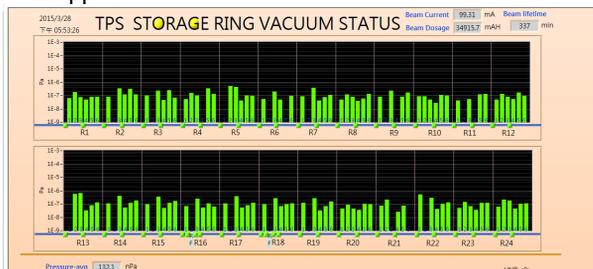
Figure 3: The graphical user interface of the TPS storage ring.

Figure 3 shows the graphical user interface (GUI) of the TPS storage ring. The bar chart of pressure reading and status of SGVs are displayed mainly. All EIGs and SGVs are listed and arranged from R01 to R24 sequentially. Other information including time, beam current, and average pressure of all EIGs also shows in GUI page for easy recording, investigation and problem solving.

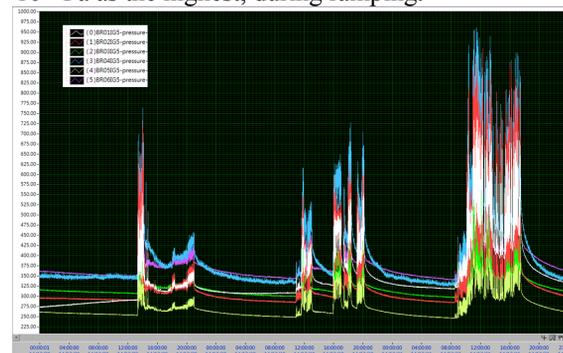
Figure 5: The behaviour of vacuum gauges at booster ring during commissioning.

The commissioning of booster ring was started on 12 December 2014. The electron beam was successfully accelerated to 3GeV on 16 December. During booster commissioning, the behaviour of CCGs at booster ring was shown as Figure 5. The average pressure was 6×10^{-7} Pa before commissioning and raised to 1.26×10^{-6} Pa, 4×10^{-6} Pa as the highest, during ramping.

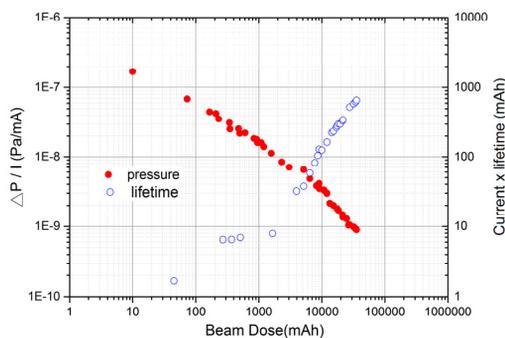
Figure 6: Average pressure rise per beam current and beam life time vs. accumulated beam dose.

After three months commissioning, 100mA beam current was archived and the average pressure reduced to 1.33×10^{-7} Pa while 26 Ah beam dose was accumulated. Just before the machine shut down for the installation of superconductivity cavities and insertion devices, beam dose was accumulated to 35 Ah with 1.17×10^{-7} Pa dynamic pressure. Figure 6 shows the pressure rise per beam current (Pa/mA) vs. accumulated beam dose (mAh). The beam cleaning effect is clear. The beam lifetime also shows in Figure 6. As expectation, beam lifetime increases with decreased pressure. 6 hour beam lifetime at 100mA beam current was archived before machine shut down.

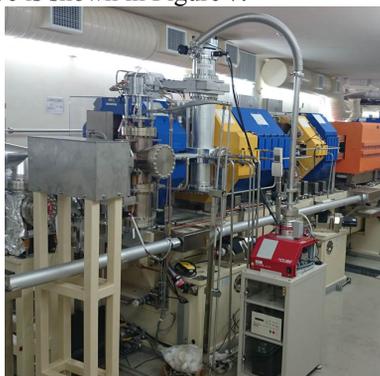
Figure 7: The exhaust pumping system in TPS storage ring.

Second is exhaust pumping systems which were used to enhance the pumping speed and extend the lifetime of NEG pumps near the crotch absorbers. The interlock of pumping system was checked carefully to reduce the risk of air back-stream from atmosphere. The exhaust system including turbo pump, fore-line dry pump, UPS and isolated valve is shown in Figure 7.

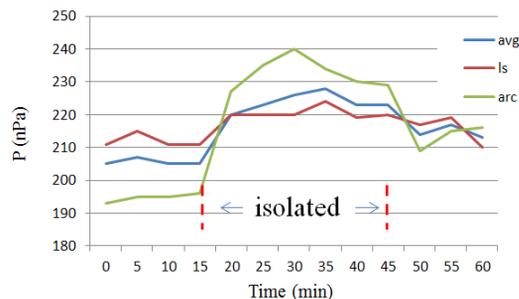
Figure 8: The reading of vacuum pressure when isolating the exhaust systems from vacuum system.

At first, the effect of exhaust pumping system was not clear due to unstable machine condition. One study was implemented by isolating all exhausting systems under stable beam current condition to inspect the performance for beam cleaning. When exhaust systems were isolated, max 20% of dynamic pressure increasing in arc sections and 12% in all average pressure were observed. The readings of vacuum pressure during isolating the exhaust systems were shown in Figure 8.
