DEMAGNETIZE BOOSTER CHAMBER IN TPS

I. C. Sheng[#], C. K. Kuan, C.T.Chen, Y. C. Yang, National Synchrotron Radiation Research Center (NSRRC), HsinChu, Taiwan

In this paper, we present how the booster chamber is uninstalled, demagnetized and reinstalled within three weeks. This procedure is proven to result in the lowest booster chamber permeability in the world and a good high vacuum booster ring is built in 3 weeks.

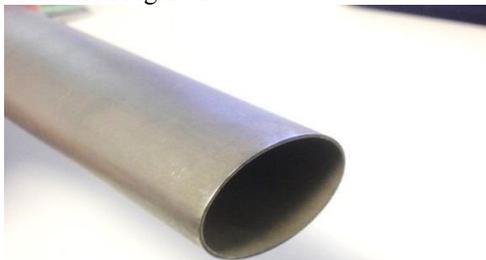
However during the booster commissioning the operation group encountered several problems such as booster dipole magnet power overheated, even the power supply group quickly resolved the problem but the operation staff still had problem to store the beam in the 500m circumference concentric booster chamber. This 35mm x 20mm stainless steel 304 elliptical chamber was drawn from circular stainless steel tube and is 0.7mm thick, as shown in Figure 1.

Figure 1: TPS booster chambers.

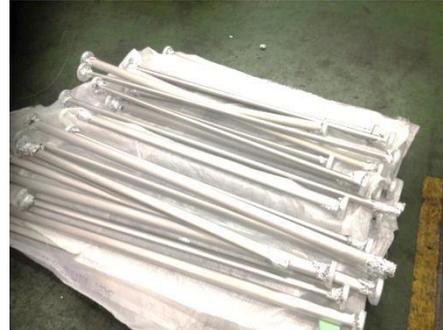
horizontal vacuum furnace which should be able to suit our needs. We ran to Tainan with few test samples and were proven to be better than we expected. In December 1, 2014, we brought total 104 tubes (including 54 bending chambers, 46 straight tubes, 2 spares) to XHT, the furnace is able to take 10~20 tubes per batch. In 35 hours the furnace ran 7 batches and delivered clean, shiny and demagnetized elliptical chambers as shown in Figure 2.

Figure 2: Booster chambers after they are demagnetized.

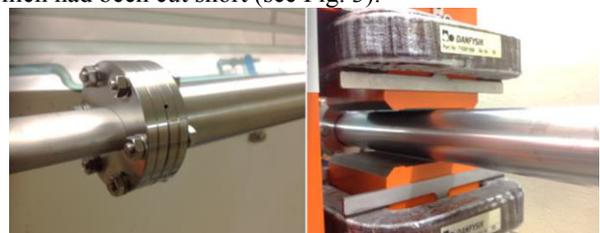
In the meantime total of 97 circular tubes had been fabricated and shipped to the lab in November 30, 2014. Each circular tube has its own specific length to accommodate with that of the original elliptical tube which had been cut short (see Fig. 3).

Figure 3: Left: elliptical chamber connected with circular chamber. Right: circular chamber goes through booster corrector magnet.

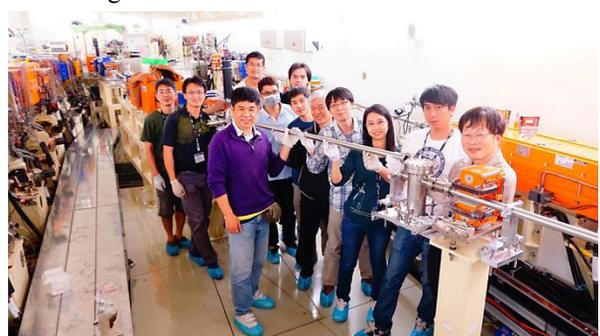
The vacuum group connected the very last demagnetized booster chamber in November 10, as shown in Figure 4.

Figure 4: Vacuum group connect the very last booster chambers.
