A NUMBER OF UPGRADES ON RHIC POWER SUPPLY SYSTEM*

Collider-Accelerator Dept., Brookhaven National Laboratory, Upton, NY 11973, USA

Abstract

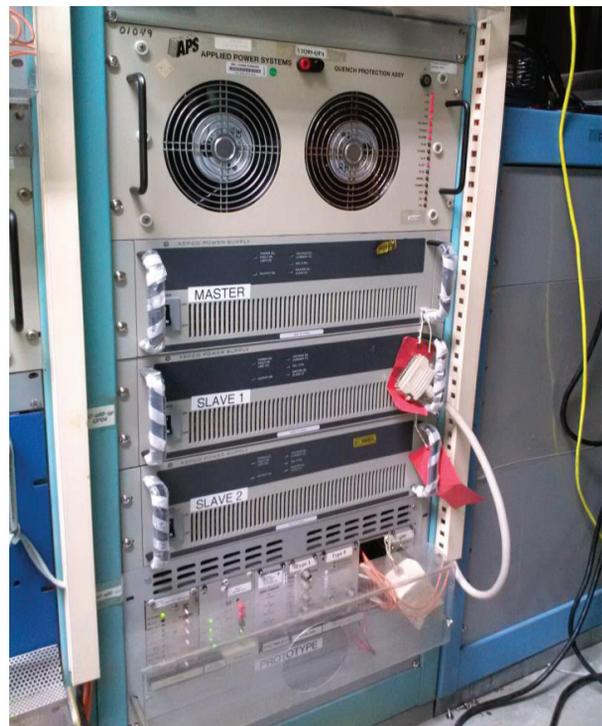
Figure 1: 3 Keeco 10-100GL Units In Parallel.

Based on requirements at various locations, we have power supplies that operate between +/-100A, +/-150A and +/-300A. We have chosen a Kepco 10-100GL model [2] as the base unit for this work. This model can be used as single power supply that operates at +/-100A and also can be paralleled up to a maximum of 4 units. This model allowed us to select how many supplies we need to parallel. For under +/-100A load requirement, we only use a single unit to power a magnet; for under +/-150A load requirement, we parallel 2 of these models etc. (See Figure 1 for 3 units in parallel connection)

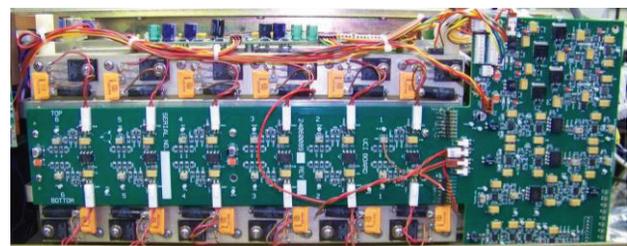
Figure 4: New PCB Installed to Replace Old 3 PCBs in Same Location.

The bipolar 150A/300A model power supplies have many PC boards installed by the original manufacturer. Three critical PC boards are internally connected by box style connectors. A newly designed circuit board, was designed which replaced these 3 critical PC boards. Now the 3 PC boards were consolidated into one PC board (Figure 4). In doing so the original 3 PC board inter-board connections (which were unreliable) were abandoned and are now internal traces on the new board which offers a

much higher level of reliability. Furthermore, the newly designed circuit board replaces all obsolete parts, and added new ground planes to provide noise immunity. Replacing these 3 original PC boards with one board has increased the reliability of this type power supply.
