DEFECT LOCATION IN SUPERCONDUCTING CAVITIES COOLED WITH HE-II USING OSCILLATING SUPERLEAK TRANSDUCERS*

Z.A. Conway[#], D.L. Hartill, H.S. Padamsee, and E.N. Smith, CLASSE, Cornell University, Ithaca, NY, 14853, U.S.A.

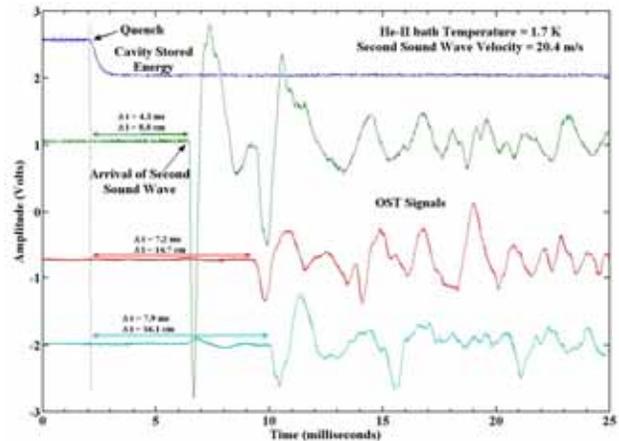
Figure 1: A typical quench event observed with three different transducers. The top trace is the amplitude of the cavity RF field. The lower three traces are the second sound signals measured with 3 distinct OST. The variation in the second sound wave time-of-arrival is well correlated with the variation in propagation distance to each transducer.

Figure 1 shows the experimental data from an observed quench at 1.7 K. The top, step-like, trace shows the cavity field amplitude in a single-cell TESLA-style cavity, which was excited with an RF pulse to $E_{acc} = 28$ MV/m. At this accelerating gradient the resonator quenched and the RF field decays. The lower three traces show the signals measured with three distinct OST

immersed in the superfluid helium bath with the cavity. For clarity the other five transducer signals are not shown. In figure 1, the OST detect the arrival of the second sound wave 4.3 ms, 7.2 ms, and 7.9 ms after quench. This indicates that the defect in the cavity is 8.8 cm, 14.7 cm, and 16.1 cm from each OST respectively. Please note, this picture is representative of many quench events and the process is highly repeatable.

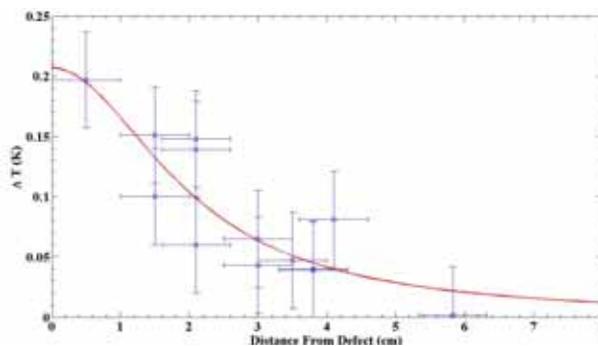
Figure 2: An example of the spatial distribution of cavity heating due to a defect.

Figure 2 compares the second sound defect location to the actual defect's temperature distribution for a cavity excited to a field amplitude of $E_{acc} = 23$ MV/m just below the quench field of 24 MV/m. There are two sets of data shown here:

- The temperature rise of the cavity outer surface measured with a thermometer array centered on the second sound determined defect-location, the solid points with error bars.
- The estimated heating due to a simulated defect from thermal model codes [8], the continuous line.

The horizontal axis is the radial distance away from the defect location determined by second sound. The vertical axis is the temperature rise due to heating, the difference between the measured temperature at $E_{acc} = 23$ MV/m and the measured temperature when the cavity is not excited. Notice, the defect location determined by thermometric measurements agrees with the second sound measurements to ~ 5 mm.

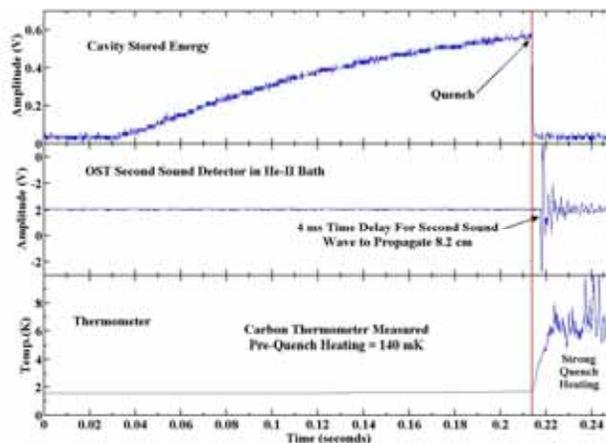
Figure 3: A single quench event measured with an OST in the He-II bath 8.2 cm away from the cavity defect and with a carbon thermometer attached to the cavity surface 2 cm away from the cavity defect.

Figure 3 compares the dynamic heating of the cavity to the detection of second sound waves. There are three sets of data shown. The top trace is the amplitude of the cavity RF field. The middle trace is the signal from an OST located 8.2 cm away from the defect in the helium bath. The lower trace is the cavity surface heating measured with a carbon thermometer in contact with the

cavity outer surface and 2 cm away from the defect. During quench the cavity heats to >9 K, the critical temperature of niobium. The second sound detector does not measure the arrival of the second sound wave (heat) until after it propagates to the OST. Notice the change in temperature scale between figures 2 and 3. The thermometer in figure 3 heats 140 mK just before quench, an amount only barely visible on this scale. After quench it warms up, 6K is the upper temperature limit of the electronics used for this measurement.

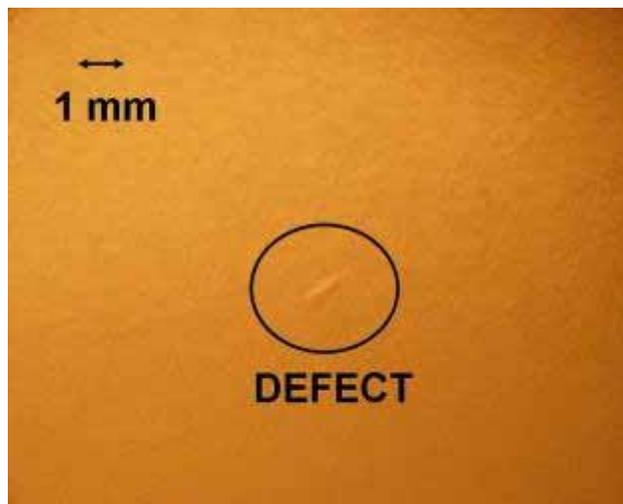
Figure 4: Defect located with second sound.

First, two single-cell cavities were defect limited due to a flaw in the die used to form the cavities. The initial cold tests found these cavities defect limited and second sound measurements located the defects to the same spot on the cavity surfaces. Subsequent optical inspection found a strange bump which was quickly determined to be due to a flaw in the die used to form the cavities. Removing the

bumps with BCP etching removed the defects and increased the cavity quench fields. Figure 4 shows the cavity defect. This defect was located with second sound measurements with a single cold test. For both cavities, fixing the defect increased the cavity accelerating gradient from ~ 20 MV/m to ~ 30 MV/m.

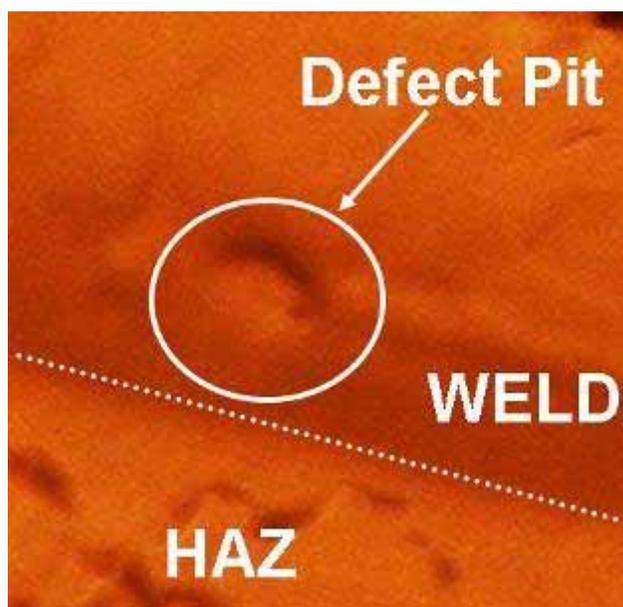
Figure 5: Defect located with second sound on a cavity equator weld. The defect is circled and the weld and heat affect zone (HAZ) are labeled [9].

In another example, second sound measurements located a pit-defect on the equator weld of a reentrant 9-cell cavity, reported on in [9]. Note that this pit is on the weld and not in the heat affected zone. This cavity was tumbled, removing just enough material to eliminate the weld pit. After reprocessing the cavity accelerating gradient exceeded 30 MV/m; previously the defect-limited cavity quenched at 15 MV/m [9].
