# BEAM COMMISSIONING OF INJECTION INTO THE LHC

V.Mertens, I.Agapov, B.Goddard, M.Gyr, V.Kain, T.Kramer, M.Lamont, M.Meddahi, J.Uythoven, J.Wenninger, CERN, Geneva, Switzerland

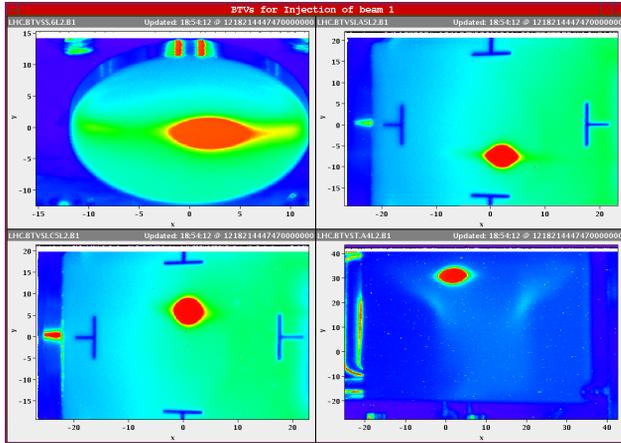
Figure 2: Injected Beam 1 on screens in IR2 on 8 August 2008, top left: after MSI, top right/bottom left: before/after MKI, bottom right: at TDI (MKI off).

understood as a simple polarity confusion, since corrector type magnets are by convention cabled with opposite polarity to bends. After ironing this out the beam passed through the injection septa and kickers (which were initially switched off) and was stopped by the TDI, Fig. 2. After some verifications and adjustments the kickers were timed in and switched on, while the beam was still stopped by the TDI, entirely closed for this purpose. After all basic checks were done the beam was allowed to continue into the LHC.

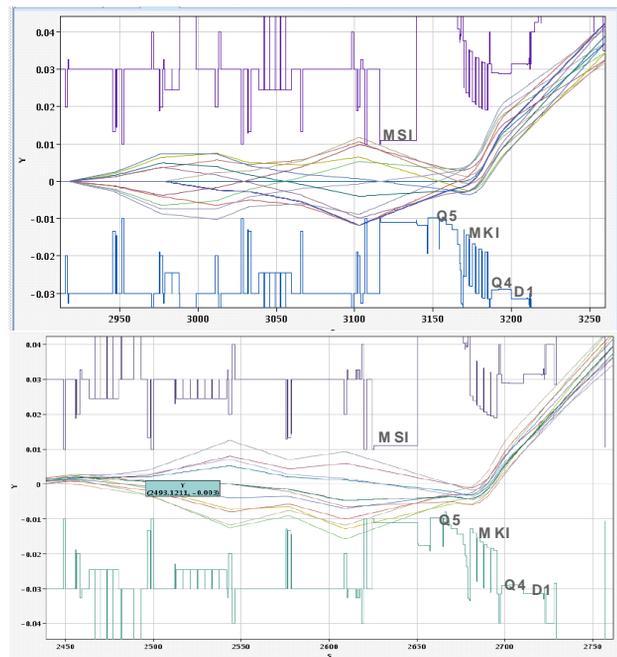
Figure 4: Vertical aperture scans of the injection regions in IR2 (top) and IR8 (bottom). The estimated edge of the beam envelope is plotted, calculated by adding the actual trajectory to the beam size. The MKI are off, and the beam direction is from left to right in both cases.

The apertures in the injection region were measured with a pair of correctors using the single pass technique of unclosed oscillations at phases of 0, 30, ..., 330 degrees, with a small emittance pilot beam ( $\epsilon_n$  of about 1  $\mu\text{m}$  per plane). The 20 mm aperture of the MSI protection device TCDIM was confirmed, with the beam well-centred in IR2 and displaced vertically by about 2 mm in IR8, Fig. 4. In IR2, however, during the first test it was quickly apparent that the vertical aperture between the MSI and the downstream Q5 quadrupole was about 6 mm smaller than expected. A radiation survey after the test confirmed a hot-spot on a vacuum valve assembly; checks revealed that this element was installed 10 mm too high. After a re-alignment the next check with beam showed that the aperture was as expected.

Some early injection steering was done for Beam 2, which was initially several mm off in the vertical plane (see Fig. 4). The algorithm converged correctly; there was no time however to re-measure the aperture and also to revisit the MSI and MKI strengths.
