MONITORING THE FLASH CRYOMODULE TRANSPORTATION FROM DESY HAMBURG TO CEA SACLAY: COUPLER CONTACT, VACUUM, ACCELERATION AND VIBRATION ANALYSIS

Abstract

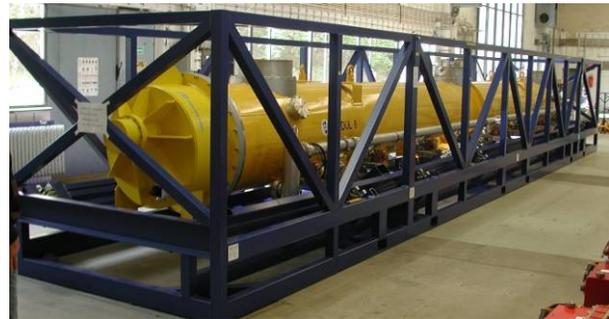
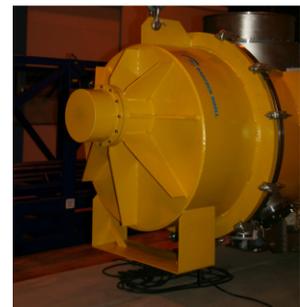
Figure 1: The damping frame, the coils and an end cap.

The cryomodule is supported with a metallic frame consisting of two cages, one fixed to the truck and the other damped with helical coils in a compression-roll configuration connected to the cryomodule. The coils are

designed to attenuate the shocks between the base frame and the module.

The supporting system includes two end-caps to lock the helium gas return pipe position at the end position and to avoid transversal movement of lateral supporting posts which can cause stresses in the epoxy glass pipes.

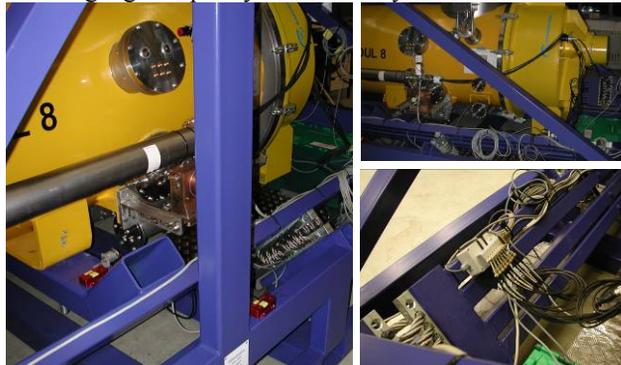
Figure 2: The installed instrumentation.

- 4 vacuum gauges: 2 monitoring the vacuum level in the coupler line (static vacuum), 2 for the beam line vacuum (cavities travel in static vacuum condition);
- a circuit to monitor coupler antenna shorts;
- 2 independent systems of accelerometers: Monilog and Sensr GP1 sensors (each system with a sensor on the fixed frame and one on the damped one);
- 4 geophones: 3 already installed inside the module (one on the center cavity, 2 on the magnet) and one on the damped frame. The geophones are equipped with a feedback circuit to extend the low frequency (1-10 Hz) acceleration mechanical range from 0.15 to more than 4 g peak-to-peak [1].

The data measured by the gauges, the coupler circuit outputs and the geophones were recorded through a stand alone data logger with a sampling rate of 180 sample/s, allowing a good quality Fourier analysis.

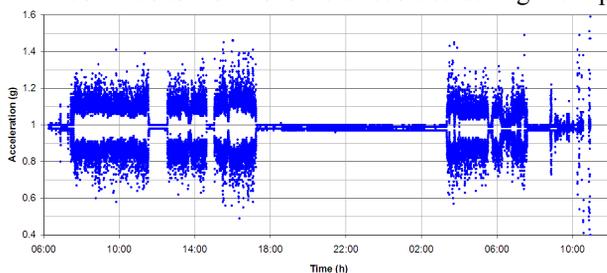
Figure 3: Data recorded by the accelerometer on the inner frame during the travel to Saclay on the vertical direction.

Figure 3 shows an example of the time behaviour of the acceleration measured during the travel. The night stop and other shorter stops can easily be recognized. Moreover, no peak shocks were measured by the sensor, while continuous vibrations were recorded during the trip.

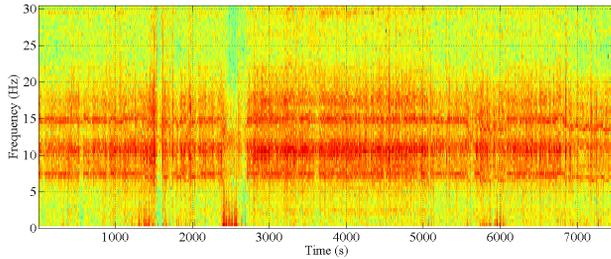
Figure 4: Spectrogram of the selected range, geophone 4 (vessel vertical movement). Frequency range: 0 – 30 Hz. Three frequencies can be recognized ~7, ~11 and ~15 Hz.

A comparison of the obtained spectrograms shows that frequencies repeat in the four graph and are presumptively frequencies due to an overall movement of the structure cryomodule and frame, rather than excited modes of a specific part. The frequencies are shown in table 3.

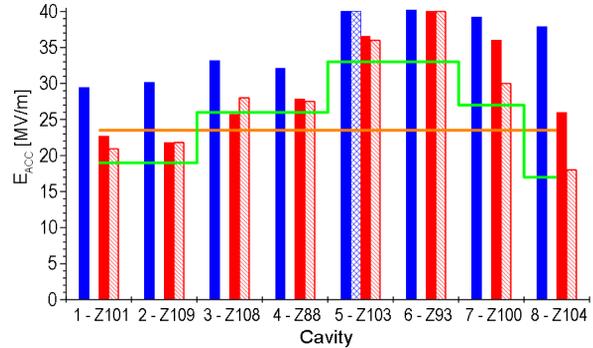
Figure 5: RF performances of the M8 cavities (blue: vertical test – dashed blue: horizontal test – red: test on CMTB before transportation – dashed red: test on CMTB after transportation) – green: FLASH, orange: XFEL goal

After the transportation the cavity performances have been tested (dashed red in fig. 5) on the Cryo_Module Test Bench (CMTB) at DESY and the results compared with the set of tests performed before the transportation (red in fig. 5).

The data shows a lowering of the maximum accelerating gradient of the last 2 cavities in the string with respect to the data collected before the transportation. As a part of the degradation was already observed after the string assembly during the first test in CMTB, it could be that some contamination was transported during the procedures related to the module transport e.g. pumping and venting cycles related to installation from and to the test stand. A direct correlation to the transport itself can neither be established nor excluded.
