THE CERN LHC - WORLD'S LARGEST VACUUM SYSTEMS

J.M. Jimenez*, CERN, Geneva, Switzerland

Abstract

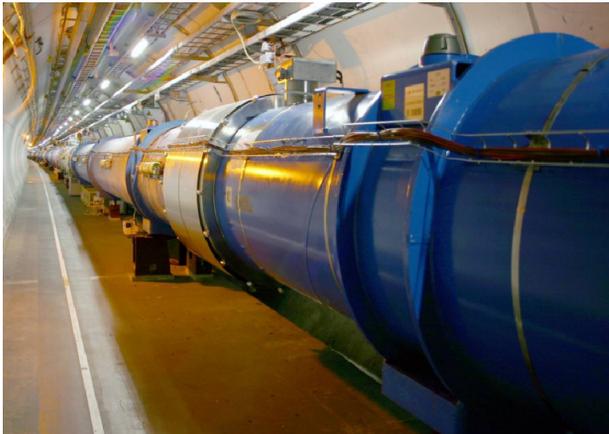
Figure 1: Picture of an LHC arc showing the magnet cryostat envelopes.

In the arcs (Fig.1) and by design, the beam vacuum is a non-baked vacuum since the beam pipe (called cold bore) is in contact with the magnet coils which cannot be baked. The beam and vacuum requirements lead to the use, for the first time in an accelerator, of a "beam screen" [3]. Inserted in the cryomagnet cold bore and operated between 5 and 20 K, it aims to intercept most of the heat load. Indeed, the removal of 1 W at 1.9 K requires nearly 1 kW of electric power. The cryopumping of gas on the cold surfaces ensures the required beam lifetime. The most critical species (H₂ and He) are kept within acceptable limits by means of holes in the beam screen allowing the transfer of desorbed molecules to the magnet cold bore surfaces where they can no longer be re-desorbed. A theoretical calculation shows that the huge cryopumping will bring the pressures well below 10⁻¹⁰ Pa.

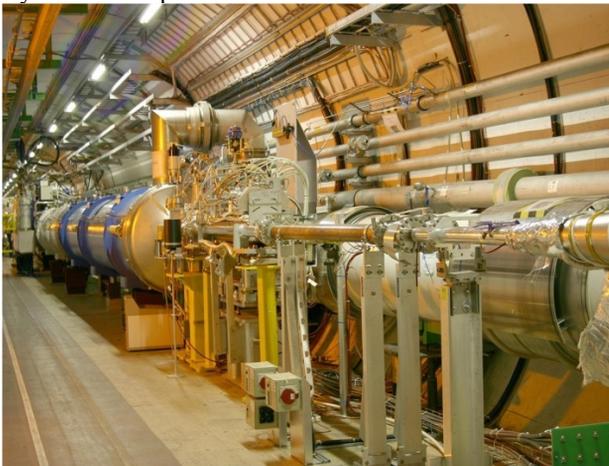
Figure 2: Picture of a long straight section showing a standalone cryomagnet (left) and the QRL line (right).

In the LSS (Fig.2), satisfying the beam and vacuum stability requirements implied the design of complex transitions, radiofrequency shielding and the development of ultra-thin (0.3 mm) bake-out equipment using the wrapping technology of a steel heating band isolated by

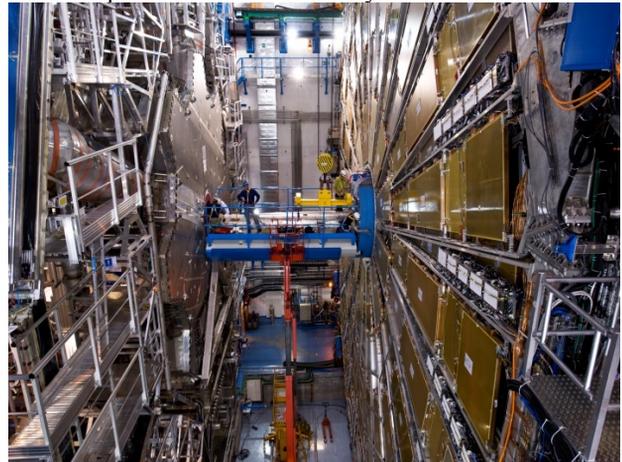
Figure 3: Installation of the last experimental beam pipe in the centre of the ATLAS detector.

The detector beam pipes (Fig.3), their associated instrumentation, pumping and bake-out equipment were both an engineering and integration challenge since encapsulated in the detectors. To maximise the detector resolution, transparent materials (beryllium and aluminium) have been used for beam pipes and bellows.

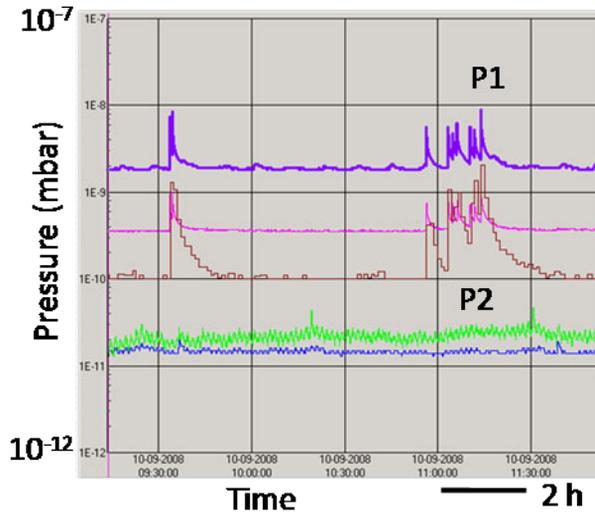
Figure 4: Pressure rise observed in the LHC-LSS induced by a single bunch beam impacting the collimator jaws.

bending section. At each step, the beam was stopped by the collimators which jaws were closed on purpose. Even the low intensity (5.10^9 p/bunch, single bunch) beams induced a factor 10 in pressure rises at the location of their stoppage (Fig.4).

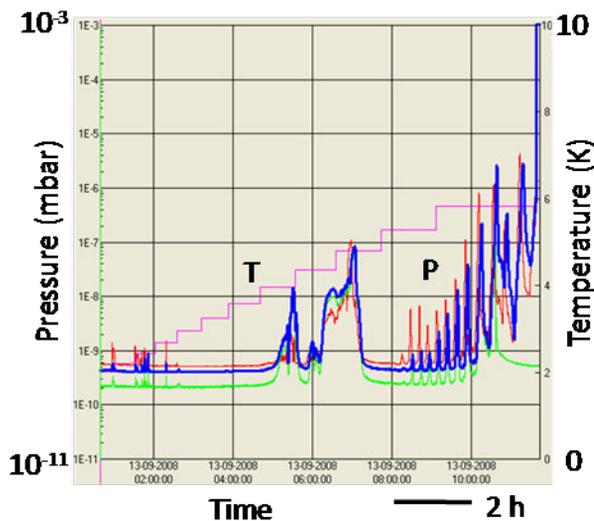
Figure 5: Hydrogen partial pressure oscillation resulting from minor temperature variation around 5 K.

At cold, the pressure in the beam pipe is strongly dependent from the temperature and small variations can lead to pressure oscillations of hydrogen and helium (in case of leaks). An illustration can be observed in Fig.5 which shows a hydrogen oscillation in the beam screen induce by temperature oscillations around 5-6 K.

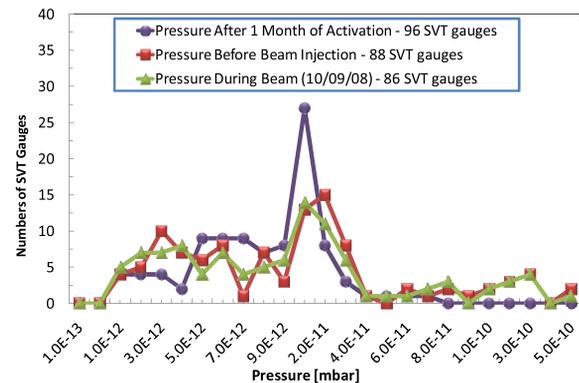
Figure 6: Static pressure distribution in the NEG-coated sectors of the LHC-LSS.

As expected, the static pressures in the RT vacuum sectors with NEG coatings are in the 10^{-10} Pa range (Fig.6), the pressure indications being dominated by the local outgassing of the gauge port [4].

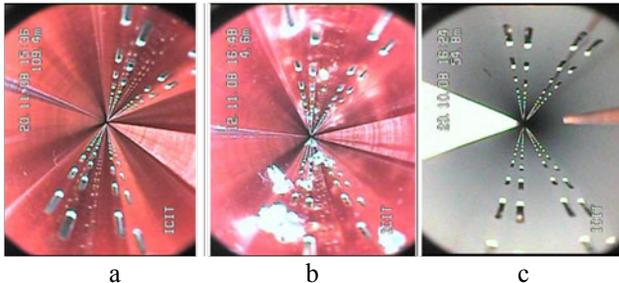
Figure 7: MLI (a) and soot (c) as appearing by endoscopy inside the beam screen compared to a clean BS (a).

On 19 September 2008, during the powering test of the main dipole circuit in sector 3-4, an electrical fault occurred producing an electrical arc and resulting in mechanical and electrical damages, release of helium from the magnet cold mass, venting and contamination of the insulation and beam vacuum enclosures (Fig.7 and 8).

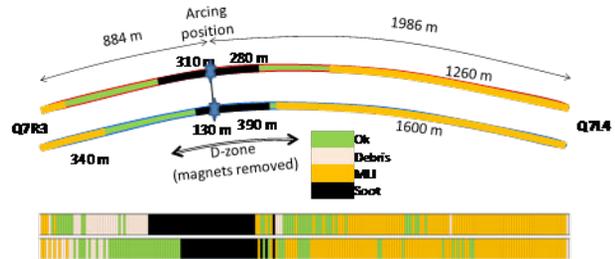
Figure 9: Schematic view of the results of the endoscopy in the sector 3-4.

The entire sector 3-4 was affected on both apertures since the arc beam vacuum is not sectorized. As shown by Fig.9 and in Table 1, the contamination extended to the entire arc, the soot remained, luckily, confined within the D-zone [5].

As shown by Fig.9, the beam vacuum magnet pipes contaminated by soot were all within the D-zone at the exception of 6 magnets within the half-cell 19R3 and 20R3. All other magnets, 53 in total (14 quadrupoles and 39 dipoles) were removed from the tunnel and treated at the surface. Among these 53 magnets removed from the tunnel, only 16 have been recovered to be reinstalled in sector 3-4 (7 MQ and 9 MB), requiring the exchange of 13 beam screens which were heavily contaminated by soot. The beam screens of the remaining 5 magnets (2 MQ and 3 MB) were conforming and were not exchanged.

The systematic endoscopy of both apertures, cm-by-cm 4.8 km in total for the two apertures, revealed the presence of the following types of debris: metallic debris (coming from the RF fingers, cold bore, beam screen and bellows), MLI and fibres. The dispersion along the arc and apertures (see Fig.9) is not explained, the metallic debris were all localised in the left side of the sector 3-4
