Status of LHC Commissioning

J. Wenninger
CERN Beams Department
Operation Group

Status of LHC Commissioning - PAC09 - Vancouver

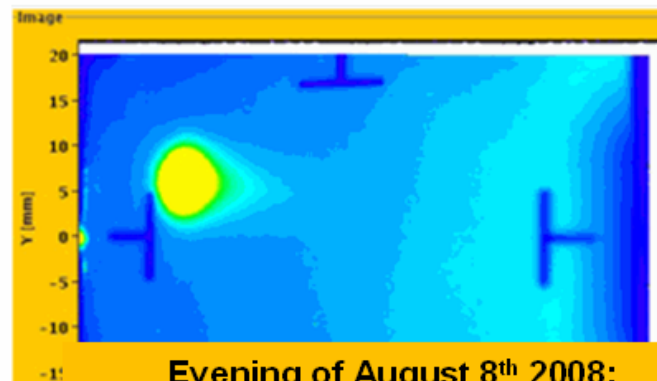
Evening of August 8th 2008:
*First beam in the LHC after ~25 years
of design and construction.*

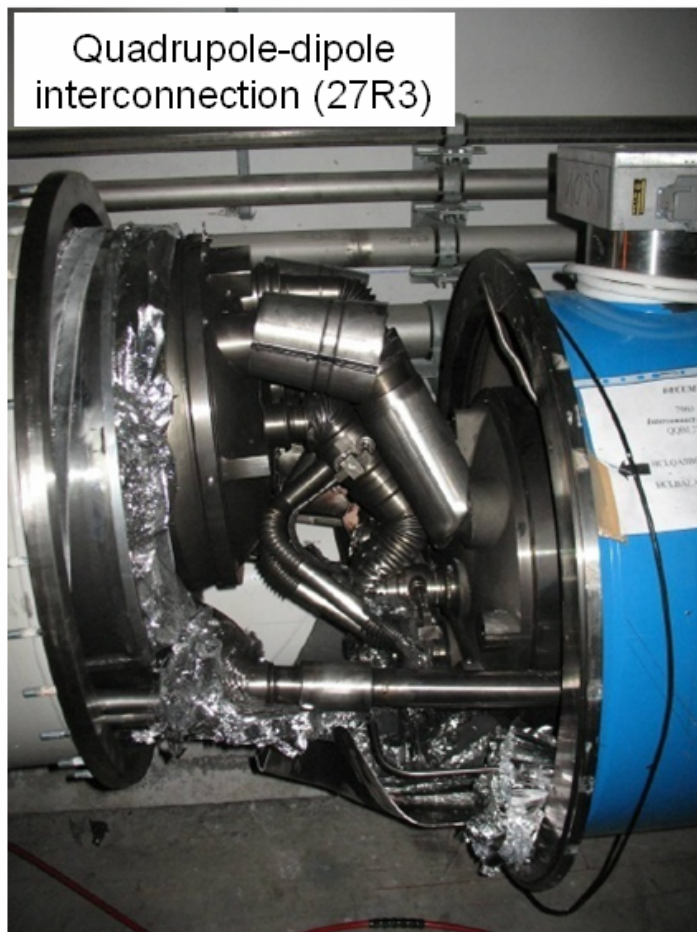
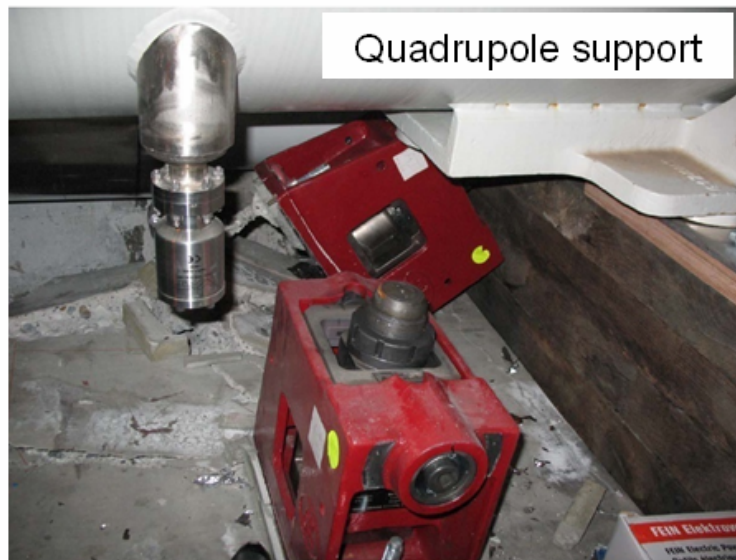
Collateral damage : displacements

Main damage area ~ 700 metres.

- **39** out of 154 **dipoles**,
- **14** out of 47 **quadrupole** short straight sections (SSS)

from the sector had to be moved to the surface for repair (16) or replacement (37).

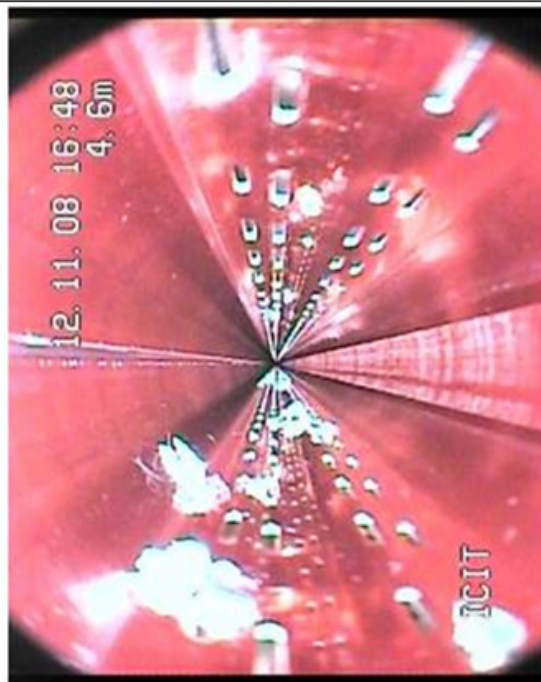
Beam screen contaminated
with multi-layer magnet
insulation debris.

≈ 60% of the chambers

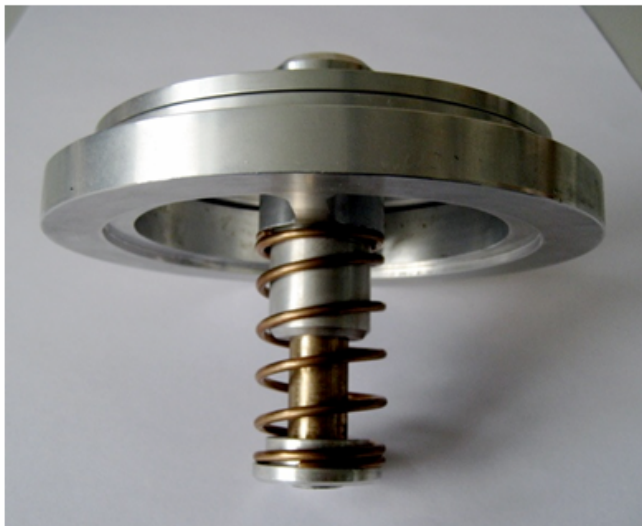
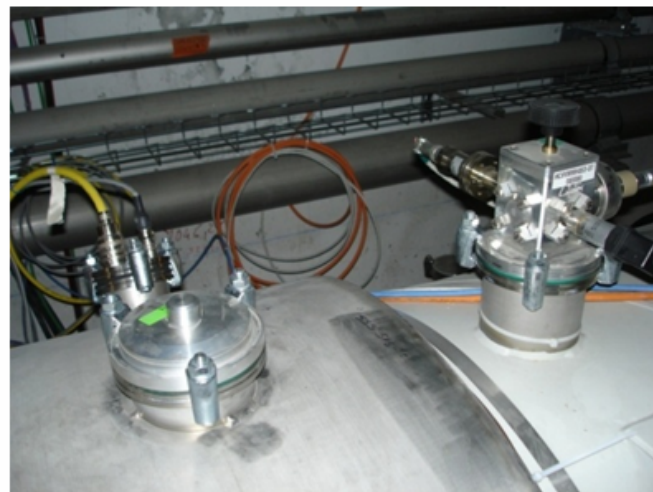
Existing relief valves (quadrupoles)

- Designed for He flow of 2 kg/s
- Estimate for incident is ~ 20 kg/s

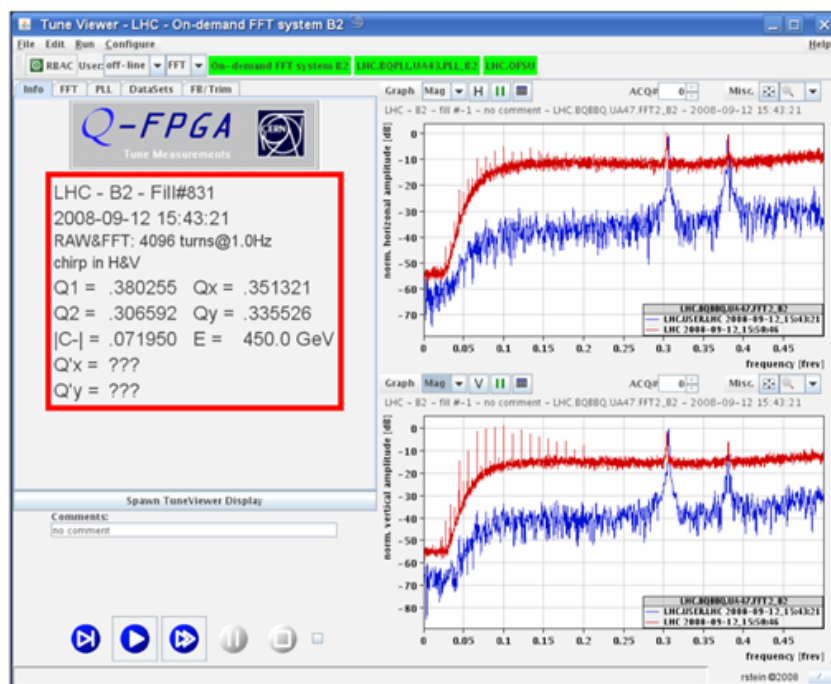
Magnetic model

- Momentum (b_1 [US=b0]):
 - LHC average momentum = 450.5 ± 0.2 GeV
 - Δb_1 between rings $\approx 1.5 \times 10^{-4}$
 - Δb_1 among 8 sectors $\approx 3 \times 10^{-4}$
- Tune (b_2 [US=b1]):
 - Measured tunes are within 0.15 of nominal ones.
 - Corresponds to an error of 25×10^{-4} on b_2 , expected $\pm 20 \times 10^{-4}$.
