X-Band Photonic Bandgap (PBG) Structure Breakdown Experiment

Roark Marsh, Michael Shapiro, Richard Temkin,
PSFC, MIT, Cambridge, MA 02139, USA

Valery Dolgashev, Sami Tantawi,
SLAC, Menlo Park, CA 94025, USA

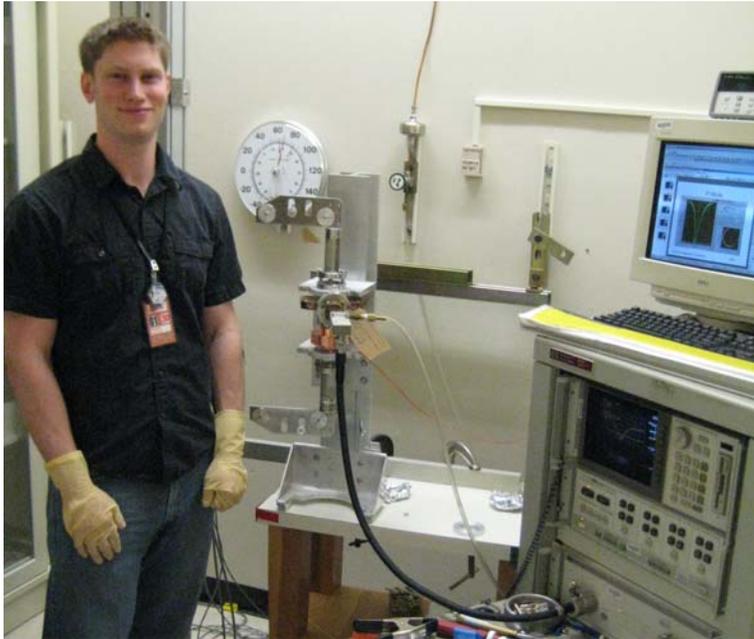
PBG Structure Cold Test

- ❑ Frequency: 11.424 GHz
- ❑ Field: $\frac{1}{2}$ field in coupling cells, full field in test cell
- ❑ Coupling: near critical

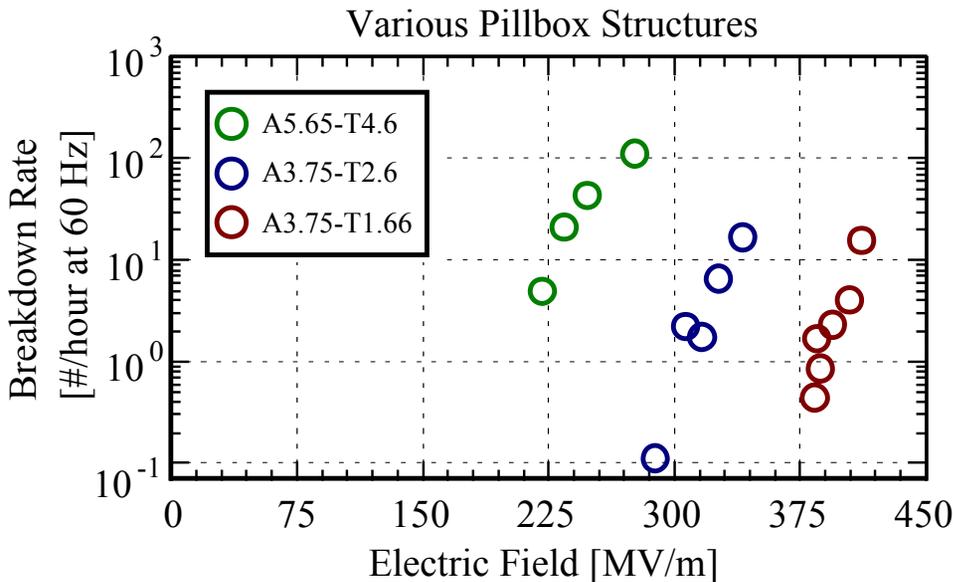
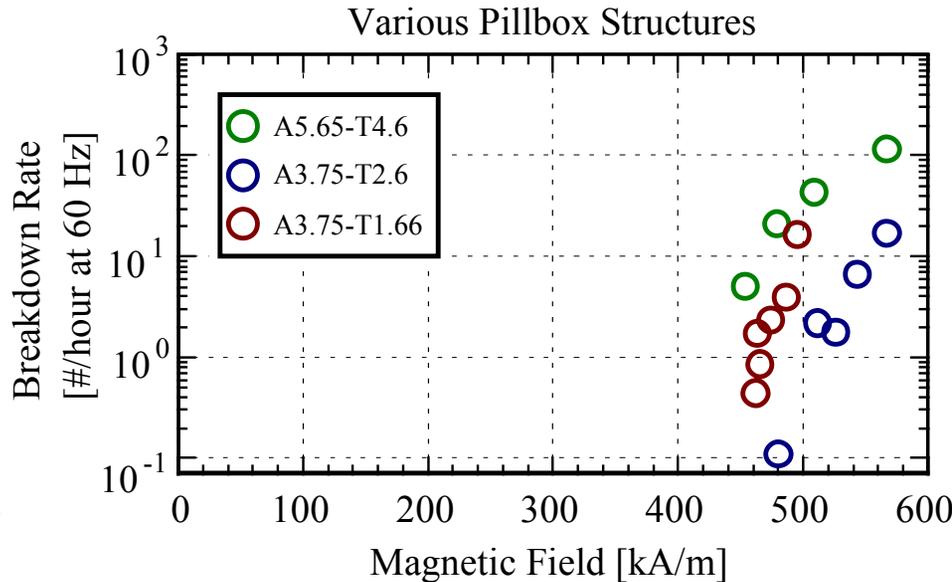
Pillbox Breakdown Results

- ❑ 17 Structures tested to date
- ❑ Various pillbox geometries can be compared
- ❑ Gradient is a two-dimensional problem: rate vs gradient, or other field parameters
- ❑ Data collapses when looking at magnetic field?
