**國家同步輻射研究中心**  
National Synchrotron Radiation Research Center

*Particle Accelerator Conference,  
4-8 May 2009, in Vancouver, BC, Canada  
Abstract ID: 2426 ; Paper ID: WE4RAC03*

# **Fifteen Years Operation Experiences of TLS Vacuum System**

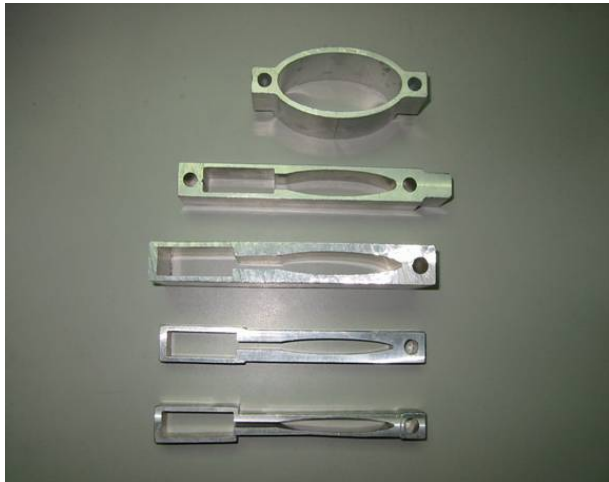
## S-Chamber

- Al Extrusion
- Chemical cleaning by acid
- TIG welding in clean room

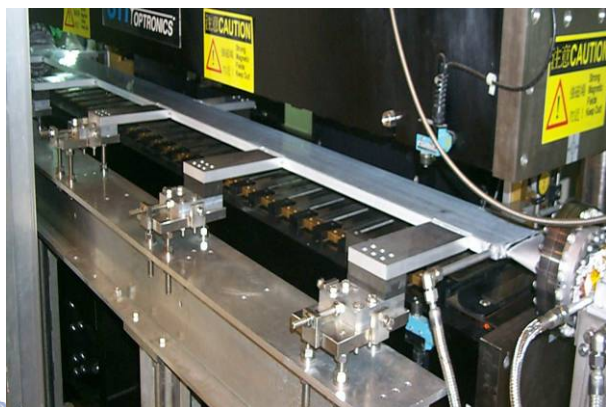
# W20 Vacuum Chamber

17 mm

Strip-type NEG pump

1. Extrusion of the pipe
2. Machining the welding edges and cooling edges
3. Chemical cleaning by acid
4. TIG welding the supporting pads, cooling joints, tapers, and flanges
5. Surface finishing by CNC machining in ethanol
6. Insert NEG strip assemblies and feedthroughs

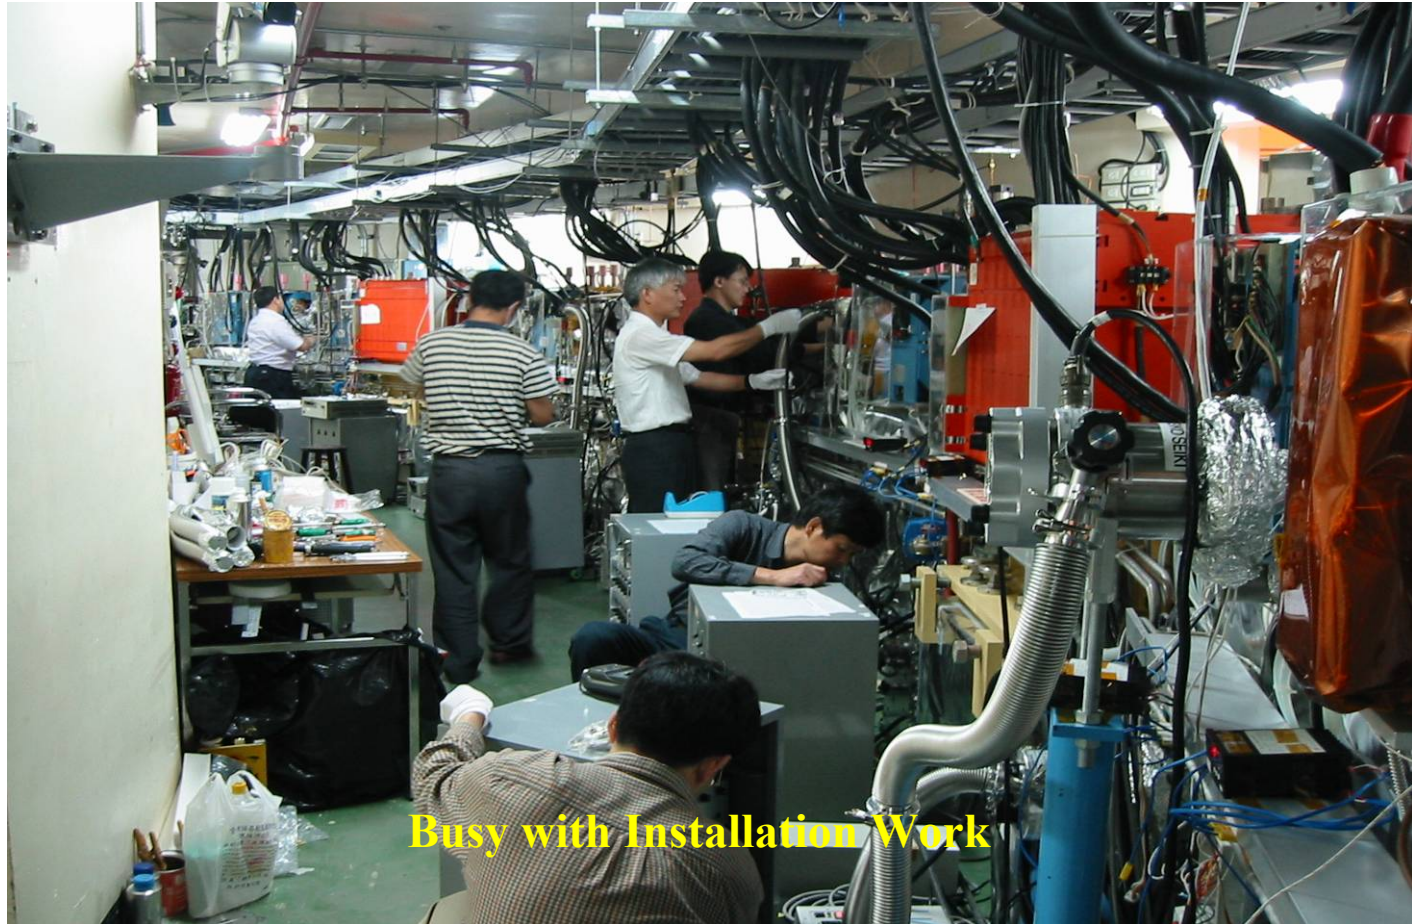
# Most of the vacuum problems caused by the baking during maintenance in the Tunnel

6. In-situ baking not only causes the problems of damage the vacuum components or positional shift due to thermal expansion, but also leave the heavy work loads and long time for the maintenance inside the tunnel. It is better to complete the baking for the vacuum components outside the tunnel and assure the good ultrahigh vacuum qualities being achieved, then using the super-dry N<sub>2</sub> purging and super-dry ambient air shower exposing system and procedure for the installation of UHV components to avoid the in-situ baking inside the tunnel.

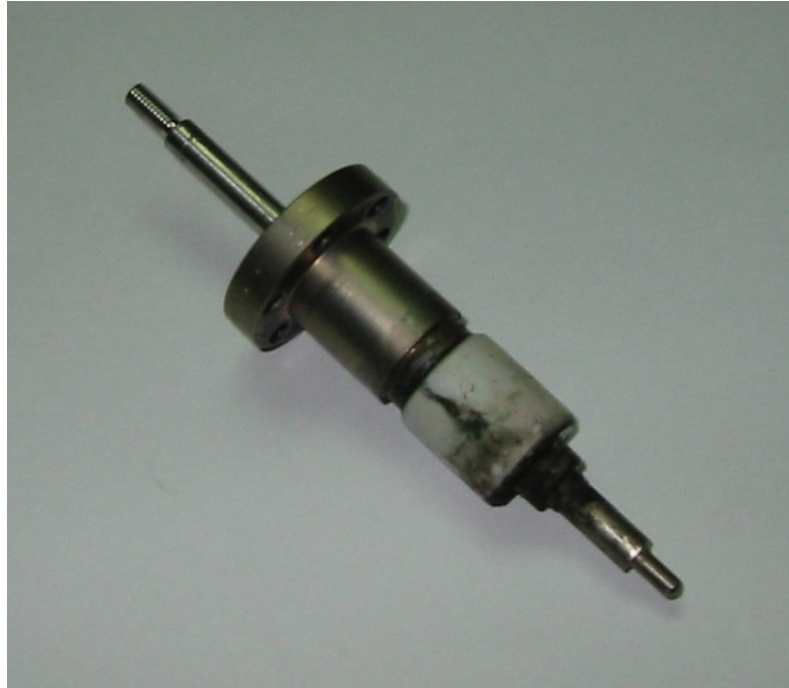
# High Temperature Baking Problems

**A feedthrough of the ion pump was broken due to high voltage sparking when degassing during the baking. Number of times for switching the IP on are reduced to  $< 3$  times.**

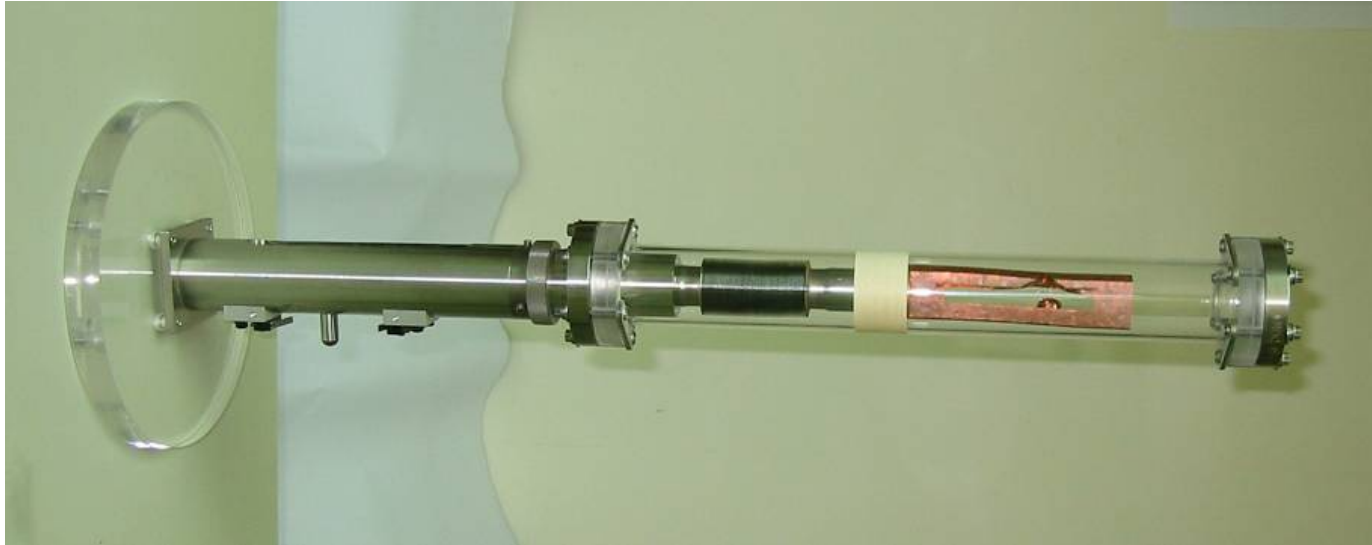
# Problem of Over Heating

**A photon aperture, horizontally installed in a front end, was melt down due to insufficient water cooling. Each loop of cooling water pipes for the absorbers or masks should connect the flow rate meter and link to the interlock system.**

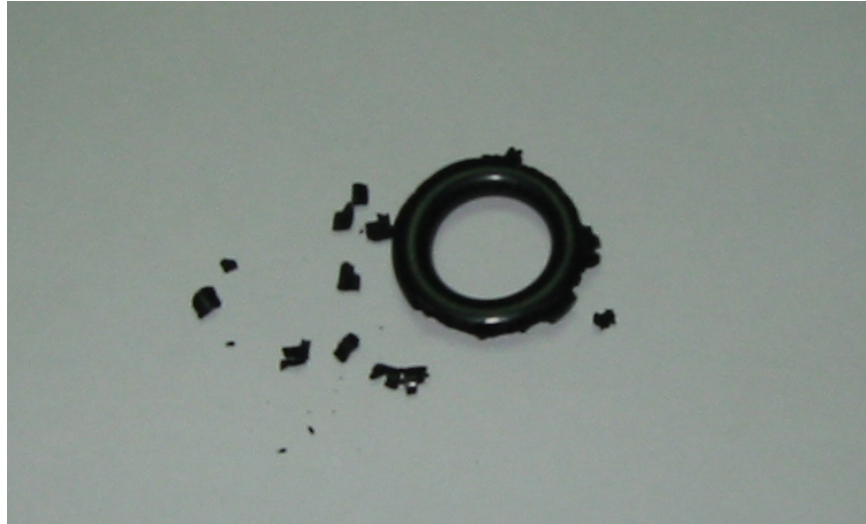
# Radiation Damage Problems

**An O-ring for a turbo-molecular pump located near the extraction septum chamber of 1.5 GeV booster synchrotron was damaged after high dosage rate irradiation. The pumps with O-ring contained has been removed from high dosage area after using.**

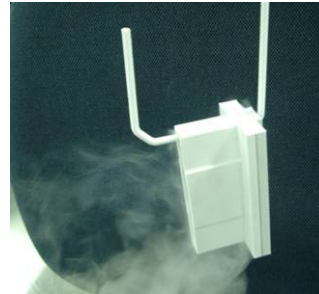
Bimetal LN<sub>2</sub> Test

(1) Al Beam duct

1. Length: 1.1 m
2. Inner width: 80 mm
3. Inner height: 11 mm
4. Outer height: 13 mm
5. Operating temperature: 100 K
6. Higher thermal conductivity
7. Lower emissivity

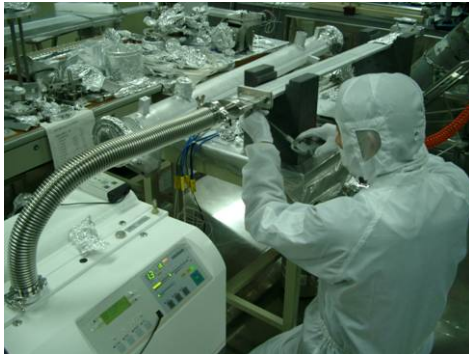
Leakage Check

Flatness Check

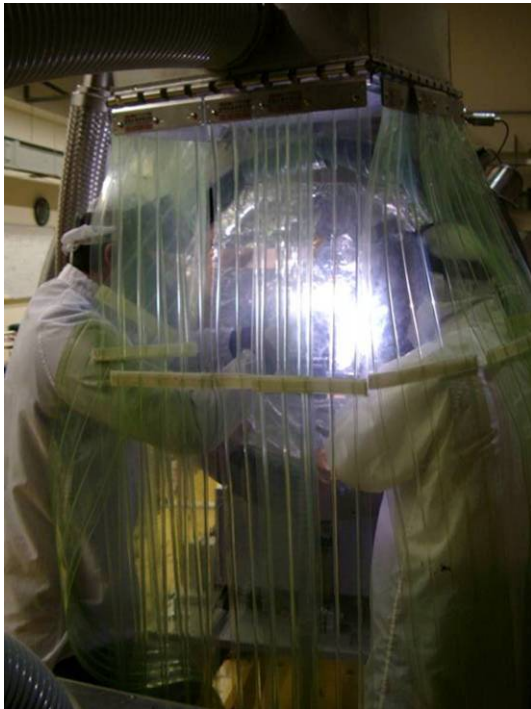
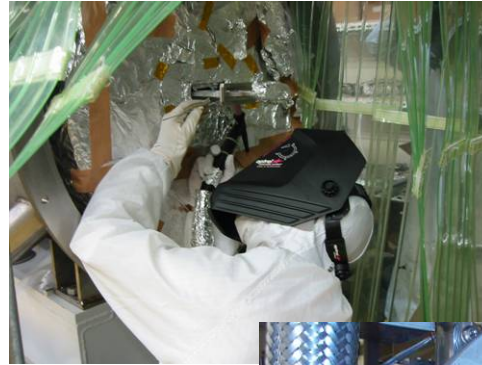
# SW6 Vacuum Chamber Welding

TIG Welding for Al beam duct

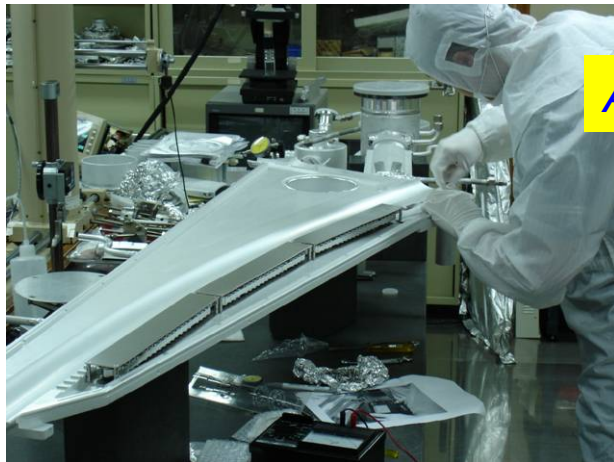
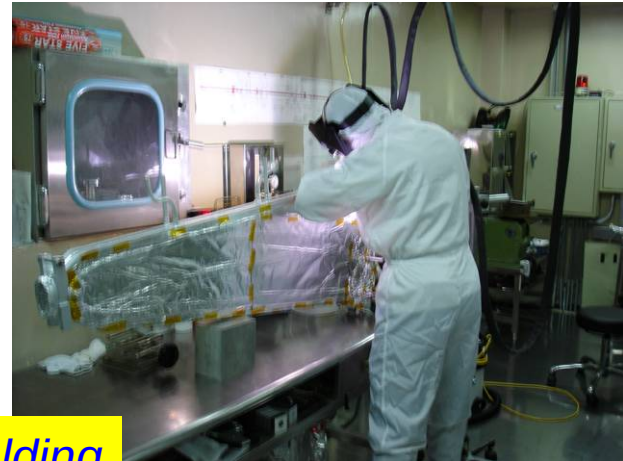
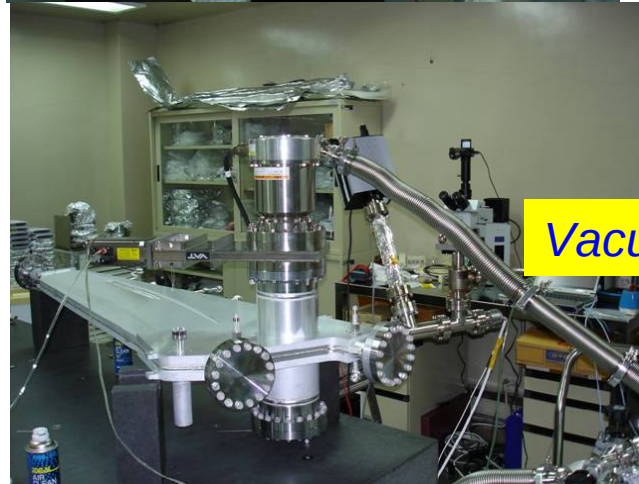
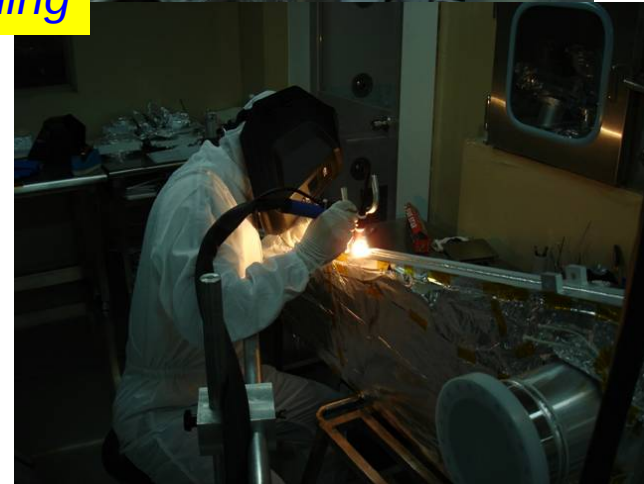
# Assembly, Welding and Testing (at NSRRC) for the B-Chamber

Assembly

TIG Welding

Vacuum Test
