Application of Electro-Chemical Buffing to L-Band Superconducting RF Cavities

H.Kitamura, Y.Kojima, Y.Kijima, Y.Murai
S.Noguchi*, M.Ono*, K.Saito*, T.Shishido*, Y.Baba**, K.Sato**

Mitsubishi Electric Corporation
1-1-2 Wadasaki-cho, Hyogo-ku, Kobe-shi 652, Japan
KEK, High Energy Accelerator Research Organization
1-1 Oho, Tsukuba-shi, Ibaraki-ken 305, Japan
Ultra Finish Technology Co. Ltd.
4-1 Mizue-cho, Kawasaki-ku, Kawasaki-shi 210, Japan

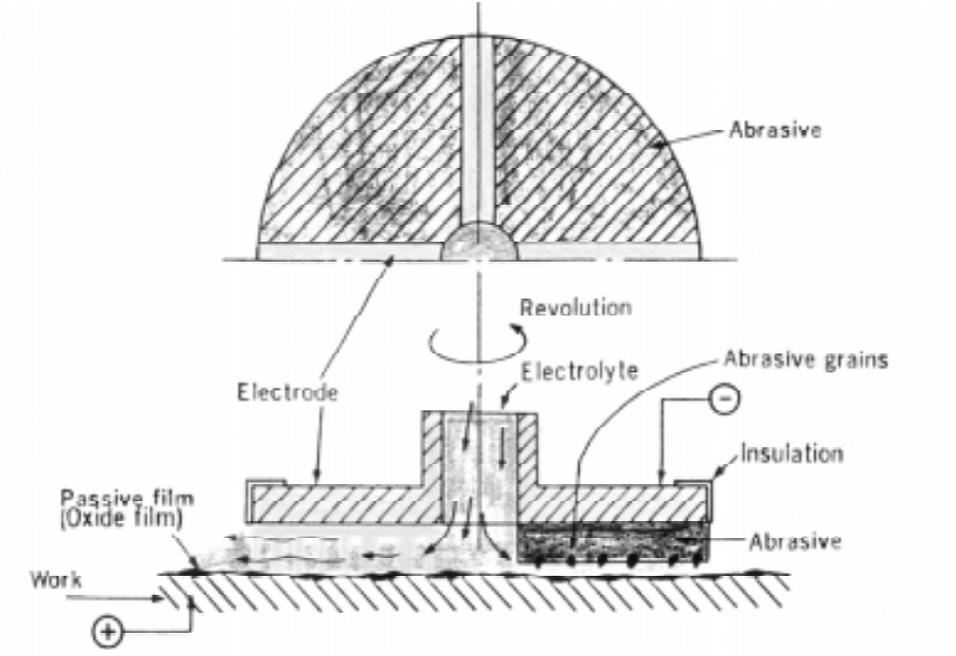
Figure 1 Polishing method of EBC

ECB, shown in Figure 1, is a combined method of electropolishing (EP) and mechanical buffing. Electrode is rotated and pressed against the work under DC voltage between a work and the electrode to perform EP. At the same time, electrolytic fluid is provided from a hole at the center of the electrode. The main ingredient of the electrolyte is NaNO_3 . The electrode has some pieces of nonwoven cloths including abrasives on it. Several kinds of electrodes are prepared to fit the cavity inner surface.

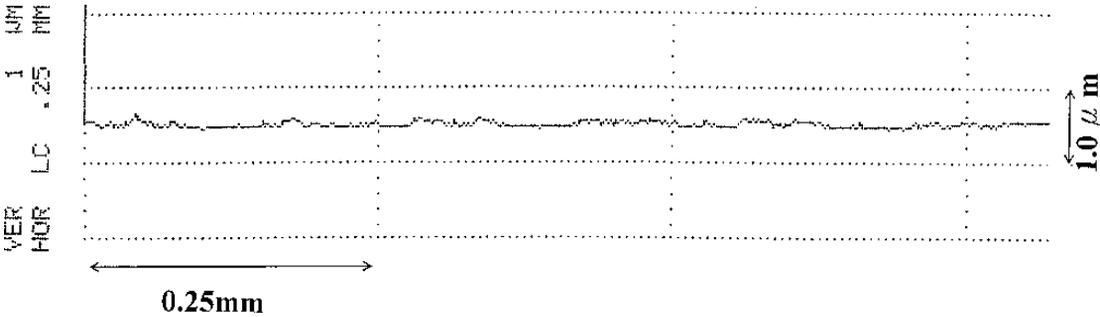
Figure 2 Surface roughness of Nb sample 96mm removed by electro chemical buffing

measured. Figure 2 indicates the surface roughness, which was 0.16 μ m (Rz). Then the niobium plate was rinsed in acetone with ultrasonic for two minutes. After that, an observation was carried out for the surface by scanning electron microscope (SEM). As many embedded abrasives were found, element analysis was performed by energy dispersive X-ray analyzer.

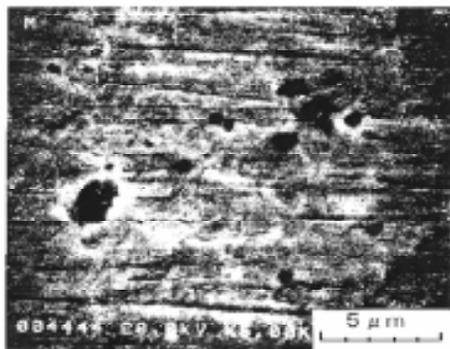
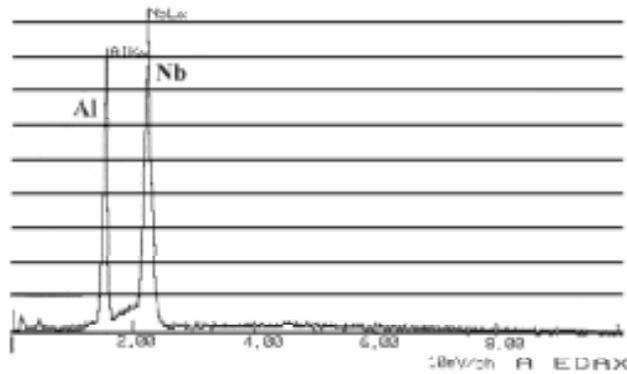
SEM image and size of embedded abrasives (× 6000)

Result of element analysis of an embedded abrasive with energy dispersive X-ray analyzer

Figure 3 Typical embedded abrasives on the surface of a Nb sample after ECB

Results of the observations and element analyses of embedded abrasives are shown in Figure 3 and Figure 4. Most of the abrasives were 1 to 2 μ m in size and Al was detected from them as a main element. As a special case, a particle as large as 4 μ m, which contains not only Al but also Si and Fe, was found.

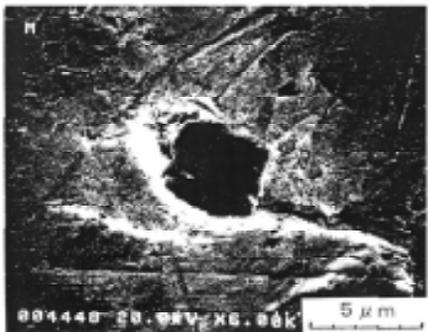
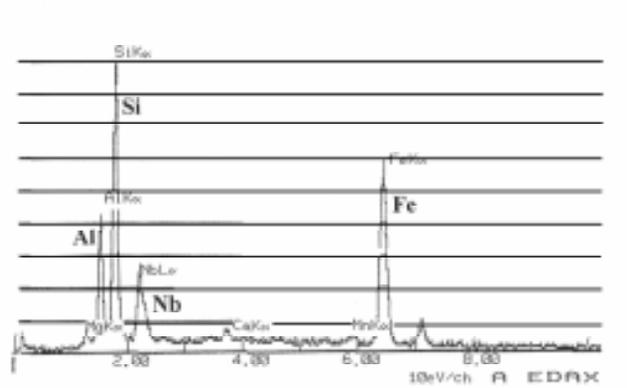
SEM image and size of an embedded abrasive (× 6000)

Result of element analysis of an embedded abrasive with energy dispersive X-ray analyzer

Figure 4 An especially large embedded abrasive on the surface of a Nb sample after ECB

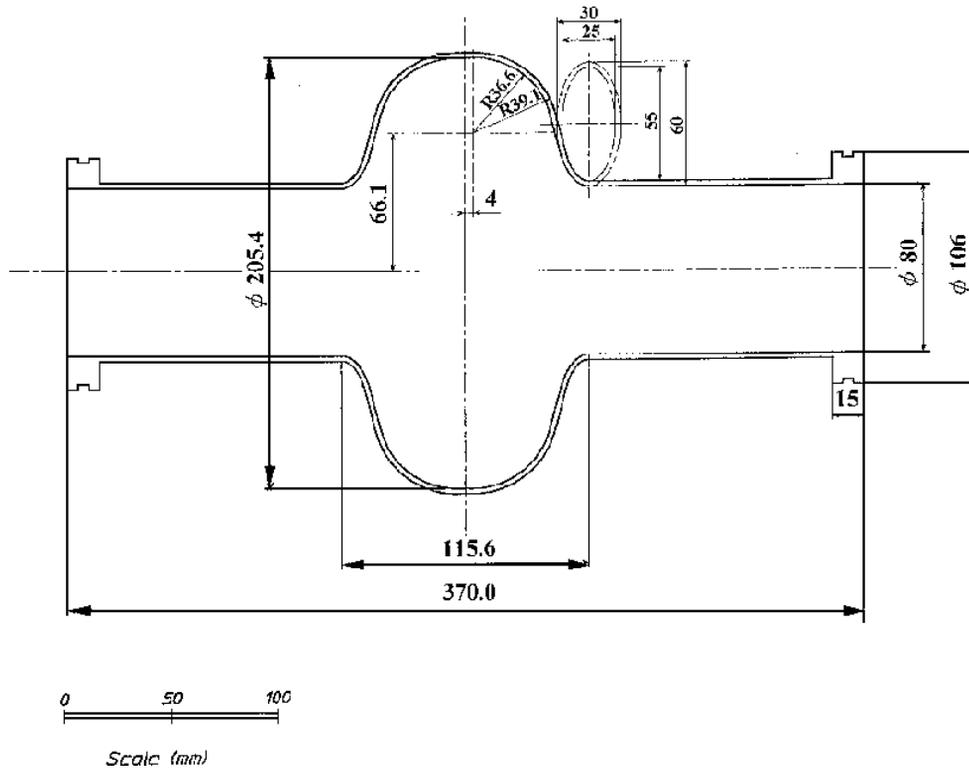
Figure 5 1.3GHz Superconducting RF Cavity

Figure 5 is a shape of 1.3GHz superconducting RF cavity. Figure 6 indicates the procedure of manufacturing and surface treatment of the cavity prior to measurement #1. In order to achieve a high electric field exceeding 30MV/m, such factors as would limit the cavity performance were carefully removed (for example surface damage layer due to fabrication procedure).

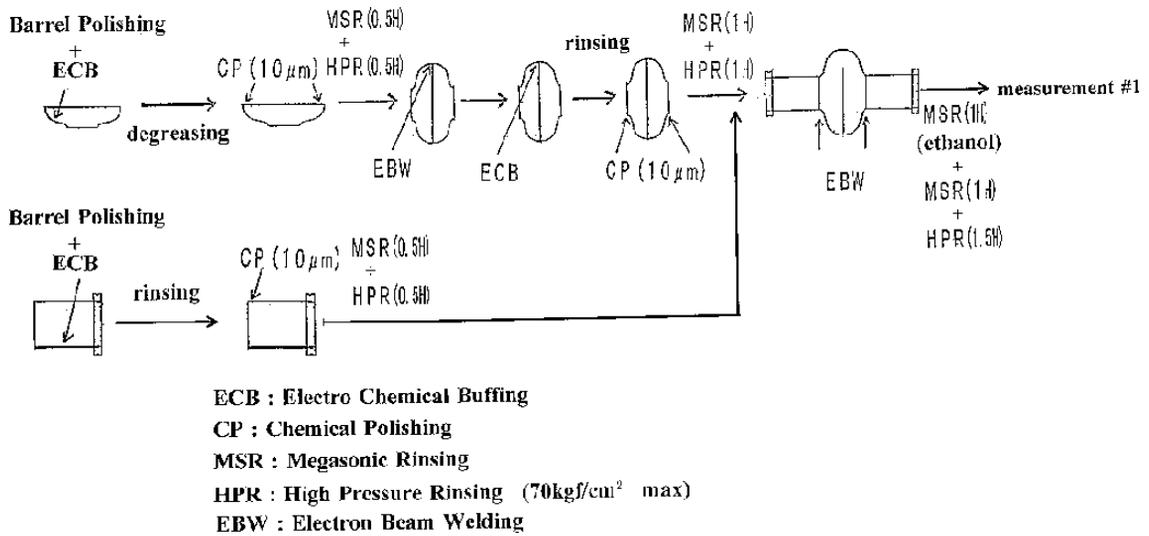
Figure 6 Fabrication procedure of L-band superconducting cavity

- (1) To avoid problems caused by the shortage of removing thickness, inner surface layer of half cells was removed by barrel polishing [1]. Barrel polishing was carried out before ECB and electron beam welding (EBW). Figure 7 is a picture of the barrel polishing. The beam pipes and half cells were held together by a jig and taped. The cavity was filled with barrel chips and soapy water. It was then rotated at 100 rpm for 270 hours for polishing.

- (2) After barrel polishing, the ECB was applied in parts before EBW, because it was difficult to apply ECB to all inner surface of the completed cavity with complex shape. The removed thickness was measured by ultrasonic thickness meter.

- (3) The half cells were joined together by EBW. EBW was done from the inside of the cell. Before EBW, equator welding region was slightly (10 μ m) removed by chemical polishing (CP) for cleaning.

- (4) ECB was applied again to the equator seam to remove the weld defects.
- (5) The cell and two beam pipes were cleaned out with megasonic rinsing (MSR) and HPR.

- (6) The two beam pipes were joined to the cell by EBW after the edges were cleaned by CP (10 μ m).
- (7) To the completed cavity, MSR(2Hr) and HPR(1.5Hr) were applied. At this stage, ECB has been applied all inner surface except iris regions of the cavity.

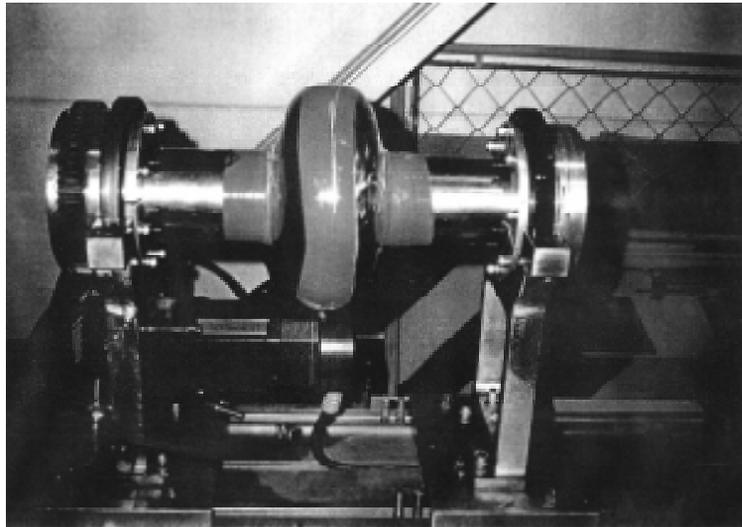
Figure 7 Barrel polishing of the L-band cavity

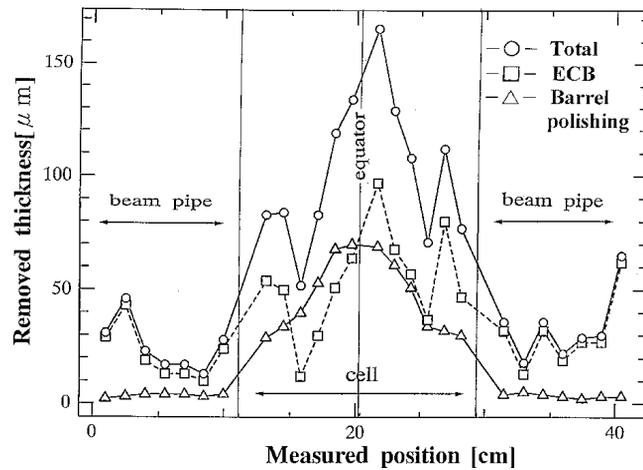
Figure 8 Removed thickness by barrel polishing and electro chemical buffing

Figure 8 shows the removed thickness distribution by barrel polishing and ECB along the cavity surface. Removed thickness by barrel polishing is about 70 m at the equator and about 30 m at the irises. By the ECB process, about 30m on the average was removed. At the equator seam, at least 100 m seemed to be removed because the equator seam became very smooth. And 50m was removed at the iris seams. Since the size of embedded grains by barrel polishing are about 5 m [2], ECB would reset the barrel polished surface enough.

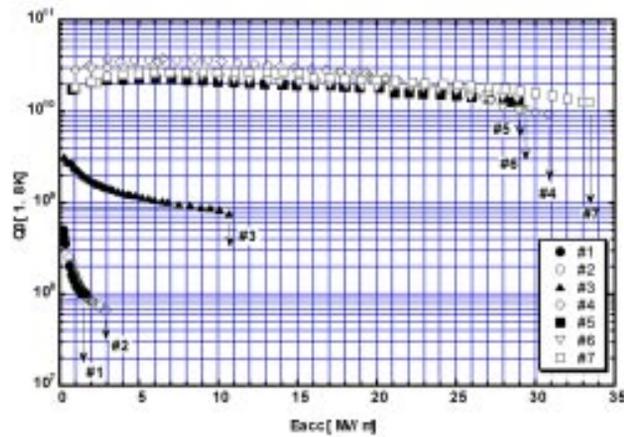
Figure 9 Result of cold test

Figure 9 is a result of cold tests of the cavity measured at 1.8 K after each step of surface treatment. All the measurement were performed after fast cooling down in an hour from room temperature to 4.2K. Q_0 -value and $E_{acc,max}$ in each measurements are shown in table 2.

In measurement #1 and #2, breakdown occurred at low fields, and the Q_0 -values were very low and decreased remarkably with increasing field. It seems to be caused by the contaminant of the embedded abrasives from the ECB.

Measurement #3 was taken after EP (10m) for removing the contaminant of embedded abrasives followed by MSR and HPR. Performance of the cavity was improved. Maximum field increased to 10.7 MV/m. But the Q_0 -values were still low. And at the breakdown point, Q_0 -value decreased to 1/4 of the lowest field. In this measurement, Q_0 -values were low and drastically decreased in low field region. This phenomenon seemed to be Q_0 -disease caused by H_2 gas absorption during EP process [3]. So, the cavity was annealed at 750 for 5 hours to degas hydrogen. And after taking HPR, measurement #4 was performed. This time, the cavity performance was remarkably improved. The maximum field attained 30.8 MV/m and the Q_0 -value exceeded 10^{10} . But at higher gradient area the Q_0 -value still decreased slightly likely caused by the contamination.

As it was thought to be difficult to remove contamination enough by conventional MSR and HPR, measurements #5 and #6 were taken immediately after additional slight EP. Removed thickness by EP before measurement #5 and #6 was 10m and 20m respectively. However there was little improvement.

Measurement #7 was taken after HPR with the increased pressure of 90 kg/cm². This time, maximum field achieved 33.4 MV/m with Q_0 -values exceeding 10^{10} .
