TRACKING DOWN A FAST INSTABILITY IN THE PEP-II LER*

Abstract

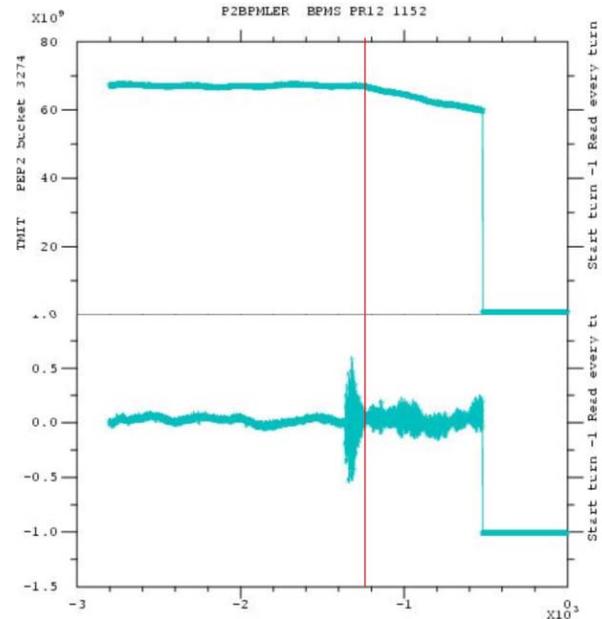
Figure 1: Loss of bunch charge (top). Fast LER coherent instability (bottom).

Fig. 1 shows the signature in the vertical plane of the observed transverse instability in the PEP-II LER.[1] The growth rate of the initial transient is between 10 and 60 ms^{-1} , much faster than any previously known instability in the LER. The max. coherent amplitude was limited, typically no more than ± 1 mm peak. Damping of the coherent motion occurred on a similar time scale, although residual coherent motion remained detectable until loss of charge triggered the beam-loss-rate interlock. The loss of charge occurred *after* the coherent signal was already significantly reduced, indicating growth of the bunches rather than coherent oscillation. The motion observed involved the whole beam as indicated in Fig. 2. A modal spectrum shows only low-lying modes (Fig. 3).

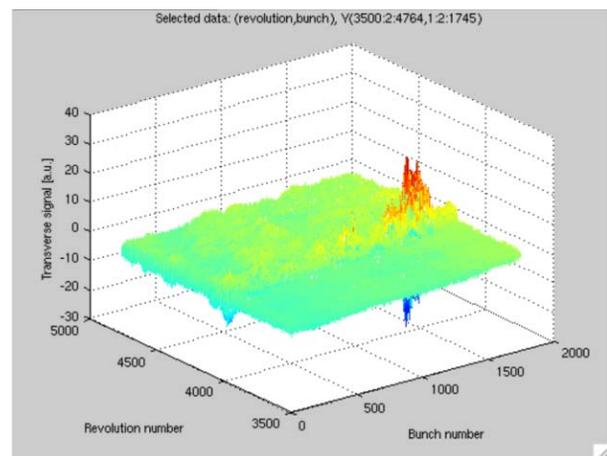
Figure 2: Bunch-by-bunch vertical position of the beam.

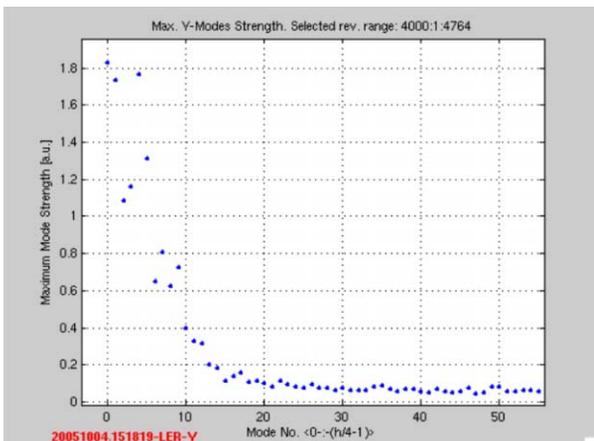
Figure 3: Modal spectrum of the motion during instability.

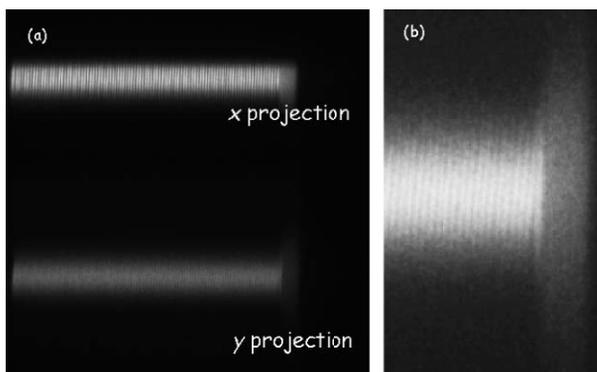
Figure 4: Sudden beam-blow-up in the LER, followed by an abort. (a) 125 images of one bunch, taken on every 80th turn (73 ms total). (b) A magnified view of the lower trace of (a), starting just before the instability. Centroid motion is visible in one image before the blow-up begins.

The transverse profile of a typical bunch in the ring was imaged on every 80th turn (0.6 ms spacing) by a synchrotron-light diagnostic using a rotating mirror[2]. Light from each turn is narrowed in one plane and stretched in the other to separate the images while showing the change in vertical size. A small centroid motion is visible in one image just before the onset of a rapid blow-up, which was seen in both x and y projections, followed by the abort (Fig. 4). A further signature specific to this instability were spectral lines at $2\nu_s$ which are not normally seen in the LER. Fig. 5 shows a "spectrogram" (frequency vs turn number) for about 4800 turns, at the end the beam aborted. Onset of the instability is clearly seen as is the onset of the $2\nu_s$ line. This hinted at a possible head-tail nature of the instability.

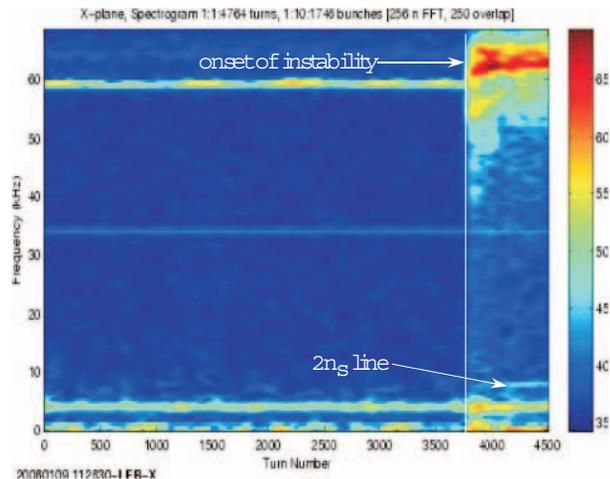
Figure 5: Vertical frequency spectrum vs turn.

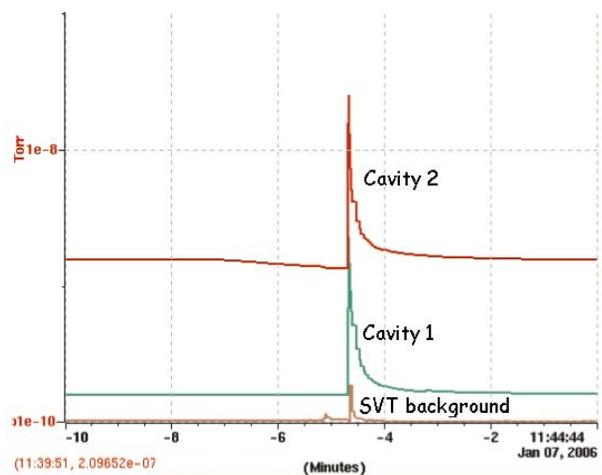
cator towards the trouble spot. Fig. 6 shows an example of such an event. It should be noted that a pump in between

Figure 6: Spike in rf station 4-2 cavity vacuum pressure coincident with beam abort.

the cavities showed an even stronger signal, suggesting a source in between the cavities.

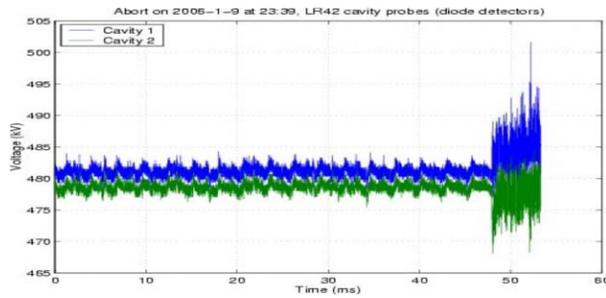
The observation of this effect caused renewed scrutiny of the fault-file data for the LER rf system following this kind of beam abort, and a signal was now seen on the field probes of the rf cavities in RF station 4-2 of the LER. Fig. 7 shows a representative plot of the observed signals. Note that such signals were not seen for the other rf cavities in the same region. The size of the signal was found to be about equal in both cavities, again consistent with the source being in between the cavities. A beam-phase detector showed a 1.6° phase transient (see Fig. 8); quantitative analysis gives an estimate of 110 keV total energy loss over 18 turns or 6 keV/turn and a total dissipation of $1 \dots 2$ J for the entire event up to the beam abort.

Figure 7: Signal of LER Rf 4-2 cavity probes during instability.

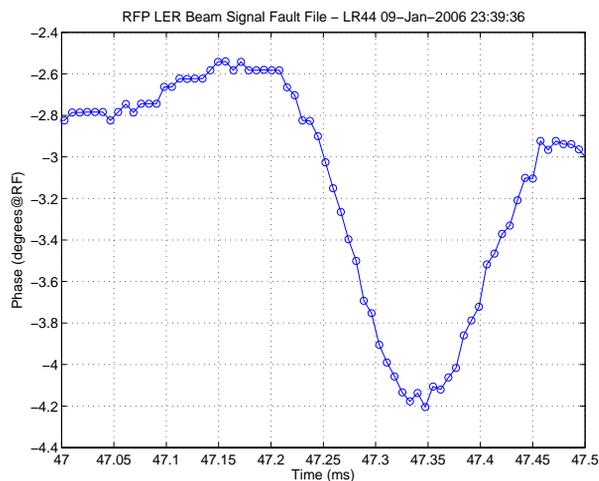
Figure 8: Phase transient of the beam at the onset of the instability.

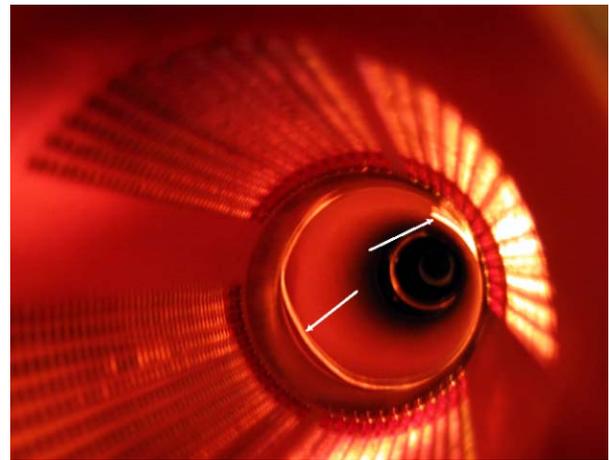
At this point the vacuum system between the cavities was opened for inspection. Borescoping the area revealed an rf seal (“gap ring”) that was misplaced, apparently during installation of this pair of rf cavities. The misplaced ring is visible in Fig. 9. On removal the ring showed discoloration and evidence of discharge. Moreover, copper could be seen having coated the vacuum chamber near the gap ring, indicating significant sputtering. The fields from the discharge apparently were broadband enough to be detectable by the cavity probe even though cutoff of the vacuum pipe is around 2.5 GHz, compared to 476 MHz rf frequency.

Figure 9: Dislocated rf seal in the LER vacuum chamber.

Once the offending rf seal (and a couple of others looking suspect) were replaced, operation quickly established the absence of this kind of instability in the LER, all but proving the source had been eliminated. The physics process has not been fully established, however. The amount of gas liberated is not sufficient to directly cause the observed beam loss by means of beam-gas scattering. The observed energy loss likely fed the discharge, which could thus act as an impedance causing instability although direct effect of the e-m fields from the discharge on the beam cannot be ruled out. The very fast growth rates also suggest the possibility of an electron cloud generated by the discharge causing beam instability as the electron-cloud instability can cause very fast growth rates.[4]

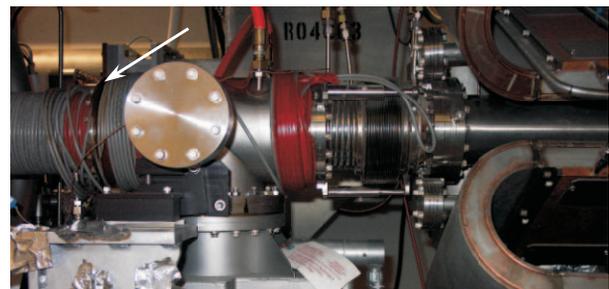
During disassembly, burn marks were found on the beam-line solenoid wound around the flange containing the offending seal, Fig. 10. Originally thought to arise from overheating of the solenoid winding it became clear that the burn marks, which were fairly local to the flange, did in fact indicate heating of the flange, which is not LCW cooled.

Figure 10: Flange with dislocated gap ring.
