Ion Instability observed in PLS revolver in-vacuum undulator

Heung-Sik Kang, T. Y. Lee, M. G. Kim, C. D. Park, T. Y. Koo, and J. Choi

Pohang Accelerator Laboratory

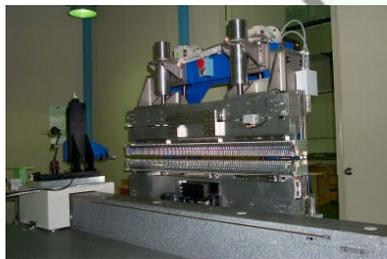
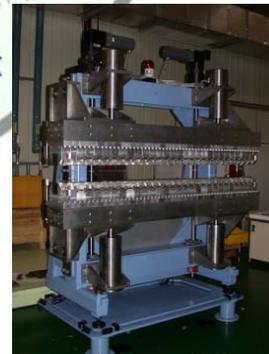
MPW14

RIVXUN: Revolver In-Vacuum X-ray UNdulator

Permanent magnet structure is a revolving type with four arrays, which provides 4 different undulator periods of 10, 15, 20, and 24 mm.

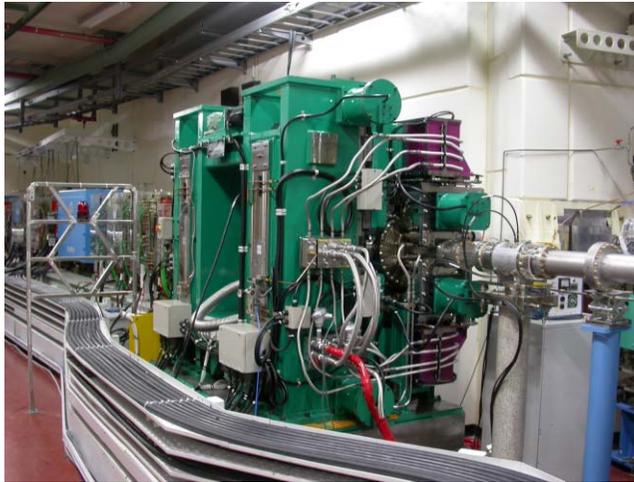
Array	Undulator Period [mm]	Number of period
C, c	10	101
B, b	15	67
A, a	20	50
D, d	24	42

Undulator magnet length is 1.2 meter

Magnet material : Nd₂Fe₁₄B
