DC TESTING AND PHASE RESOLVED PARTIAL DISCHARGE MEASUREMENTS OF THE NEW TRIGGER TRANSFORMERS FOR THE LHC BEAM DUMP KICKERS

T. Stadlbauer, A. Chmielinska, L. Ducimetière, D. Kontelis, T. Kramer, V. Senaj
CERN, Geneva, Switzerland

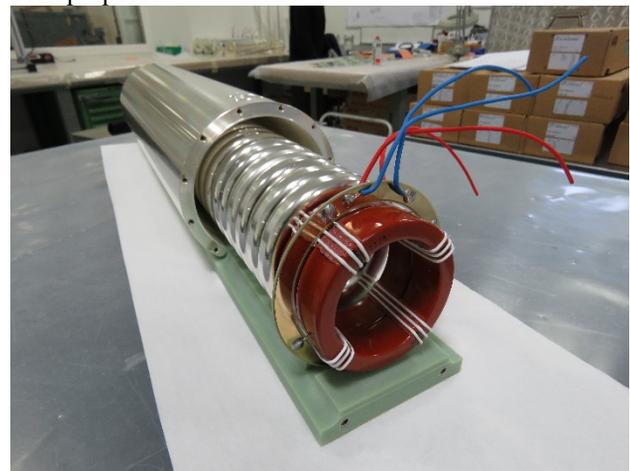
Figure 1: Trigger transformer partially out of housing and before moulding.

After the mechanical assembly and before the moulding each transformer (Fig.1) is pulse tested. For these tests a small pulse generator has been constructed which allows to easily apply fast pulses with 1.8 kA amplitude to the transformer windings to identify any assembly issues. After moulding, the trigger transformer is DC high voltage tested. For the HV tests, all 10 secondary windings are voltage graded by resistors creating equivalent conditions as in the final installation. Eventual sparking activity is monitored and captured. In case of suspicious behaviour close to the decision criterion additional HV 50 Hz AC tests have been proposed.

taps 1 to 4 (Fig. 1 in the front) no PDs up to the nominal voltage have been measured. The taps from 4 up to the highest potential have PDIVs between 11 kV and 12 kV peak.

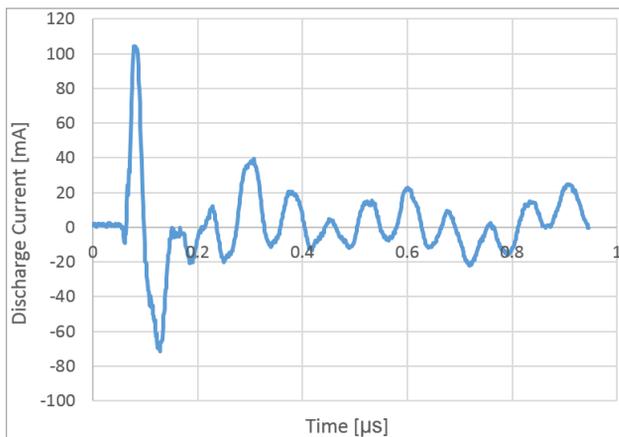
Figure 2: High spark signal monitored with Oscilloscope during DC sparking tests.

After the moulding the trigger transformer is placed in an HV test box to undergo a 48 h DC sparking test. For this test 27 kV is continuously applied, representing a situation and voltage level equivalent to the normal operating conditions in the generator. The high voltage is supplied by a standard HV power supply with low ripple and any sparking is monitored by a standard oscilloscope via a current transformer in the supply leads. Figure 2 shows an exemplary screenshot for an electrical discharge as seen during the sparking tests. The test criterion is that only two sparks in 24 h are allowed. The number of sparks and their magnitude is used to assess the transformer quality. Bad moulding processes or pollution during assembly can result in several hundred sparks per hour up to complete breakdown.

Table 2 shows 4 transformers of the final series. Transformer 13 and 16 showed suspicious behaviour (Fig. 2) during the DC HV test with high amplitude discharges.

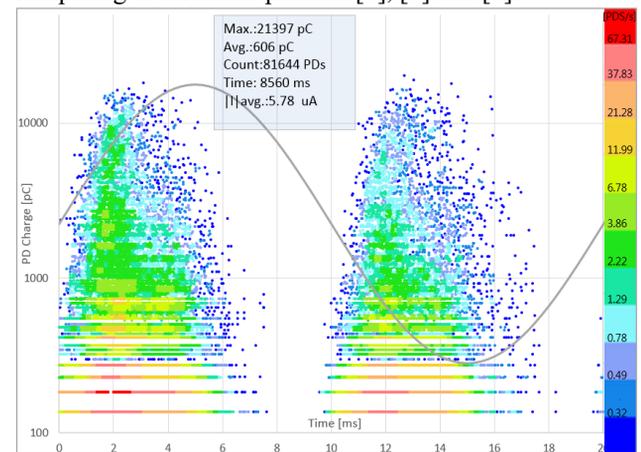
Figure 3: PRPD of pre-series trigger transformer with signs of surface discharge at 27 kV.

The following measurements were conducted at the high potential secondary at the maximum peak operation voltage of 27 kV. The rest of the taps have been voltage graded by resistors. In Fig. 3, the PDs are correlated to the voltage phase of the sinusoidal HV excitation. The Phase Resolved Partial Discharge (PRPD) pattern of the pre-series trigger transformer (Fig. 3) shows signs of surface discharges by comparing to reference patterns [6], [7] and [8].

By comparison, of the PRPD and PSA results the different sources of the discharges (corona, surface, void, floating potential, etc.) can be distinguished more easily. All 3 figures indicate surface discharges [6], [9].

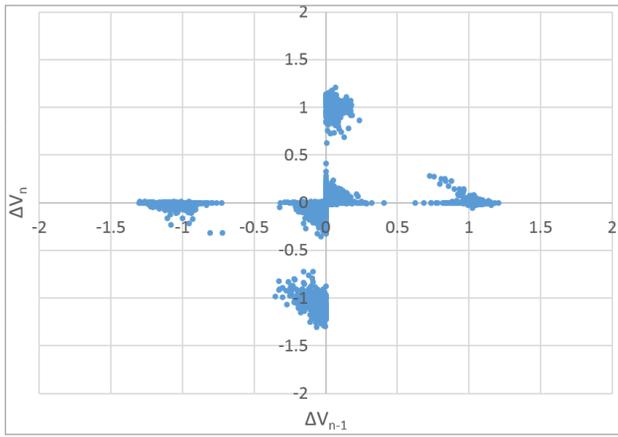
Figure 4: PSA Pattern $\Delta V_n / \Delta V_{n-1}$ of pre-series trigger transformer with signs of surface discharge at 27 kV.

Another way of analysing the measurements is the Pulse Sequence Analysis (PSA) where several correlations can be made. The correlation of the normalized excitation voltage level between two consecutive PDs ($\Delta V_n / \Delta V_{n-1}$) is shown in Fig. 4 and the PSA plot of the phase correlation between two consecutive PDs ($\Delta \Phi_n / \Delta \Phi_{n-1}$) is shown in Fig. 5.

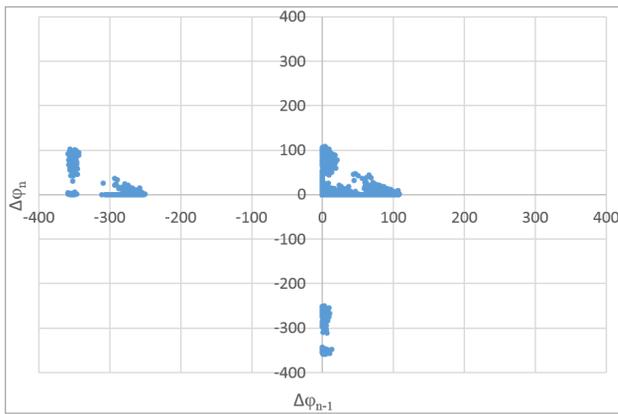
Figure 5: PSA Pattern $\Delta \Phi_n / \Delta \Phi_{n-1}$ of pre-series trigger transformer with signs of surface discharge at 27 kV.
