CONTROL SYSTEM STUDIO TO MONITOR FRONT END AND BEAM-LINES STATUS AS WELL AS LIGHT SOURCE STABILITY

W. Y. Lin, C. S. Huang, B. Y. Chen, T. Y. Lee, C. H. Kuo
 National Synchrotron Radiation Research Center, Hsinchu 30076, Taiwan

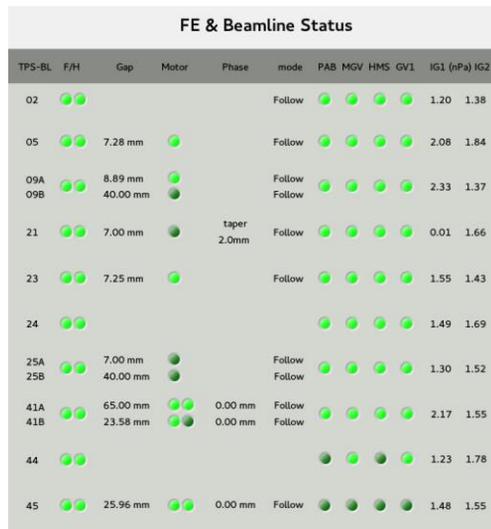
Figure 1: TPS Front end and beamline status monitoring page.

All real-time information mentioned above is collected on one page (Fig. 1), so that the operator can understand the state of the front end and beamline.

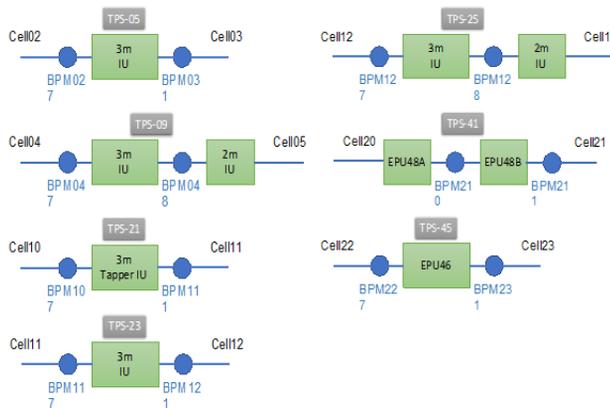
Figure 2: Corresponding diagram of beamline, ID and upstream/downstream electron BPMs.

The light source stability is very important for users [1] and we use therefore the CSS to record electron orbit changes upstream and downstream of IDs during user operation (excluding the injection period). Figure 2 shows the corresponding diagram of beamline, ID and upstream/downstream electron BPMs. When a change exceeds the allowable range, the synchrotron radiation will suffer a large offset. When such a problem is discovered, it should be excluded as much as possible at first or it will become the reference basis for further optimization of the system.

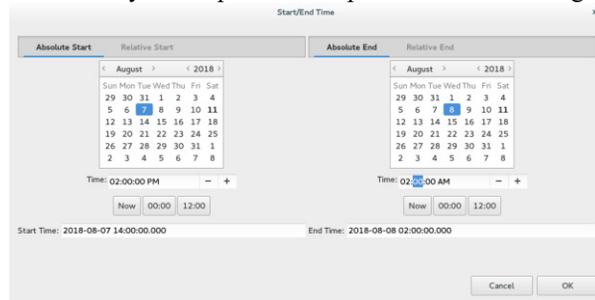
Figure 3: Selection of the temporal display interval for data recording.

From the design parameters of the TPS, the tolerable orbit variation is 10% of the electron beam size (design value $\sigma_x = 39.7 \mu\text{m}$; $\sigma_y = 15.8 \mu\text{m}$), which is about $4 \mu\text{m}$ in the X- and $1.5 \mu\text{m}$ in the Y-direction. Figure 4 shows the BPMs located at the up and downstream of TPS-21 and ID gap, the horizontal axis on the graph represents the past 12 hours to the present time, which is the maximum number of hours a particular operator may on duty. The data can also be selected for any other specific time period as shown in Fig. 3.

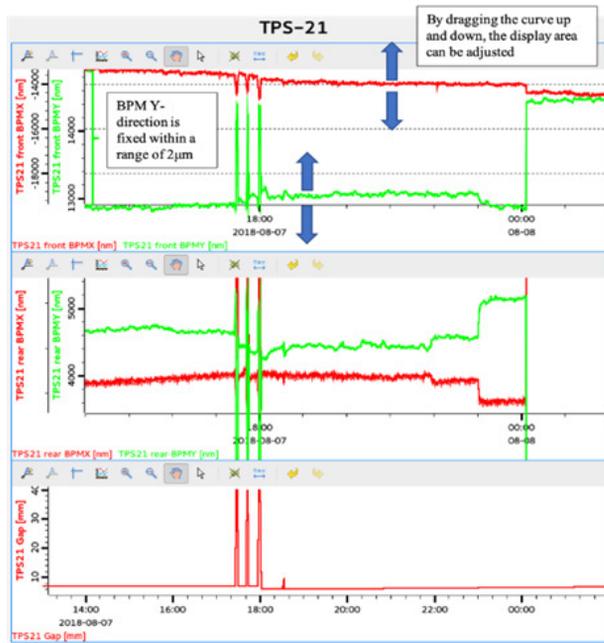
Figure 4: TPS-21 IU22-3m up (BPM107) and downstream (BPM111) electron orbit change and ID gap change record during a typical shift.

The vertical axis in the BPM X-direction is fixed within a range of 6 μm , and the BPM Y-direction within a range of 2 μm . By dragging the curve up and down, the display area can be adjusted. The electron orbit changes as measured by BPM107 - BPM111 and ID gap changes are recorded from 2018/08/07 14:00 to 2018/08/08 02:00.

From Fig. 4, it can be seen that at 2018/08/07 17:30~18:00, the ID gap was changed between 7 and 40 mm three times. BPM107 shows that the electron orbit in the X-direction changed slightly by about 0.8 μm , and in the Y-direction by about 1.5 μm . The electron orbit changes in BPM111 even exceeded the display range. It can be seen that the electron orbit changes exceed 6 μm in the X-direction and exceed 2 μm in the Y-direction. The actual values are 8 μm in the X- and 5 μm in the Y-direction. It can be seen that currently the TPS-21 can cause significant orbit changes for big ID gap changes with the downstream impact being particularly dramatic.

From Figs. 4 - 9 data we conclude, that the three circulating events of TPS-21 ID gap changes from 7 to 40 mm during the period of 2018/08/07 17:30~18:00 also have a different degree of influence on other beam lines. TPS-05, TPS-25, TPS-41, TPS-45 experience only small changes (less than 1 μm) to the electron orbit and TPS-09 is almost unaffected. The TPS-23 beam line located downstream of the TPS-21 is significantly affected. The amount of electron orbit change upstream of the ID is about 3 μm in the X-direction and about 1.2 μm in Y-direction. The downstream electron orbit change is about 2.5 μm in the X-direction and about 2.5 μm in the Y-direction.

Furthermore, it can be found that on 2018/08/08 00:06, the X-direction electron orbit at the upstream TPS-21 is slightly changed, by about 0.5 μm , and in the Y-direction by about 1.5 μm . The electron orbit changed in the X- and Y-directions downstream of TPS-21 are beyond the display range (the exact value is about 8 μm in the X-direction and about 5 μm in the Y-direction); There is also a significant change in the TPS-23 located downstream of TPS-21. The X-direction electron orbit of the upstream TPS-23 is about 2.5 μm , and the Y-direction is changed by about 1.2

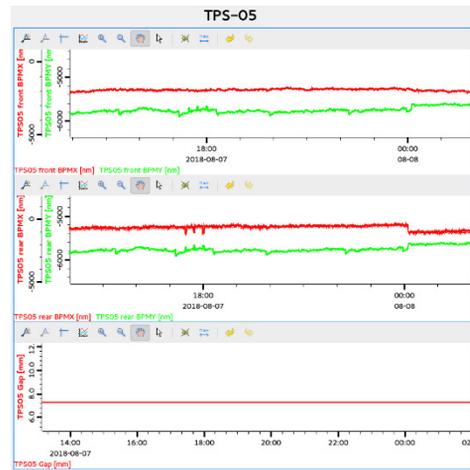
Figure 5: TPS-05 IU22-3m up (BPM027) and downstream (BPM031) orbit and ID gap change record.

Figure 5 shows the TPS-05 IU22-3m, Fig. 6 the TPS09 IU22-3m, Fig. 7 the TPS-23 IU22-3m, Fig. 8 the TPS-25 IU22-3m, Fig. 9 the TPS-41 EPU48B and Fig. 10 the TPS-45 EPU46 upstream and downstream electron orbit change and ID gap change record. From Figs. 4 to 9 we can observe the changes of the upstream and downstream electron orbits for all IDs in the TPS within 12 hours and the influence of single gap changes on the orbit for individual beamlines.

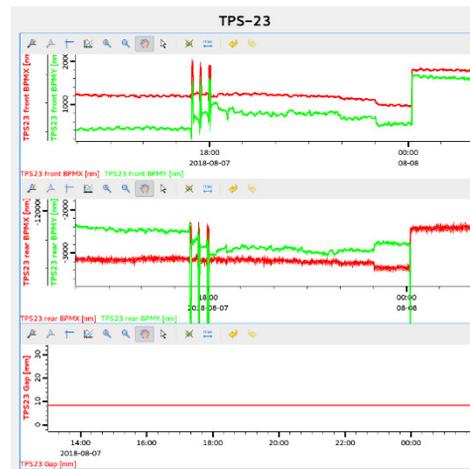
Figure 6: TPS-23 IU22-3m up (BPM117) and downstream (BPM121) orbit and ID gap change record.

μm . The X-direction electron orbit of the downstream TPS-23 is about 3 μm , and is changed in the Y-direction by about 2.5 μm . At the same time, the TPS-05、TPS-09、TPS-25 TPS-41 and TPS-45 experience also a slight orbit change by less than 1 μm . On 2018/08/08 00:06, it can be found there is no change of the ID gaps in any of the beamlines. Therefore, the electron orbit changes are not caused by ID gap changes but the actual causes are still unknown and need to be clarified.

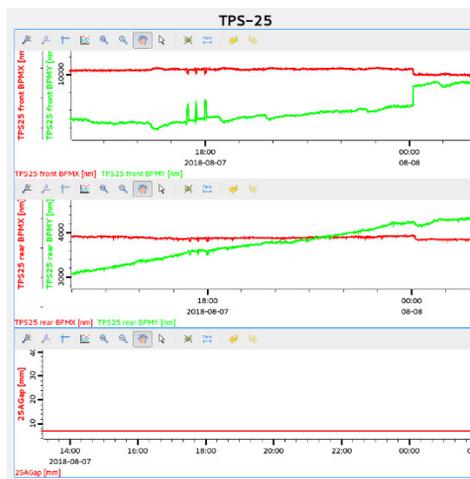
Figure 7: TPS-25 IU22-3m up (BPM127) and downstream (BPM128) orbit and ID gap change record.

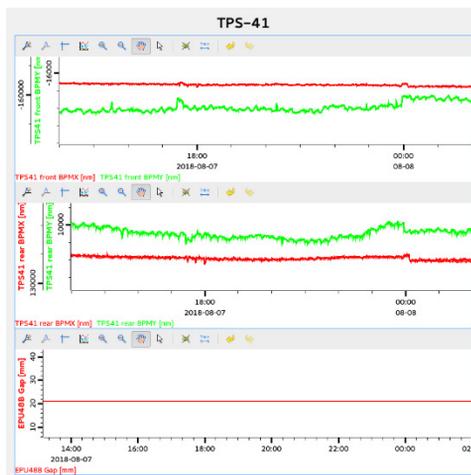
Figure 8: TPS-41 EPU48B up (BPM210) and downstream (BPM211) orbit and ID gap change record.

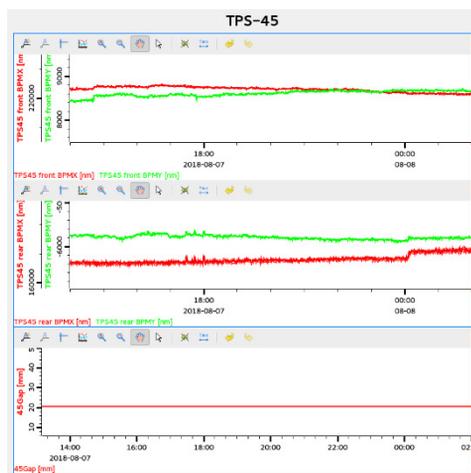
Figure 9: TPS-45 EPU46 up (BPM227) and downstream (BPM231) orbit and ID gap change record.

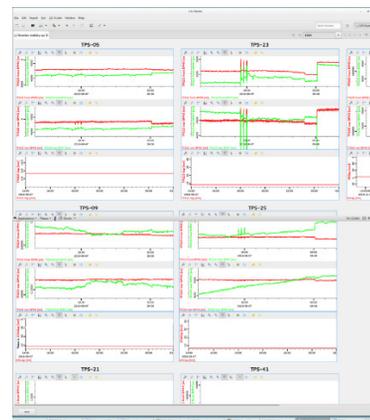
Figure 10: Overall computer control display.

Figure 10 is the overall picture on the control computer display, so that the operator can quickly grasp the light source status without having to manually retrieve the data one by one at the start of his/her shift. If the machine shows any abnormality, it can be seen immediately.
