THE MANUFACTURING OF THE CSNS DTL TANK

X. L. Wu^{1,†}, H. C. Liu¹, K. Y. Gong, H. Song, S. M. Liu¹, L. Dong, T. Luo¹, Institute of High Energy Physics, Chinese Academy of Sciences (CAS), 100049 Beijing, China
¹also at Dongguan Neutron Science Center, 523803 Dongguan, China

The DTL tank is a crucial component of the China Spallation Neutron Source (CSNS) linear accelerator (LINAC), which mainly use the technology of oxygen-free copper (OFC) electroplating on the inner surface of the 20# carbon steel tube. It is the first time to perform OFC electroplating with high electrical conductivity in the high intensity beam accelerator in China. In the process of cavity manufacturing, problems such as machining deformation, plating surface nodule and plating peeling are encountered. In this project, based on pre-research and information from literature, the formula of acid solution was improved to construct a stable pickling process protocol. The manufacturing process of DTL tank and the measurement details are introduced in this paper.

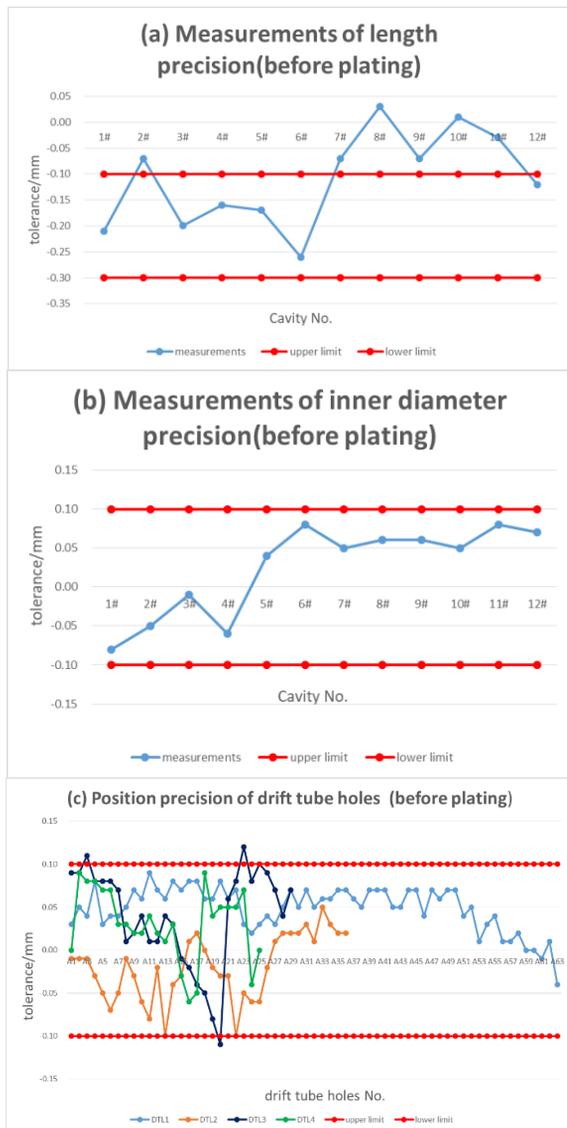
Figure 1: Measurements of the machining: (a) length precision, (b) inner diameter precision, (c) position precision.

It's analyzed that the reason for the deviation of the cavity 1# is because the process has been reversed between turning the inner surface of the cavity and milling cooling sink around the out-wall. In order to solve the problem, we strengthened communication with manufacturers, reconfirmed the process route, and required manufacturers to strictly implement the process. Offset value is offered by the laser tracker before the fine boring of the side holes on the cavity 2#. Our colleagues were stationed in factories to track the quality of machining at the critical stage of the processing. Finally, we successfully completed the machining of all cavities. The key indicators are shown in Fig.1.

The length precision is partially out of tolerance (Max ΔX=0.13mm), which can meet the design requirements (after plating) by controlling the plating thickness on the end plate. The inner diameter precision of all cavities meets the requirements. The position of all 153 drift tube holes is measured and only 3 out of tolerance (Max ΔX=0.02mm), which we considered to meet the installation requirements.

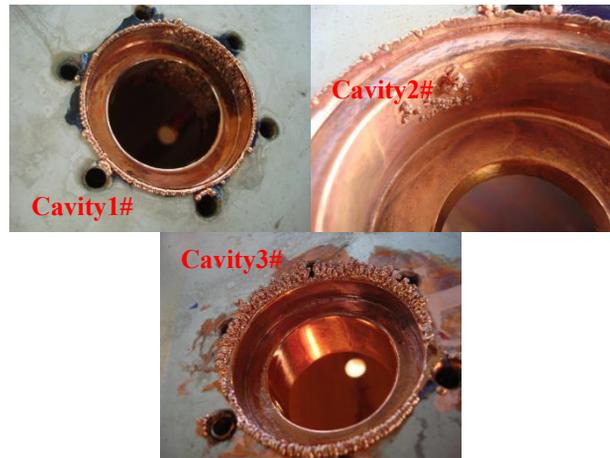
Figure 2: Electroplating of the first three cavities.

All side holes of the cavity 1# are nodulated (Fig. 2) after electroplating. The nodules are in the same direction of each side hole (downward by gravity), and the closer to the bottom of the plating bath, the more severe the nodule.

The main reason for the nodule are as follows: 1) the surface isn't completely degreased before plating; 2) the dirty things flow out of the screw holes to contaminate the plating solution; 3) the anode current density of the side holes is high.

We improved the process when plating the cavity 2#, including: 1) the plating solution is equipped with circulating filtration equipment; 2) all the screw holes are blocked with clean rubber; 3) all side holes are installed with flushing pipes; 4) filter bags are installed on all side anodes; 5) reduce anode current. The nodules of the cavity 2# are significantly reduced (Fig. 2).

The process was further improved when plating the cavity 3#: 1) we use a cleaning agent to scrub the oil instead of the electrolytic degreasing; 2) cleaning the anode mud and the filter bag; 3) reduce the copper plating time of the side holes by half. There is no nodule on the inner wall of all side holes after the improvement (Fig. 2).

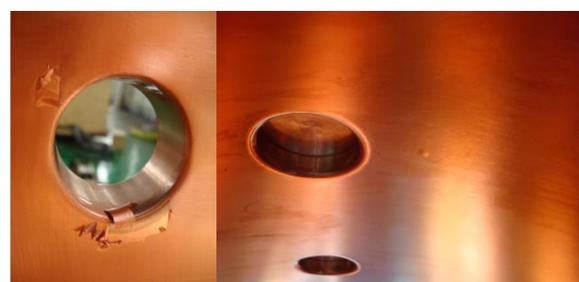
Figure 3: Plating peeling.

After electroplating, the cavity 2# was cleaned and baked at a high temperature (100°C for 72 hours), followed by a large amount of peeling phenomenon (Fig. 3), that is, the plating layer and the substrate were detached.

We performed ultrasonic testing on the material to eliminate the possibility of defects in the substrate. It's judged that the factors causing peeling mainly include: 1) machining defects on the surface, such as gear mark, scratches, etc. 2) there are still uncleaned areas on the surface. The following improvements are made: 1) strengthened the surface quality acceptance of machining; 2) strengthened the intensity of degreasing and eliminated the blind spot (Fig.4). The standard of degreasing is that the water film does not crack 30s while washing.

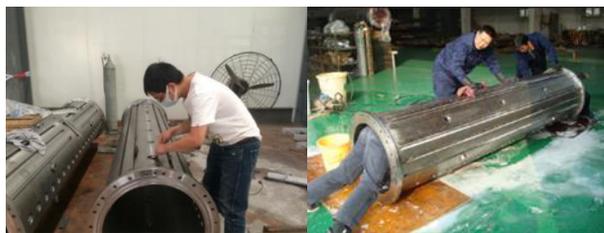
Figure 4: Surface acceptance and degreasing.

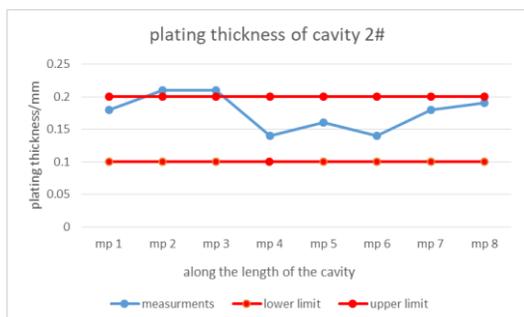
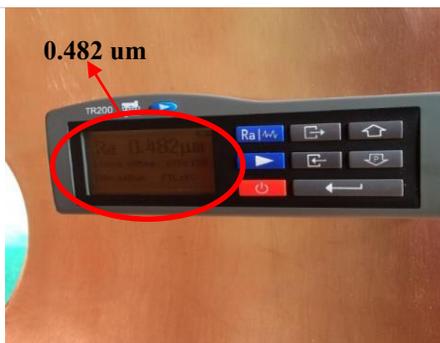
Figure 5: Plating thickness measurements and surface roughness measuring.

The plating thickness is controlled from 0.05mm to 0.21mm, and the surface roughness is about $0.5 \mu\text{m} < 0.8 \mu\text{m}$ (Fig. 5).

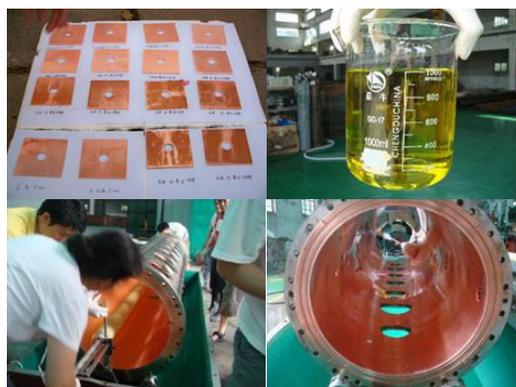
Figure 6: Pickling.

The main process (Fig. 6) of pickling is as follows: degreasing, water washing (cold, hot) and drying, pickling, wash (tap-water, pure water) and dry, vacuum baking and seal.

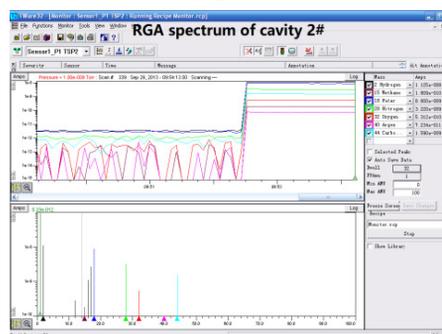
Figure 7: RGA spectrum of cavity 2#.

We performed vacuum leak detection on all the cavities after pickling, and the leak rate satisfy the requirements. The ultimate vacuum test and residual gas analysis (RGA) were performed on the cavity 2#. The result was that the lowest pressure reached $3.3\text{E-}6 \text{ Pa}$, and the RGA spectrum (Fig. 7) showed no macromolecules such as oil. The vacuum test results meet the requirements.
