## STATUS OF THE INDUCTION ACCELERATION SYSTEM\*

### Abstract

A single proton bunch confined by the barrier voltage was accelerated by the induction step-voltage from 500MeV to 6GeV at the KEK 12-GeV proton synchrotron in March 2006. Various technical issues in the induction acceleration system, which have been faced in actual operation, are summarized.

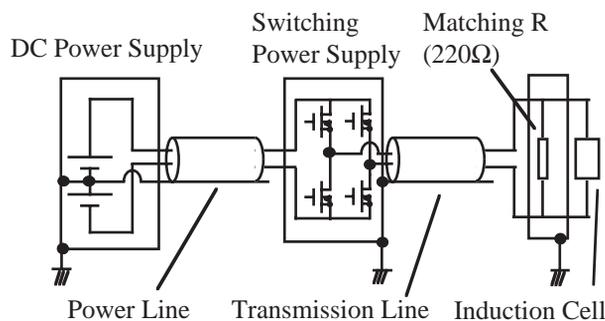
To generate the acceleration voltage, an induction cell is energized with a high-voltage switching power supply employing power MOS-FETs as switching elements, which is connected to a DC power supply (see Fig. 1).

Figure 1: Equivalent circuit of induction acceleration system.

cable with the copper shield, passes along the control line of the BR, and (2) an antenna temporarily put near the power line picked up the large signal when the induction acceleration system was turned on and the beam intensity of the BR became unstable [7], suggested the importance of direct measurement of the common mode current leaked from the power line. The result is shown in Fig. 5(a). The common mode current of 4A was observed in the operation condition of 1.8kV / 15A, 1MHz and the duty of 50%. This common mode current was suppressed by changing the wiring throughout the induction acceleration system of Fig. 1 as shown in Fig. 5(b).

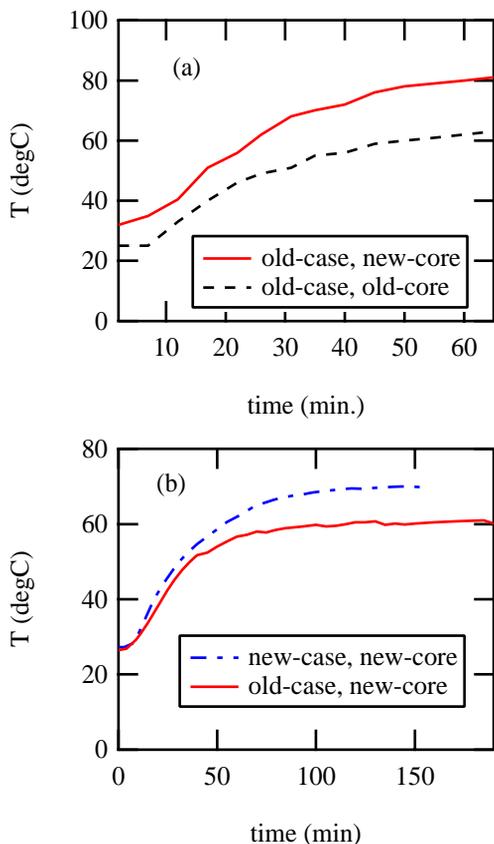
The improvement of the core-material and the case was performed from the economic point of view at that time. However, it was found after the melting accident that (1) improved core tends to be hot more than the old-one, which depends on the thickness of the Finemet ribbon and the thickness of the Finemet in the new core is 18μm and that in the old core is 13μm, as shown in Fig. 2(a). In addition, (2) the flow of the oil through the new-case was not effective in comparison with the old-case (see Fig. 2(b)), even though same magnetic material was used. These reasons resulted in melting of the polyethylene pipe as shown in Fig. 3. So, the polyethylene pipe was changed to the one with higher melting point.

Figure 2: Temperature of polyethylene surface dependent on (a) core material and (b) structure of case.

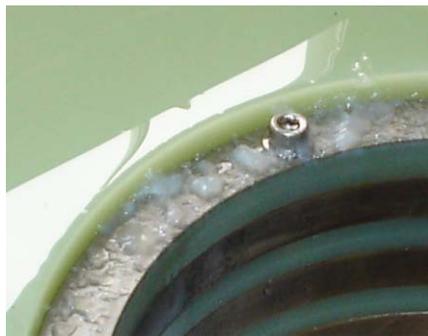
Figure 3: (white) Melted polyethylene on (thin silver) metal plate for fixing current bar around (thick silver) magnetic cores. Green is glass epoxy.

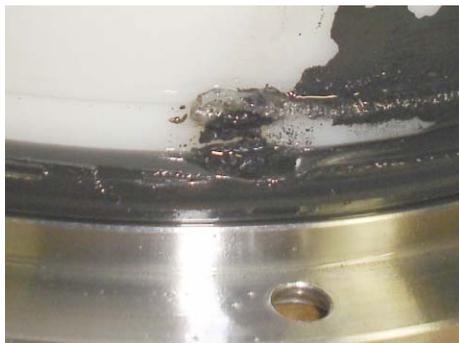
Even though the melting point of the polyethylene pipe becomes higher, it melted as a result of the arcing, as shown in Fig. 4. The arc discharge occurred between the case and the metal to fix the current-bar surrounding the magnetic core. At that time, not only the pipe but also the O-ring for sealing oil was damaged, and a little leak of the oil was observed. To avoid the arc discharge, this metal became roundish. This effect will be checked by a next long heat-run.

Figure 4: (white) Polyethylene pipe and (middle black) O-ring melted by discharge.

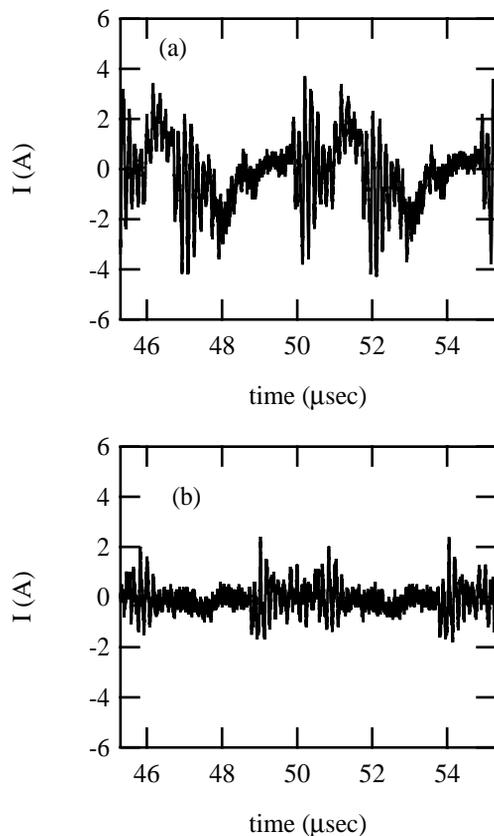
Figure 5: Common mode current passing through power line of Fig. 1.
