RECENT RESULT OF CAVITY INSPECTION FOR THE SUPERCONDUCTING CAVITIES AT KEK-STF

K. Watanabe[#], H. Hayano, E. Kako, S. Noguchi, T. Shishido, Y. Yamamoto, KEK, Ibaraki, Japan
 Y. Iwashita, Kyoto ICR, Uji, Kyoto, Japan

Abstract

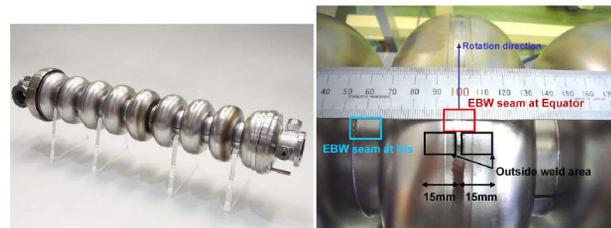
Figure 1: MHI-05 cavity and area of the inspection.

The images of MHI-05 and areas of the inspection (Rectangular mark in the picture show a image size of the inspection.) are shown in Figure 1. The images are taken for the inspection in the following cases,

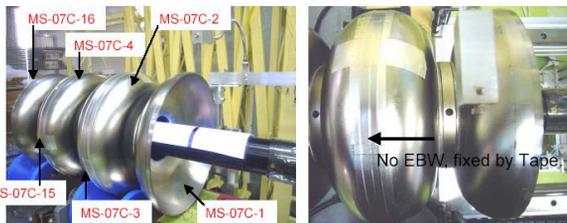
Figure 4: The setup of the inspection for three dumbbells of the MHI-07.

The inspection of three dumbbells for MHI-07 cavity was carried out to search that “When were suspicious spots made?”. The setup of the inspection is shown in Figure 4. The result of this inspection is shown in Figure 5. The spots were observed on the surface even in the dumbbells stage. The spots do not occur in neither the surface treatment nor EBW process. The locations of the spots were within 15 mm from a joint point of equator.
