Performance of the LHC magnet system

Vittorio Parma, Lucio Rossi CERN, Technology Dept.

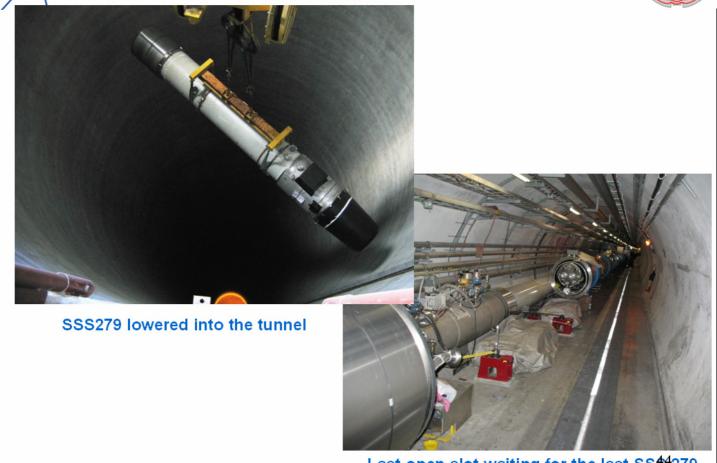
30th April 2009: last magnet for sect.3-4

Last open slot waiting for the last SS\$4279.

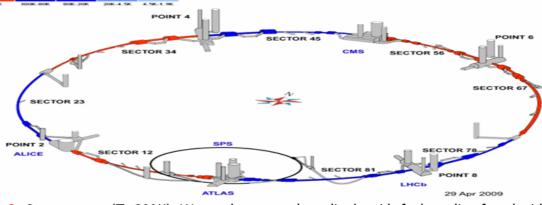
The LHC on 2nd May

- **Sect.1-2**: Sector warm (T=300K). Warmed up to replace dipole with faulty splice found with calorimetric measurements. Done.
- Sect. 2-3: Cool-down started (Tav=80K)
- Sect.3-4: Sector warm (T=300K)
- Sect.4-5: Sector left floating during Shut Down (Tav~80K)
- Sect.5-6: Sector warm (T=300K). Warmed up for other repairs
- Sect.6-7: Sector warm (T=300K). Warmed up to replace dipole magnet with a faulty splice found with calorimetric measurements. Done.
- Sect.7-8: Sector left floating during Shut Down (Tav~50K)
- Sect.8-1: Sector left floating during Shut Down (Tav~50K)
