DEVELOPMENT OF A FAST SIGNAL-GATING CIRCUIT FOR OBSERVATION OF FAST GLITCH OF PHOTON BEAM INTENSITY AT NSRRC

Abstract

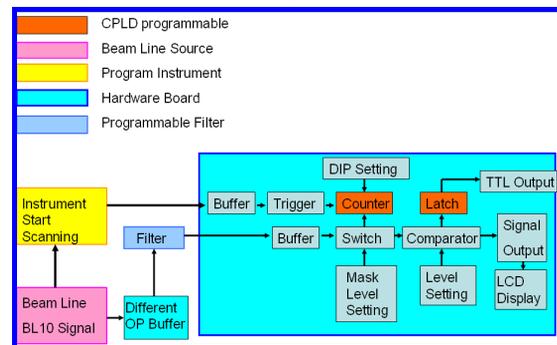
Figure 1: The home-designed hardware architecture.

The hardware structure acquires the correct signals, timing and signal source. Figure 1 shows a block diagram of the home-designed hardware architecture that

Such a gating function was designed and divided into several parts with this structure:

- signal source amplification and noise reduction, by differential circuit
- synchronous trigger source
- digital filtering
- hardware synchronous timing
- home-designed mask circuit, and
- Analysis with oscilloscope.

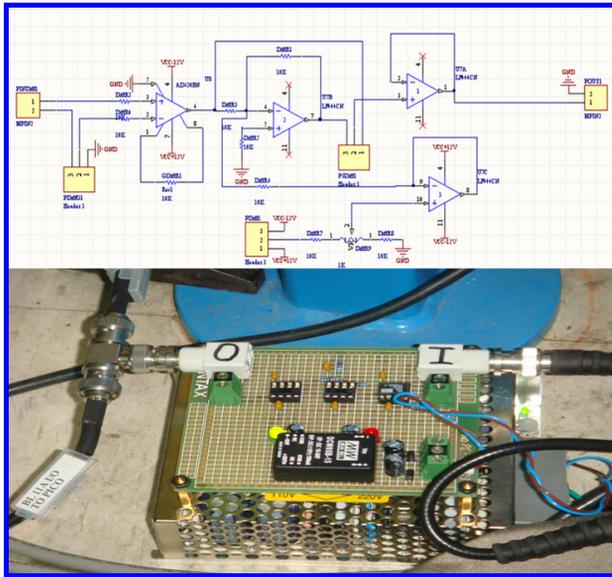
Figure 2: Differential circuit.

The distance between the source of the I_0 signal (located at BL11) and the location of observation (a SRF rack in the core area) is about 45 m. The I_0 signal is wired to a junction box on the SRF rack and connected to a diagnostic system. The distance 45 m is a challenge for signal propagation, especially for a small signal such as I_0 . Along the path between BL11 and the SRF rack, there are many power lines; the 60-Hz oscillation of the power might cause EMI of the I_0 signal. Interference of this kind is solved with an interference reduction circuit as shown in Figure 2. An integrated circuit (IC, AD620), acting as a differential amplifier with unit gain, serves in the circuit to reject interference.

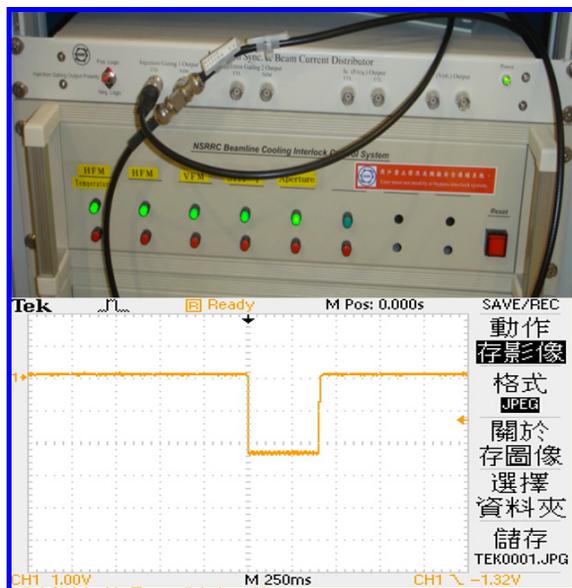
Figure 3: Trigger signal.

When the I_0 measurement instrument switches to a scanning mode, the diagnostic system must synchronize the timing of the switching. A trigger source is thus required for the diagnostic system, but the original trigger source, from the instrument and control group, has negative pulses with extremely narrow time period (about 400 ms) as shown in Figure 3. The low-level oscilloscopes can not take such signal as a trigger source because of the narrow time period and the 45-m travel. To solve this problem, we designed a transform circuit to transform the signal in the narrow time period to a standard falling-edge TTL signal. The TTL output of this circuit can thus serve to trigger the oscilloscopes.

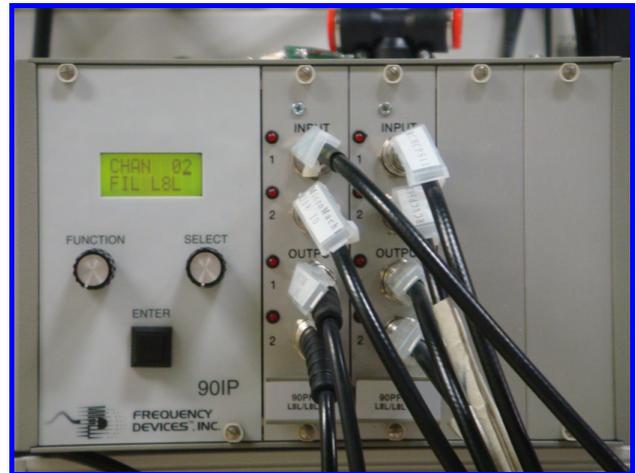
Figure 4: Frequency Device INC 90IP Filter.

Many unwanted signals are located in various frequency bands at the output of an interference reduction circuit. To reject these alien signals and to purify the I_0 signal, we use a low-pass digital filter (Frequency Device INC 90IP) to exclude signals with frequency above 30 Hz. Figure 4 illustrates the digital filter.

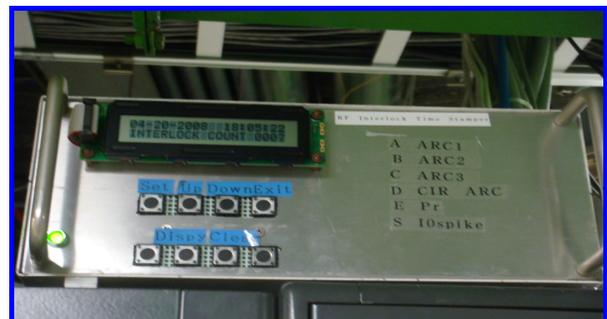
Figure 5: Home-Design Timing Recorder.

We designed a module for a timing recorder, which records the real clock of a trigger event, as shown in Figure 5. The real clock, specifying year, month, date, hour, minute and second, can be manually set. A memory, which is erasable and reusable, is installed in the timing module. To activate the timing recorder, a falling-edge TTL trigger signal is needed. The gating function provides such a TTL signal to activate this module. When the timing device acquires the error information, it stores a timing message in its memory. This module is convenient for tracking the timing of glitch of photon intensity.

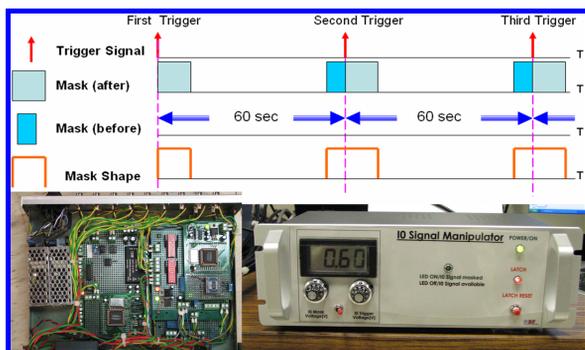
Figure 6: Home-Design Mask Generator Function.

The temporal resolution of a digital circuit can be as great as microseconds, which is helpful to design a mask-generation circuit with fine time resolution. A complex programmable logic device ALTERA (EPM7064SLC44-10) is employed as the core of the mask generation circuit. Instead of the I_0 signal, an adjustable reference bias is output within the blocking period. Accordingly, the CPLD is configured as a controller of the output signal switch between the mask reference bias and the I_0 signal. A smoothly adjustable reference bias is generated with an integrated circuit (LM385AXZ-2.5), and a digital switch (DG412) with switching time less than 175 ns is employed.

As shown in Figure 6, the trigger source generated by the trigger synchronization circuit has a period 60 s. As the mask generation circuit receives a TTL signal from the trigger synchronization, the circuit generates a posterior mask for 6 s. After that, the circuit outputs a low state until the fifty-sixth second of every trigger cycle. At that point, i.e. 4 s before the next trigger, a prior mask is generated that covers fully the 10-s scanning period. The signal within the mask period becomes blocked to ensure the accuracy.
