UPPSALA
UNIVERSITET
DIPAC 2011

DIAGNOSTICS OF RF BREAKDOWNS IN HIGH-GRADIENT ACCELERATING STRUCTURES

A. Palaia, Uppsala University, Sweden

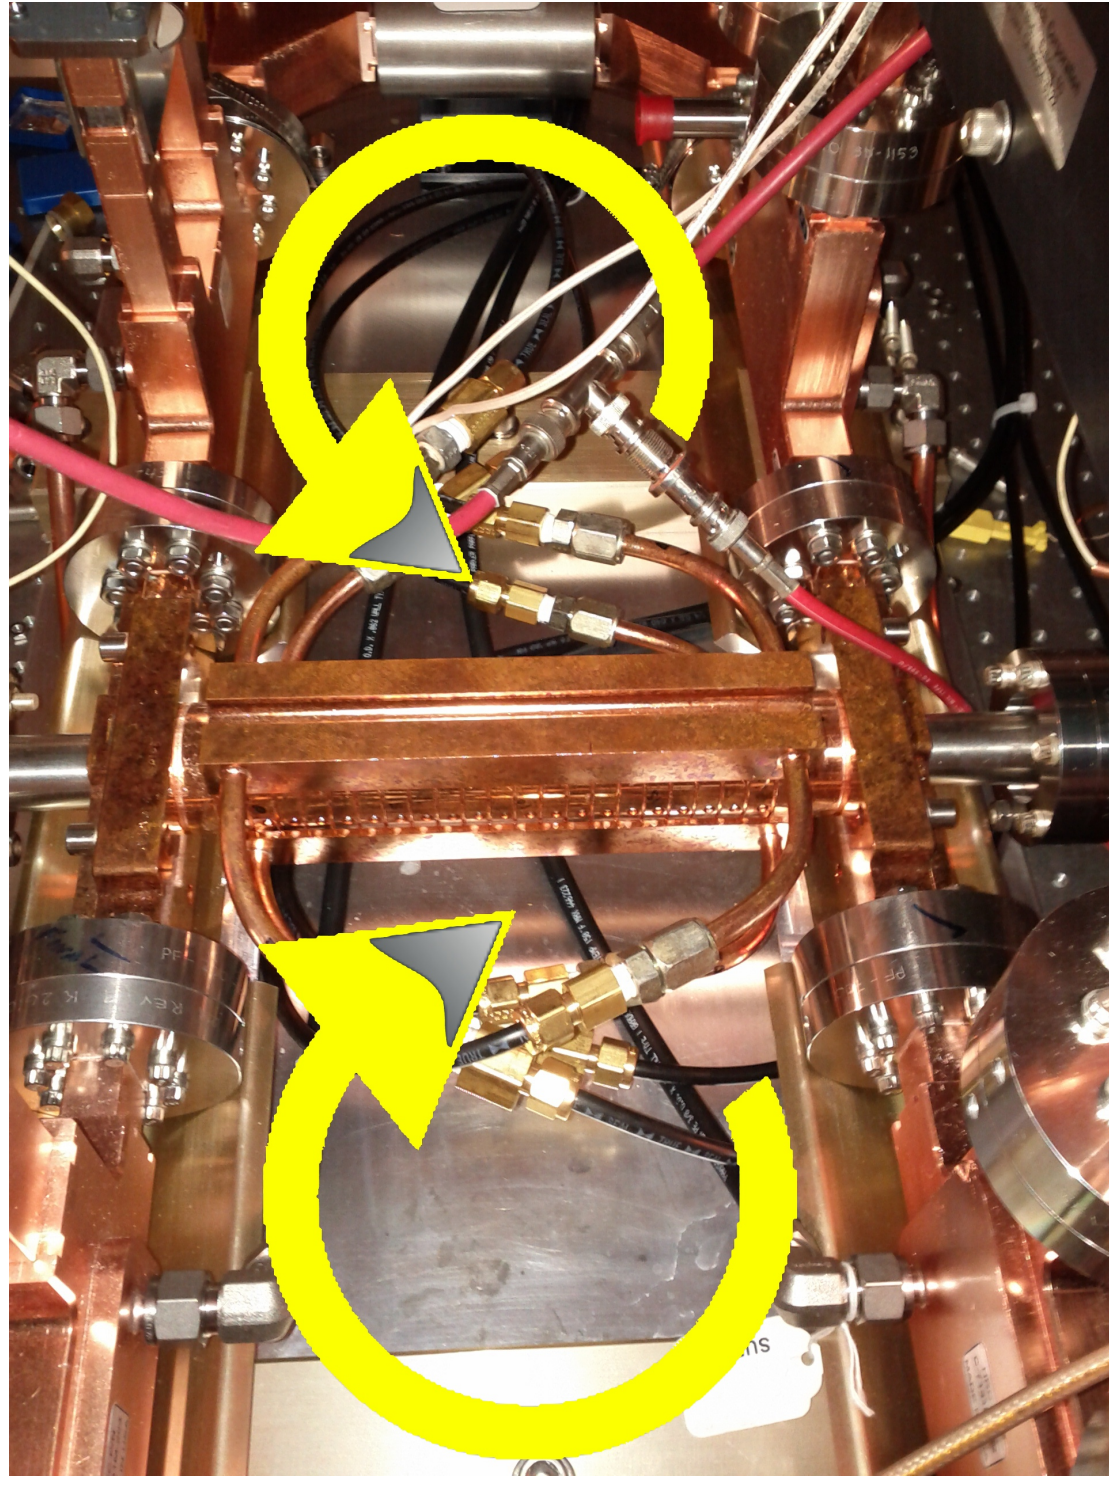
The resonant ring at ASTA allows high power structure testing in a two-arm wave guide loop meant to recirculate the field such that it constructively interferes with itself increasing the power level in the structure at every turn.

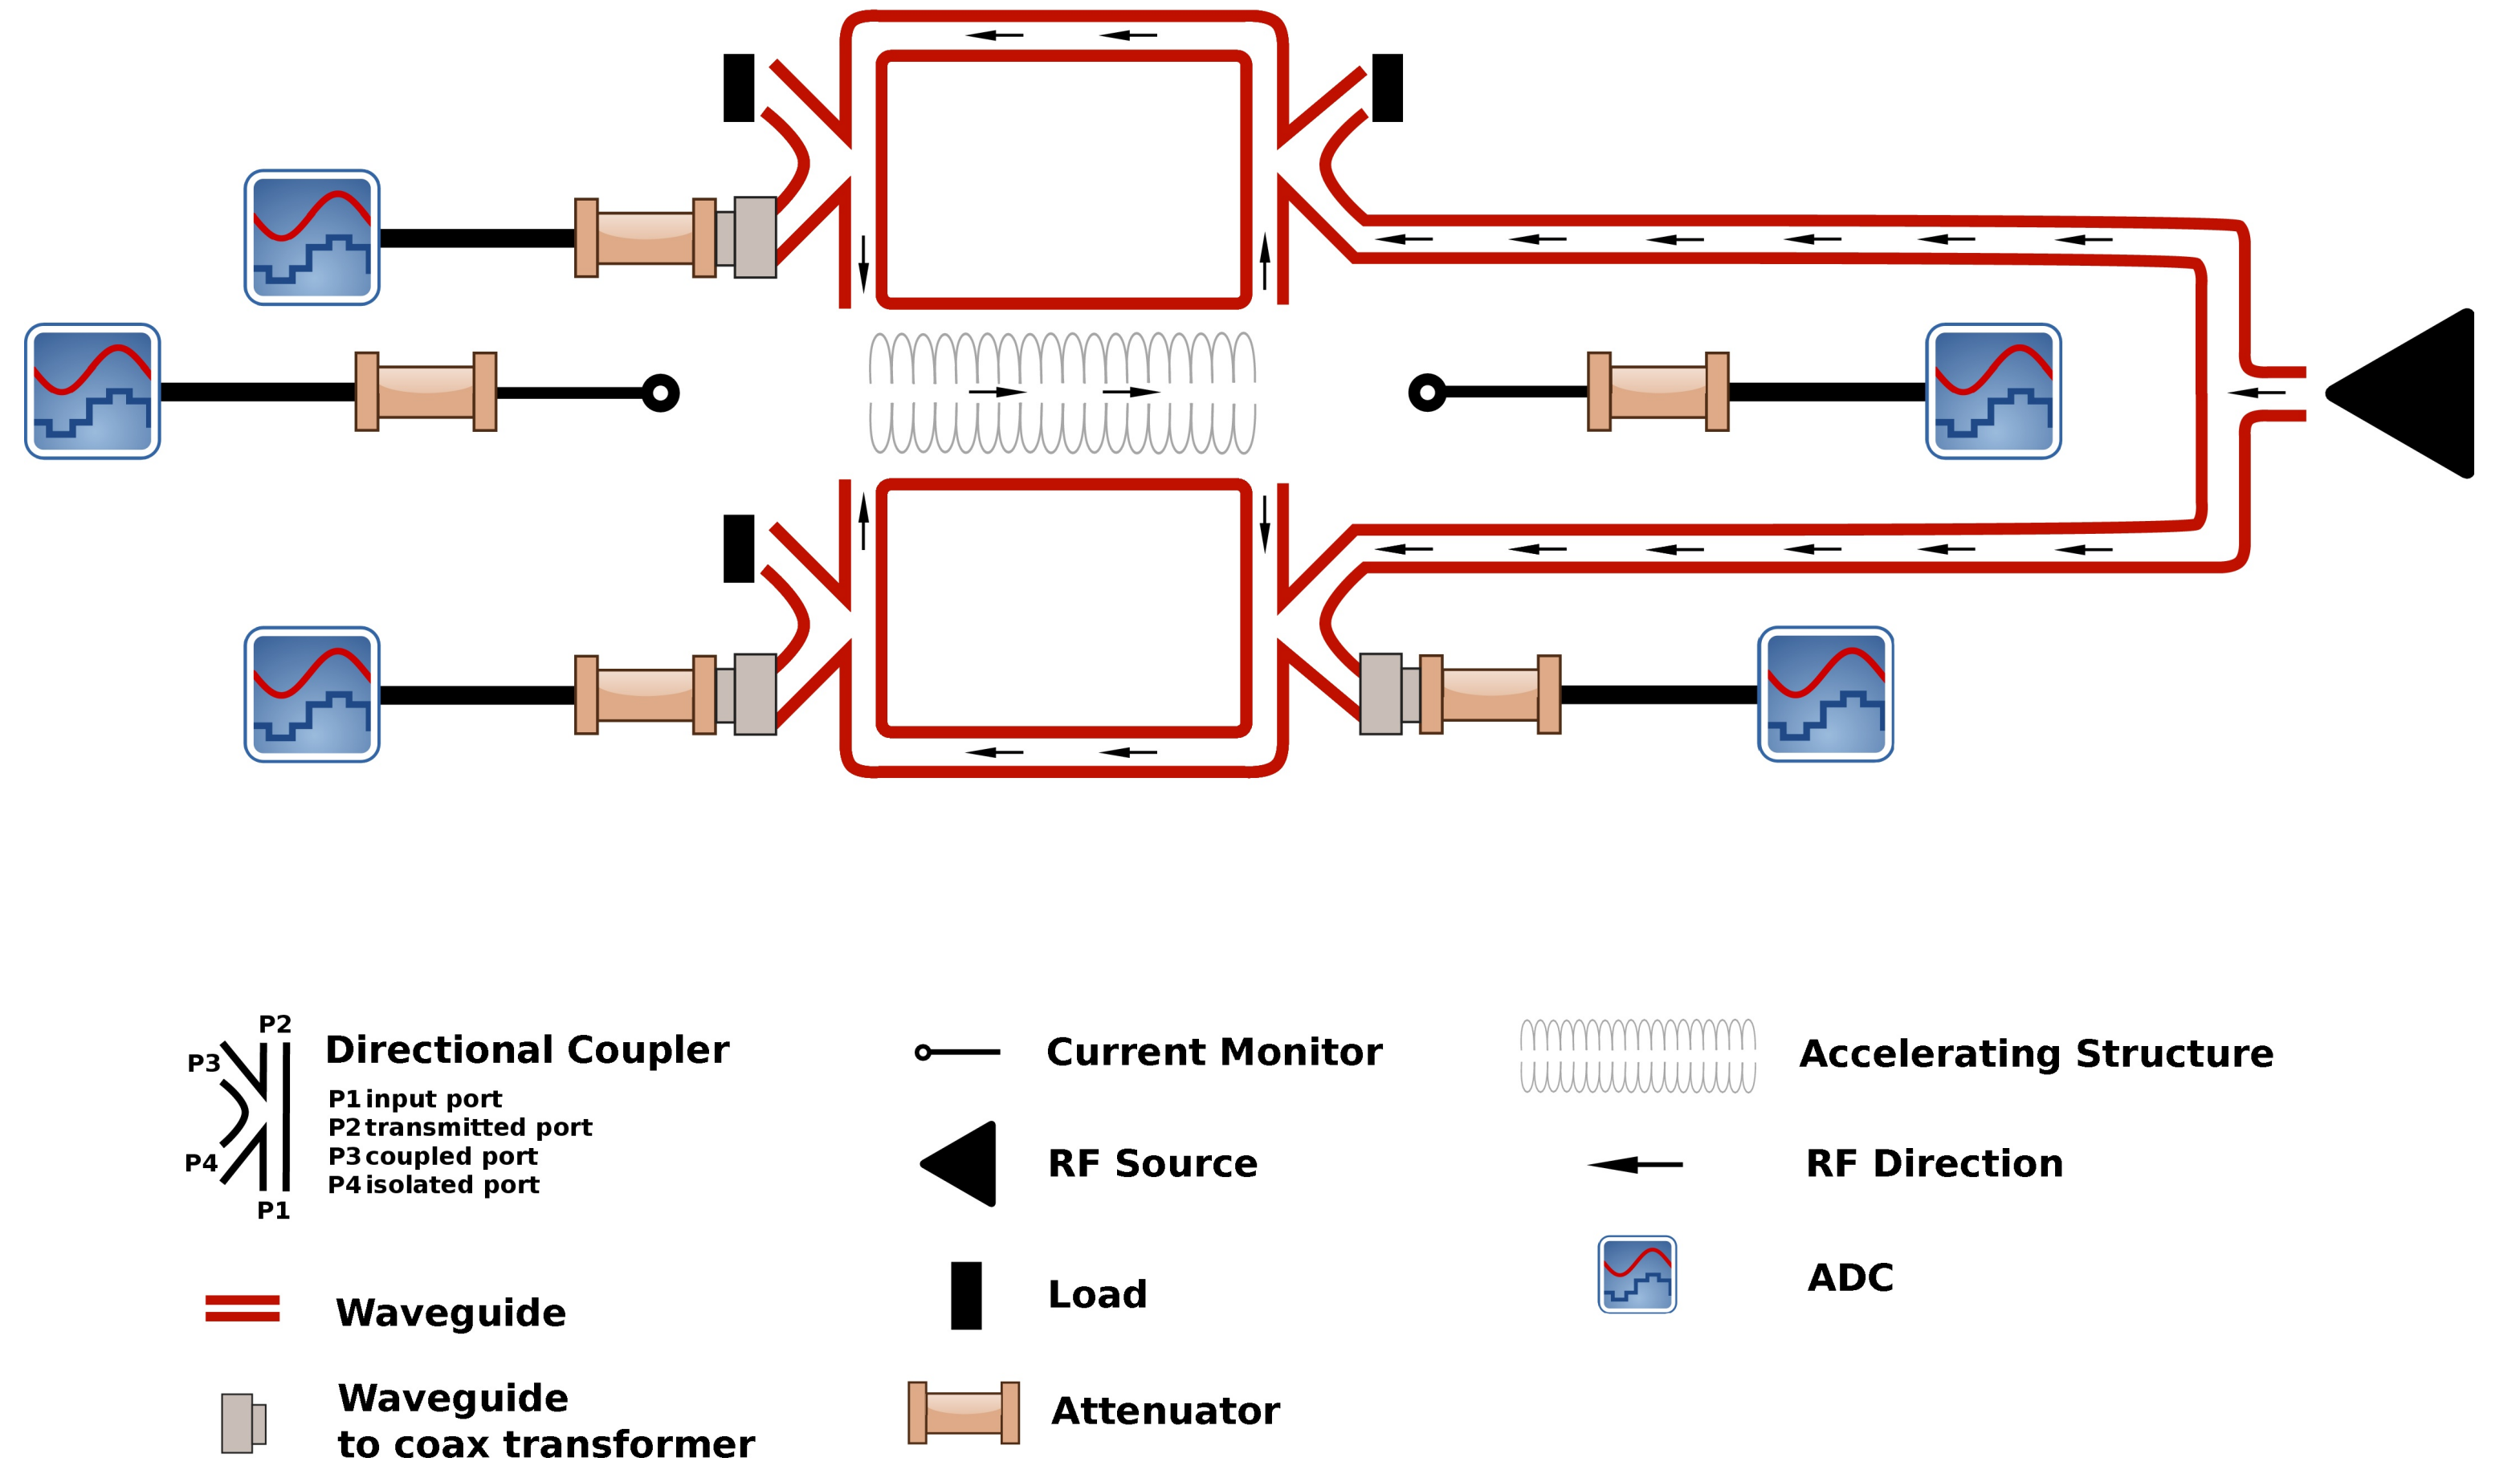
The T18_vg2.6_disk is a $2\pi/3$ travelling wave X-band structure based on CLIC requirements (100 MV/m). It is the result of the CERN-SLAC-KEK collaboration.

T18 structure tested at ASTA
resonant ring at **SLAC**
NATIONAL ACCELERATOR LABORATORY

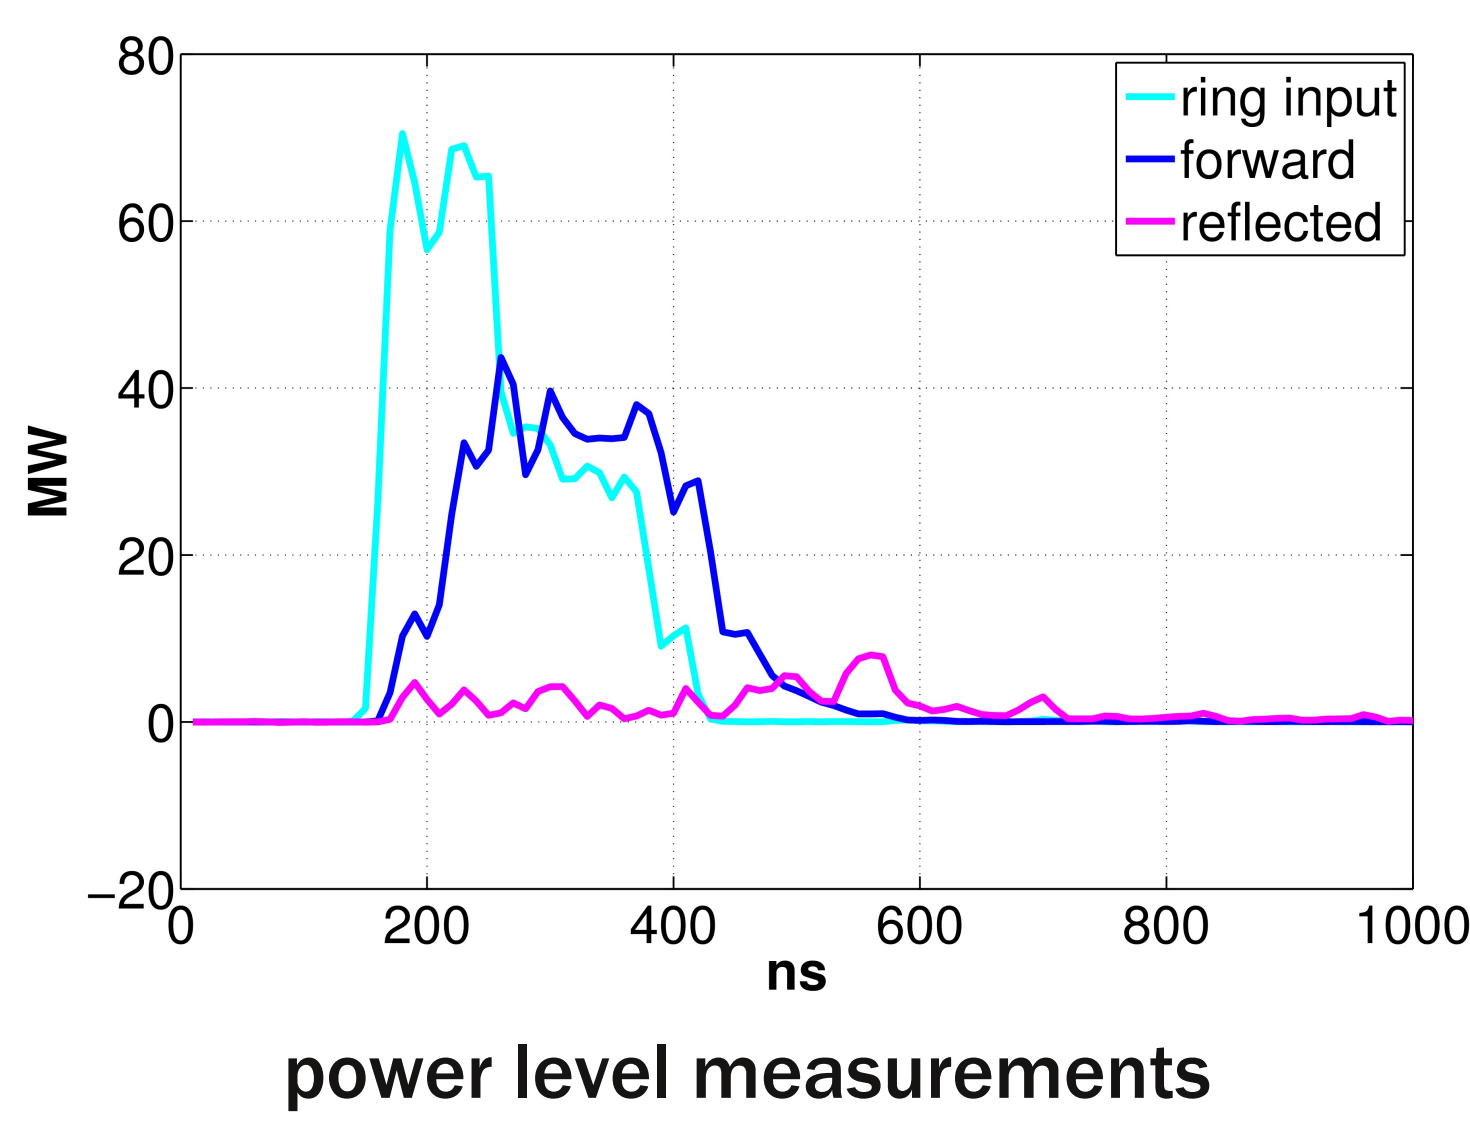
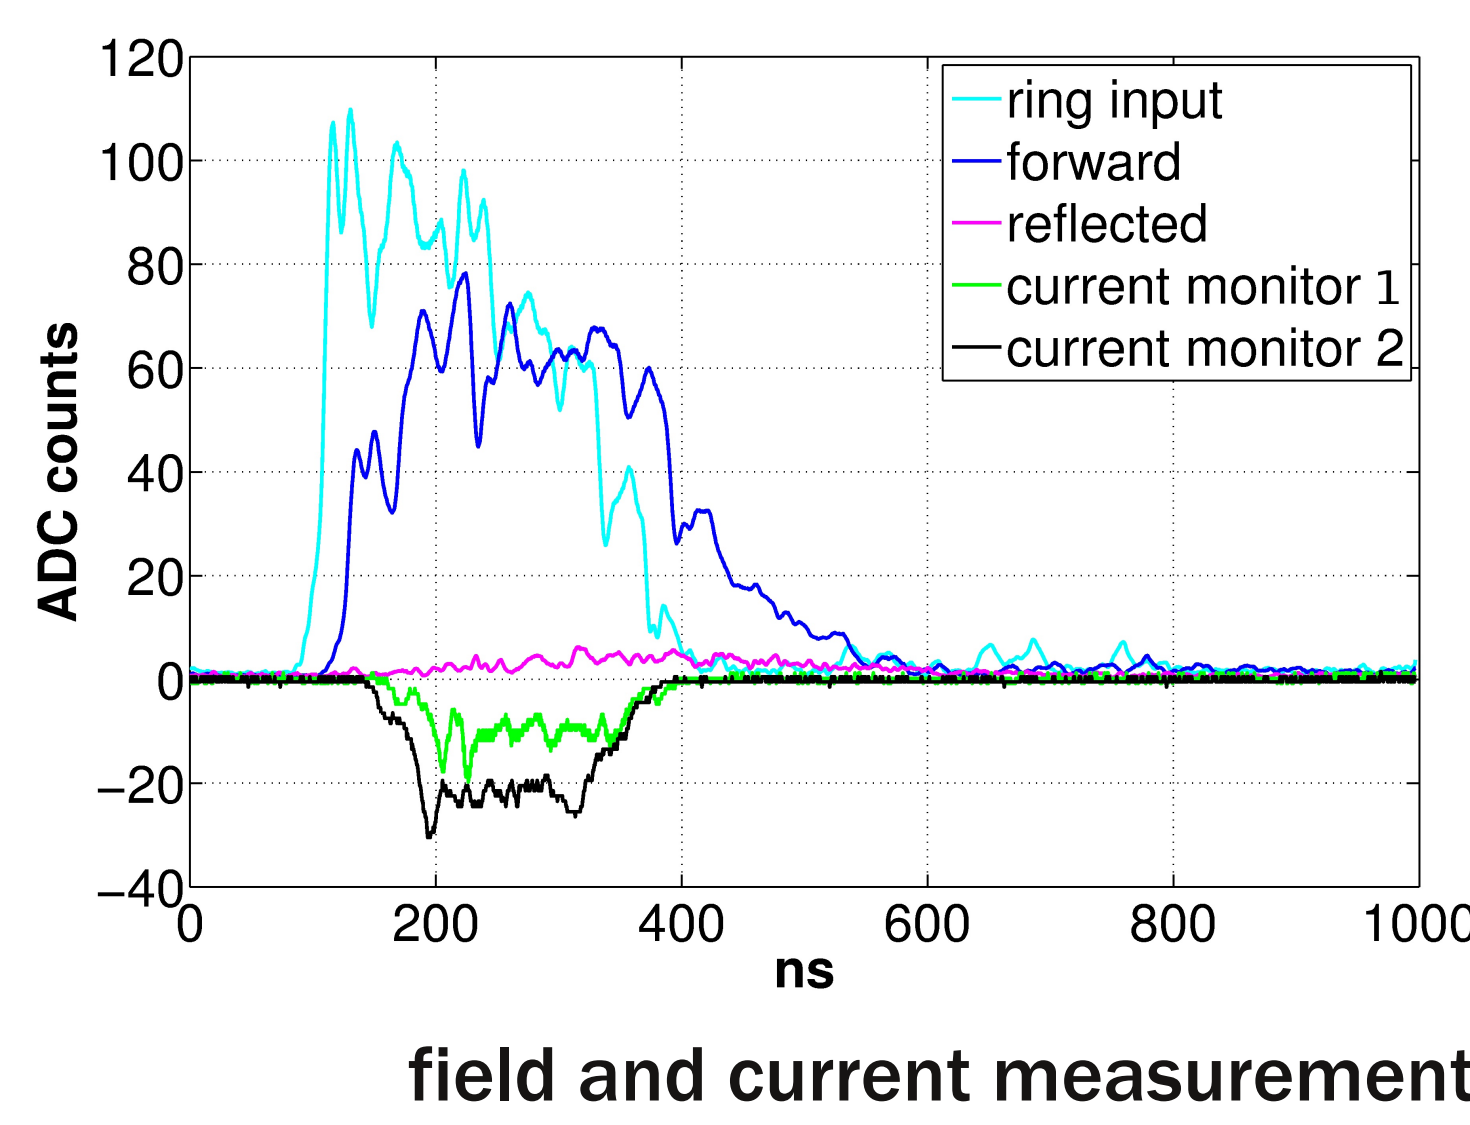
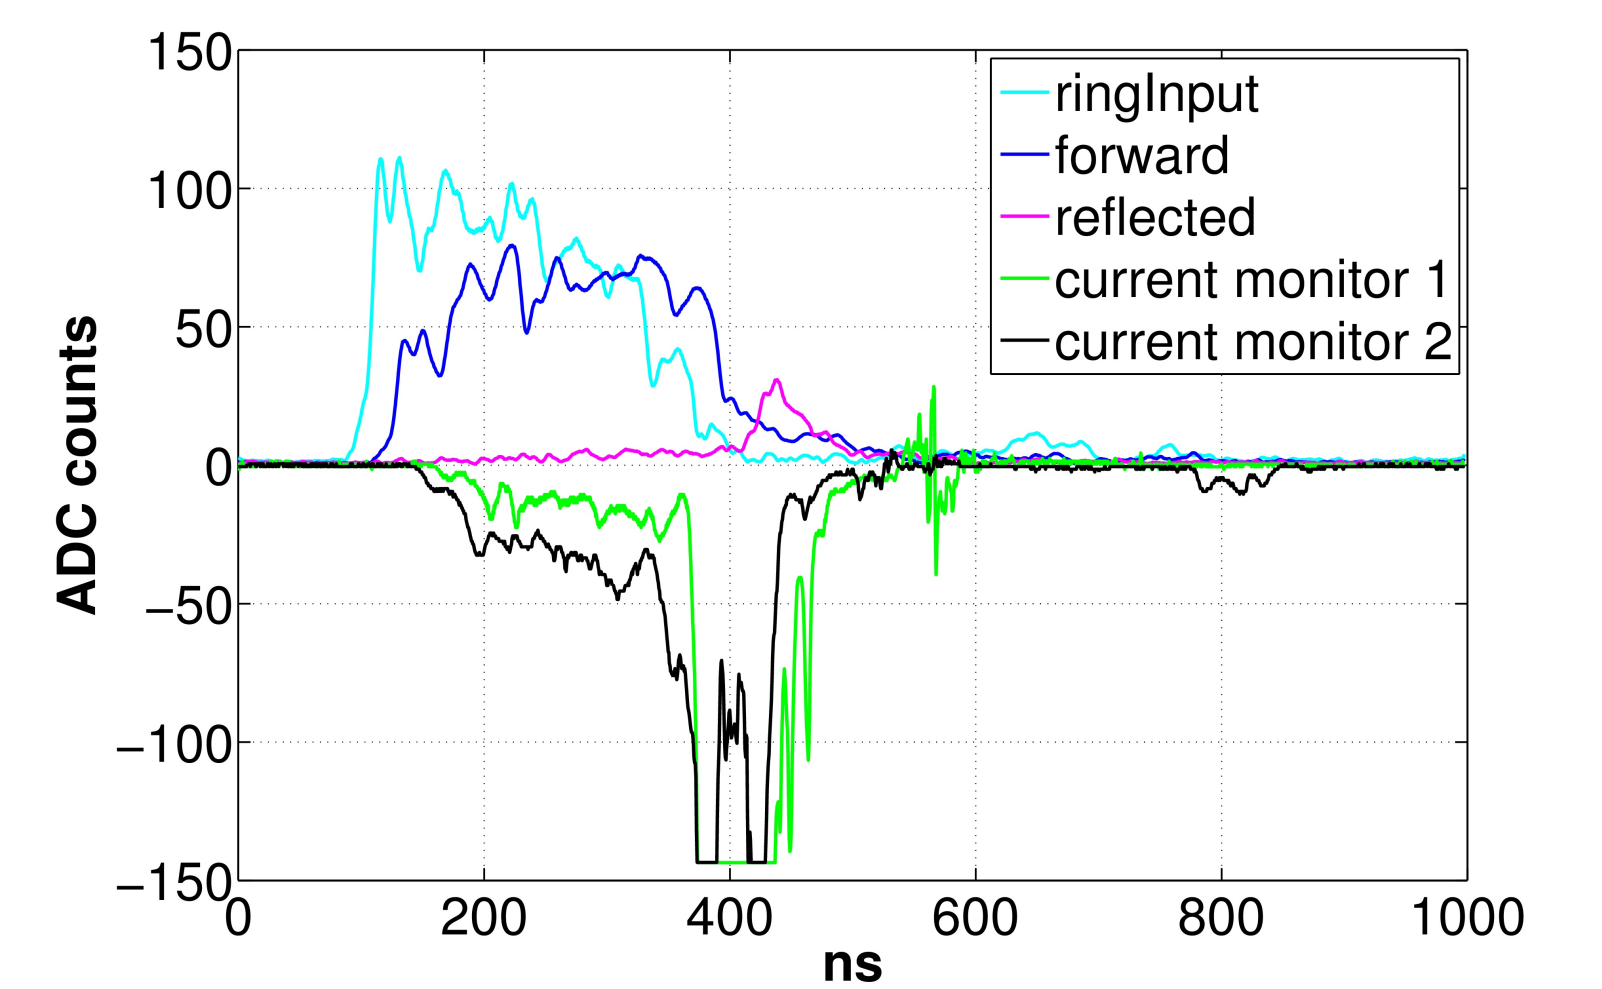
The diagnostics built for the resonant ring allows power level and field measurements as well as the measurement of currents emitted during and after a breakdown.

RF signal processing (IQ demodulation and envelope detection) is numerically realized off-line.

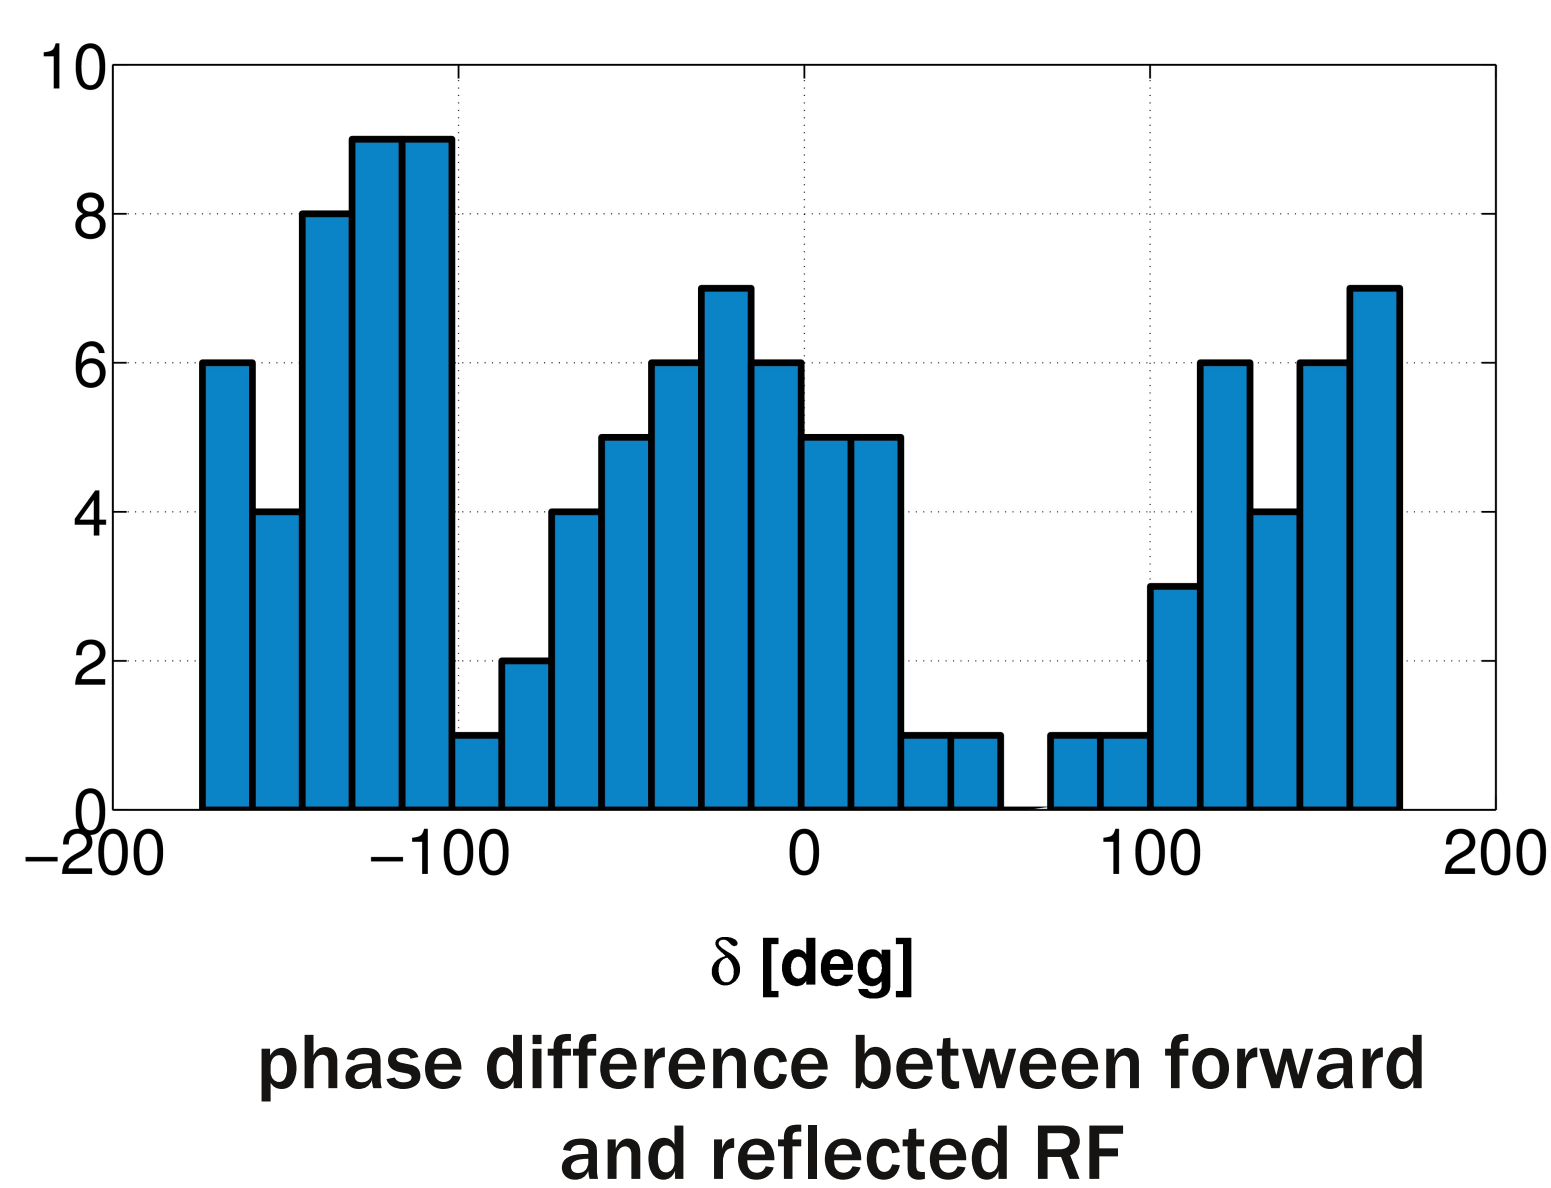
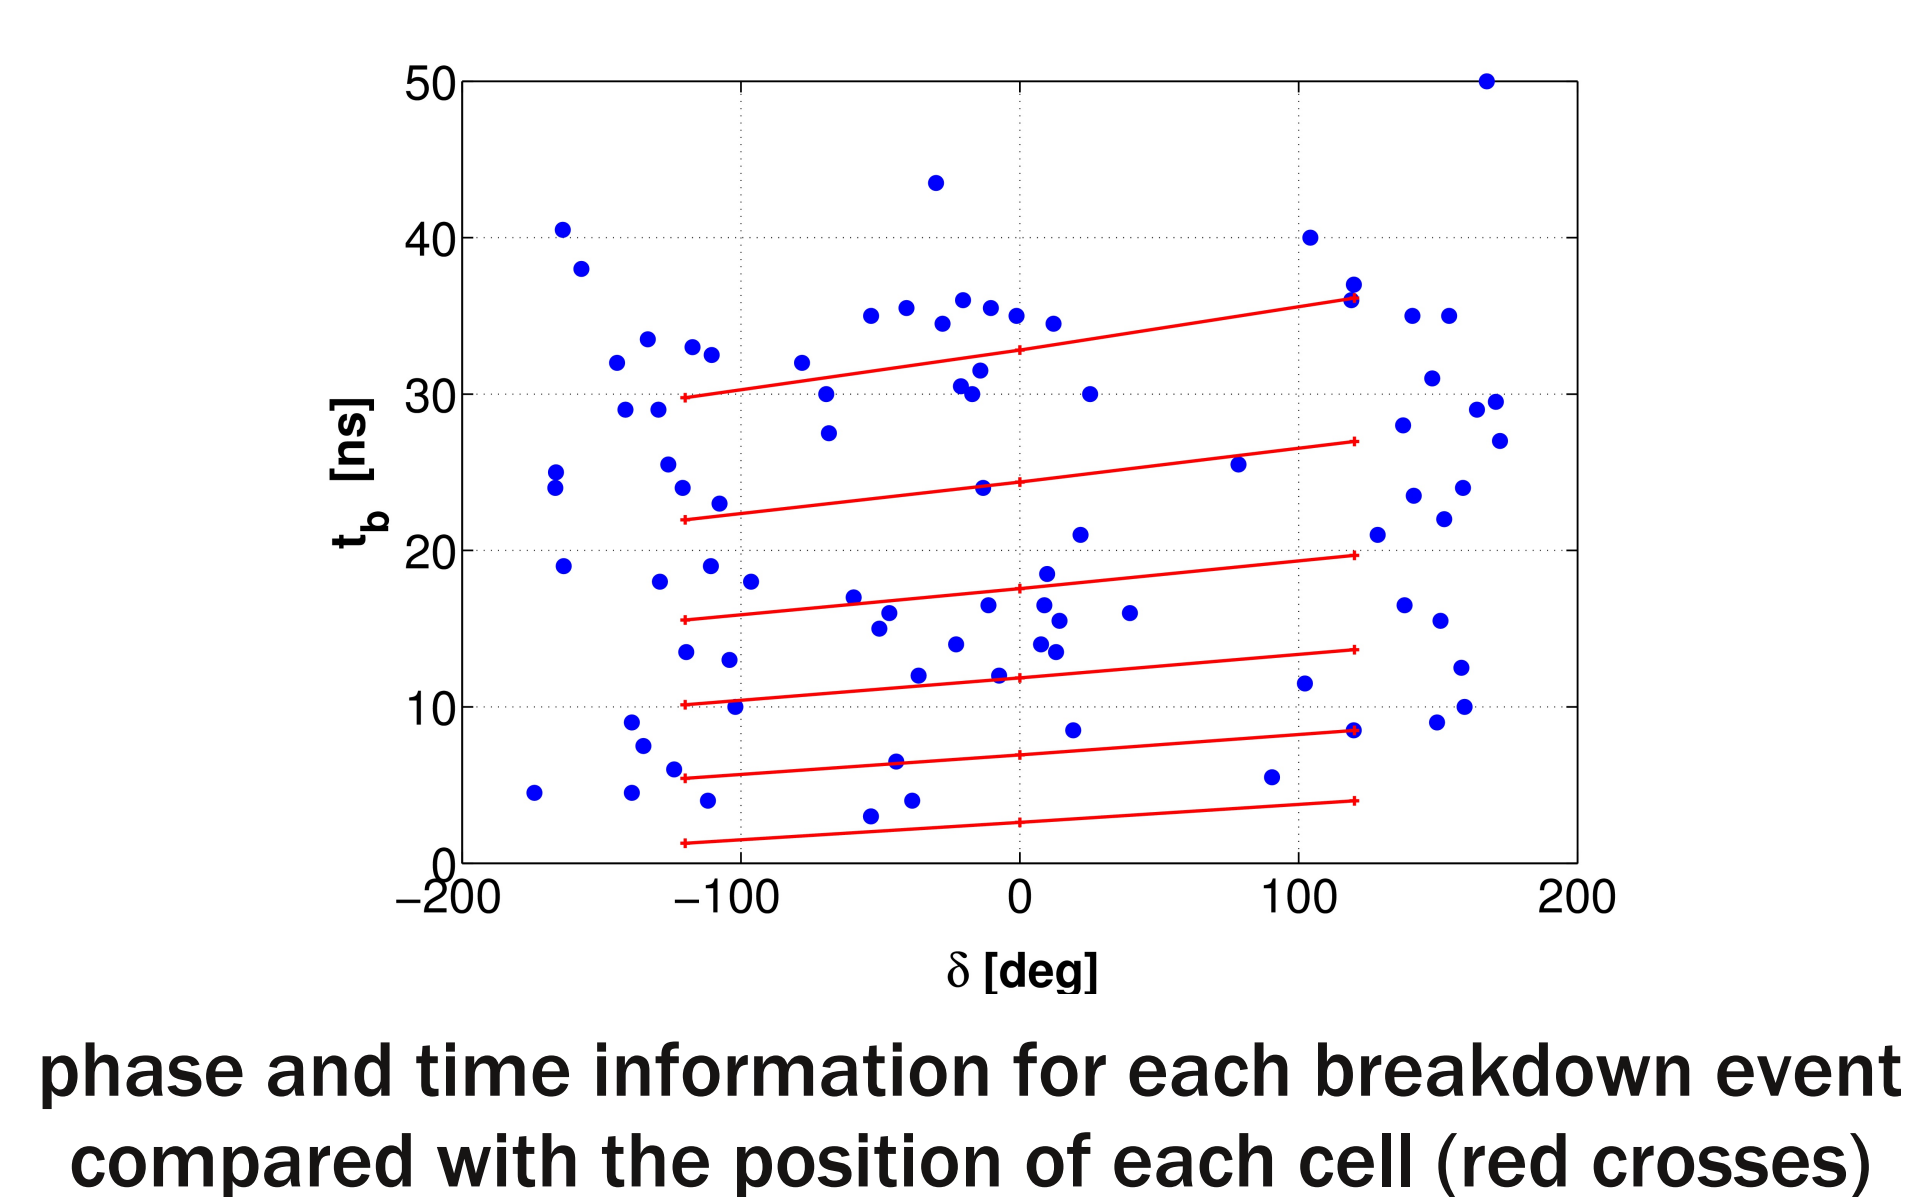
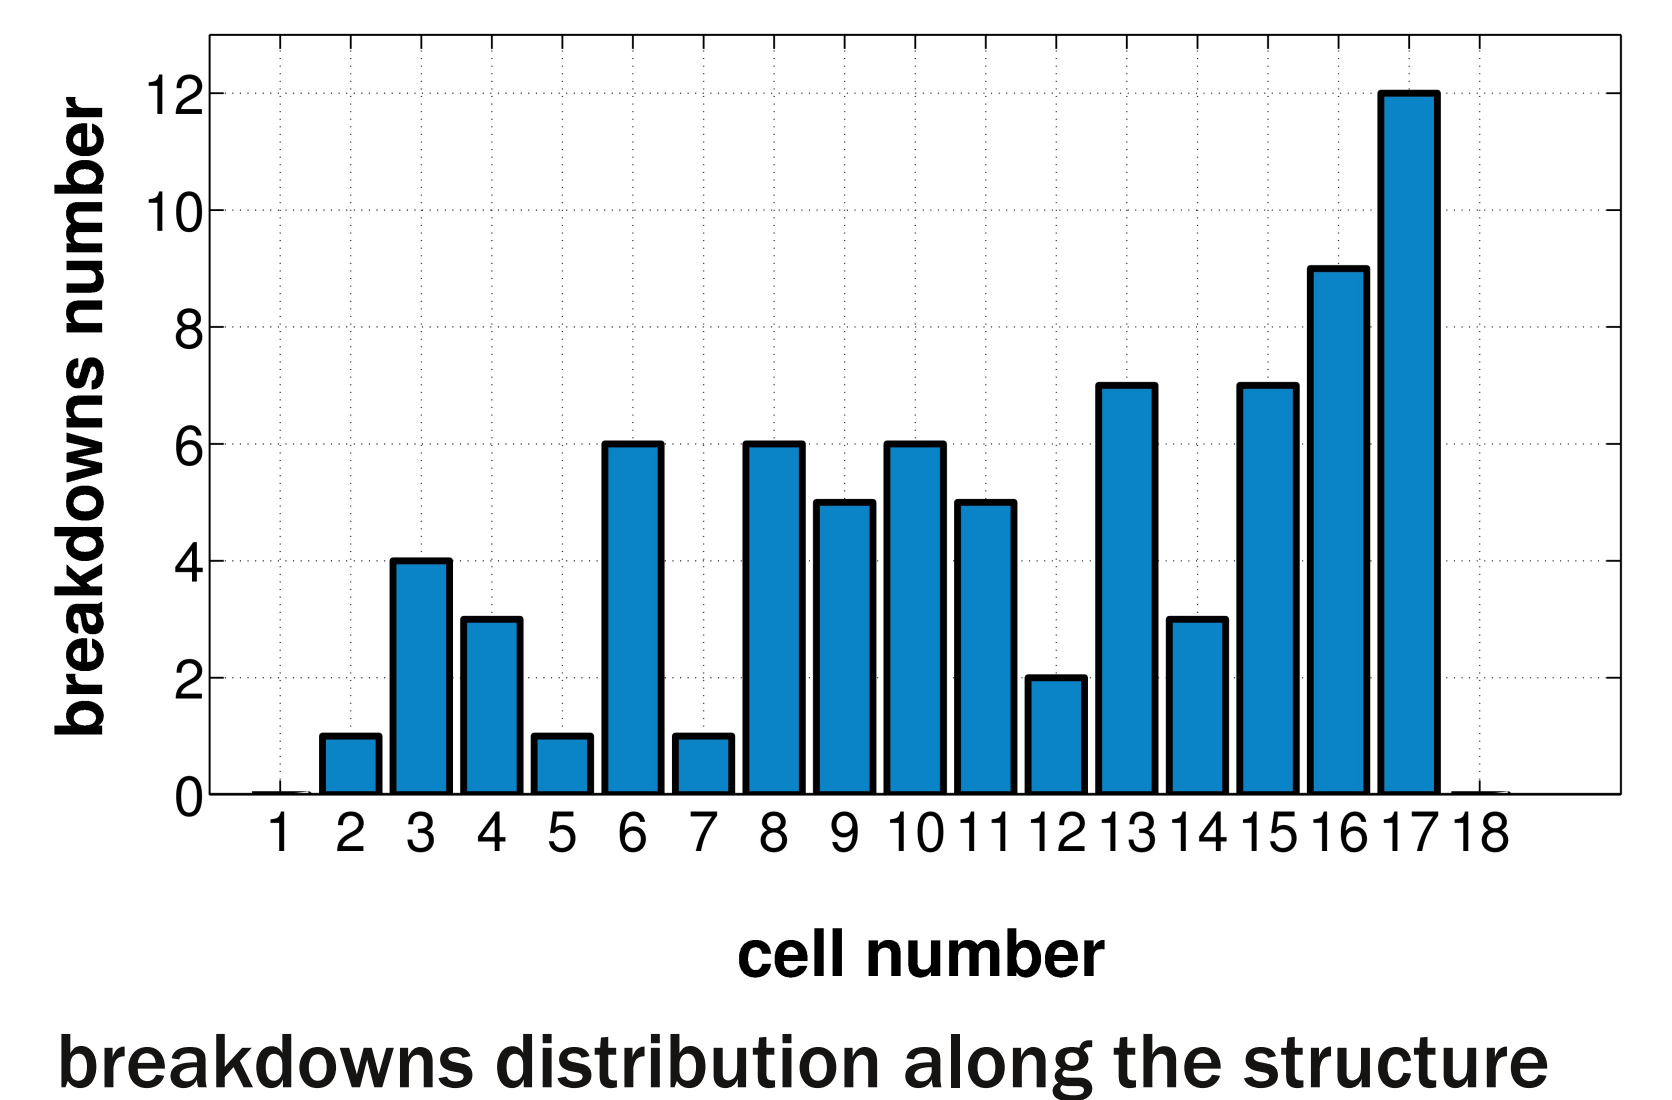
Estimation of the breakdown locations in the structure using phase and time information from RF measurements

The phase difference between forward and reflected field tells us the breakdown location in the structure short of an integer number of wavelengths.

Time information given by the instant at which the reflected field appears and the instant at which the forward field measurement shows missing power together with phase information uniquely determines the breakdown location in the structure.

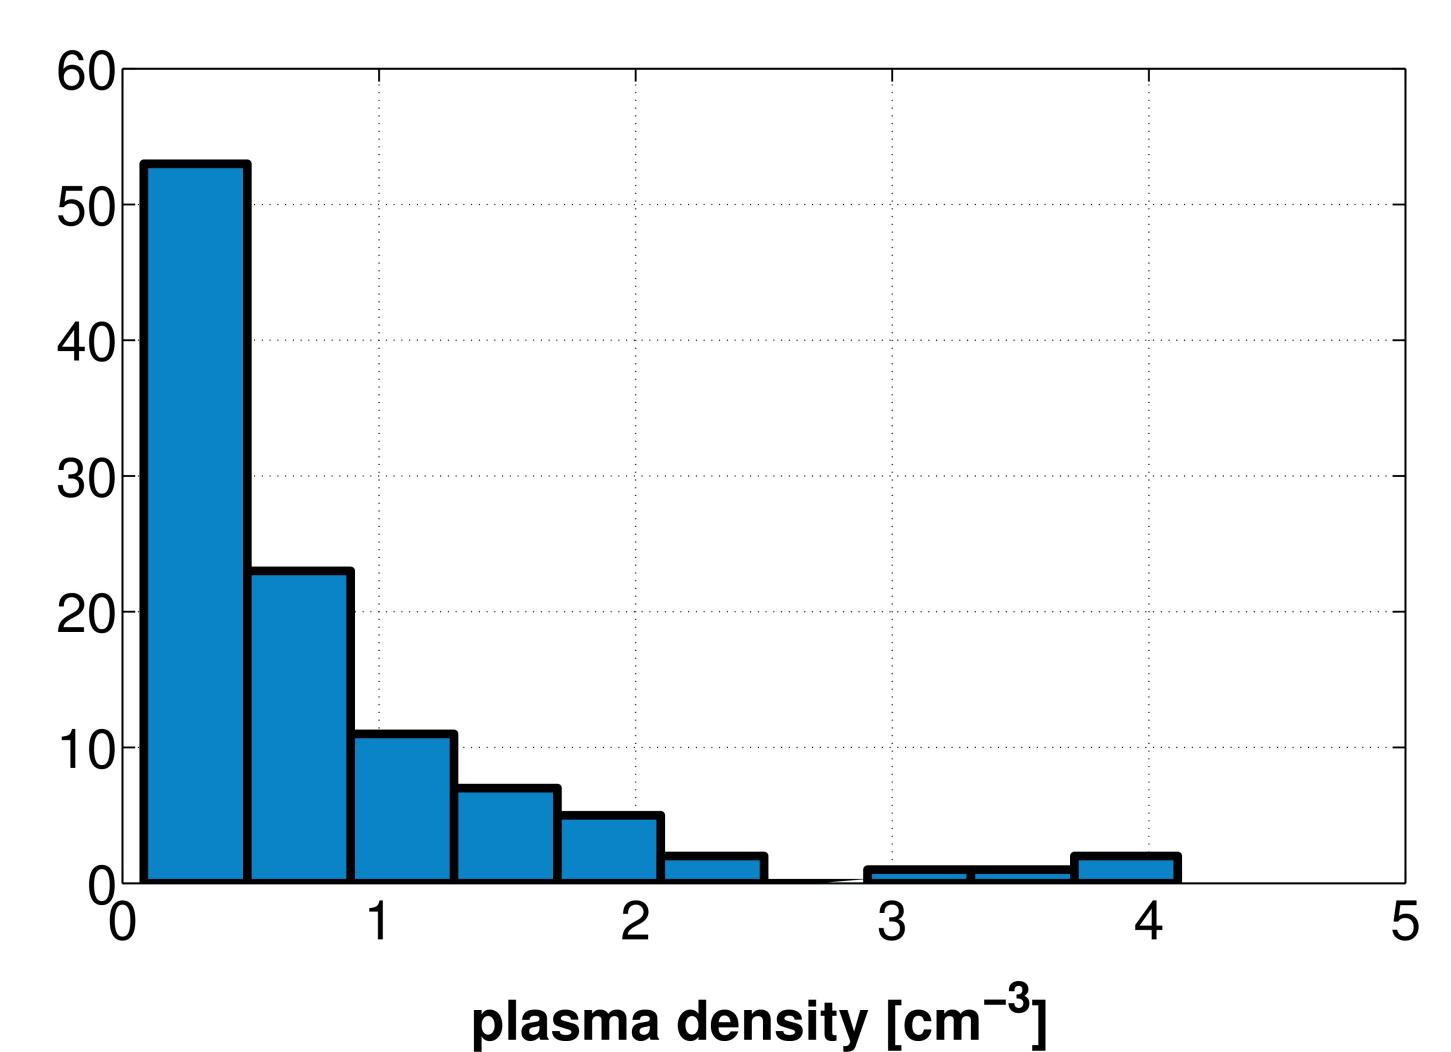
The RF reflection measured during a breakdown can be thought as the reflection due to a mismatched load of normalized impedance z_L in a microwave circuit.

Exploring the possibility that the RF reflection is caused by a plasma (non-collisional and quasi-neutral) with permittivity ϵ grown in the structure during the breakdown, suggests that its density would be about $5 \cdot 10^{15}$ electrons per cubic centimetre.
