400 mA BEAM STORE WITH SUPERCONDUCTING RF CAVITIES AT PLS-II*

Younguk Sohn[#], Myung-Hwan Chun, Taekyun Ha, Mansu Hong, Youngdo Joo, Heung-Sik Kang, Hyung-Gyun Kim, Kyung Ryl Kim, Tae-Yeon Lee, Chong-Do Park, Hong-Jib Park, In Soo Park, Seunghwan Shin, In-Ha Yu, Jong Cheol Yun, PAL, Pohang, Korea

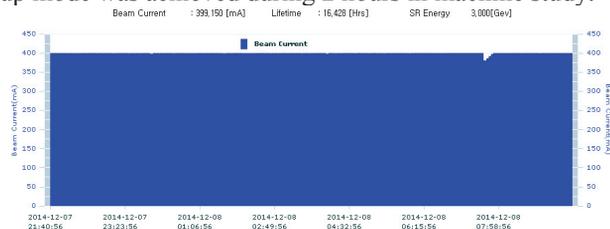
Figure 1 : Achievement of 400 mA top-up mode.

Then, the beam current with two SC cavities by top-up mode in 2013 was 120 mA at beginning of user run to 280 mA at last run. During the machine study, 400 mA beam current was touched during several ten minute, but it couldn't go on due to vacuum burst. Also we tried to increase beam current with one more SC cavity installation in 2014. Even with frequent partial warmup and pulse conditioning, the window vacuum burst still one of trouble for high beam current. It was overcome with deep study of relationship between RF forward power, reflected power and window dissipation heat [3]. With these result, stable 400 mA beam current with top-up mode was achieved during 2 hours in machine study.

probability of RF breakdown of the RF window, which comes with a rapid increase of the window vacuum pressure. Based on these studies, we can find out the optimal reflection power at the given RF voltage and beam current by avoiding window breakdown. This would be the key contribution to store 400 mA top-up mode beam current. We demonstrated the design performance of SRF system with 400 mA user beam operation as shown in Figure 1.

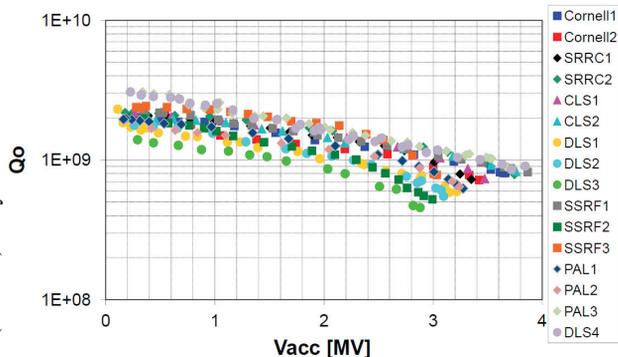
Figure 2: Cavity characteristics of CESR-B family.

PLS-II RF system consists of three independent SRF stations which have CESR-B type 500 MHz SC cavities. The SC cavities were prepared with usual recipe as careful quality controlled cavity fabrication, degreasing with light chemical etching, then barrel chemical polishing (BCP) as much as 100 μm, high pressure water rinsing (HPR) with conductivity, 12.5 MΩ-m, annealing 10 hours at 600 °C with vacuum environment, final BCP-20 μm and HPR, finally leak tight of cavity assembly. All the cavities showed V_{acc} as high as 2.8 MV (E_{acc}, 9.3 MV/m) at Q₀ of 8.5x10⁸. Figure 2 shows cavities characteristics of CESR-B family, in which PAL 1, 2, and 3 are for PLS-II.

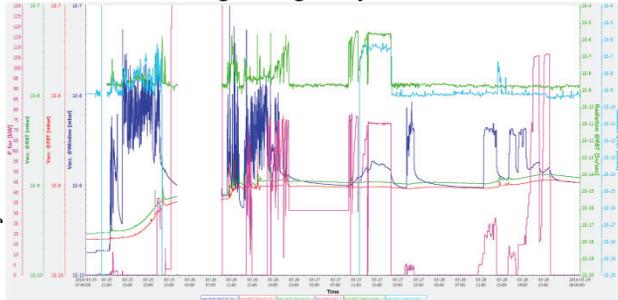
Figure 3: Conditioning history of cryomodule 1 with pulse & continuous RF power; blue and red colors are vacuum pressures, green color is radiation intensity.

The RF window and cavity were conditioned with several different pulses of which width, repetition rate and intensity by on-resonance travelling wave power and off-resonance standing wave power before beam commissioning. Figure 3 shows the history of cavity and window conditioning during 4 days.

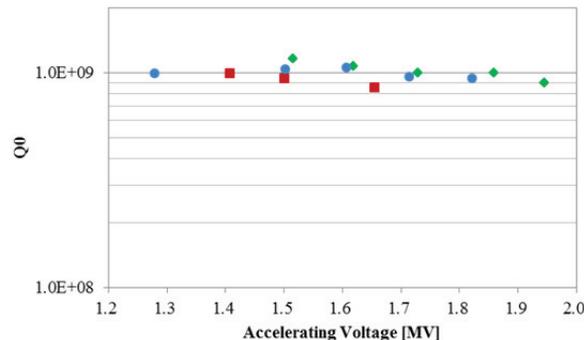
Figure 4: Measured Q₀ with Cryomodule 1; Green for after installation in SR tunnel, red for 4 months beam operation, and blue for one year operation.

After conditioning cavities and window, Q₀s are measured with measurement of liquid Helium evaporation rate. As comparison of Q₀ between vertical test and horizontal test about 10 % of Q₀ were degraded by combination of components like coupler, beam tube, He vessel, filed pickups, and so on.

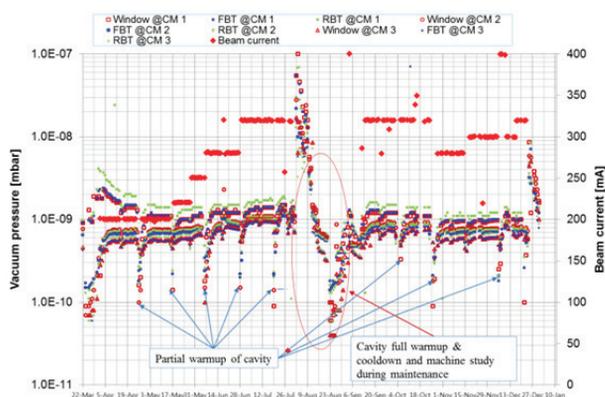
Figure 5: History of beam current increase with 3 SC cavities in 2014.

For vacuum conditioning of storage ring by synchrotron radiation, the beam current increased gradually from reasonable low current for the normal user service during every commissioning of SC cavities. The vacuum pressures from every cavity and windows looks decreasing gradually run by run, even though beam current increases or stays shown in Figure 5, which is to be beam cleaning effect. To reduce cavity trips by vacuum burst the cavity partial warmup and pulse conditioning are conducted in very frequently as every 2 user-run and every user-run, respectively from 2013. That would have contributed the reduction of cavity trips.

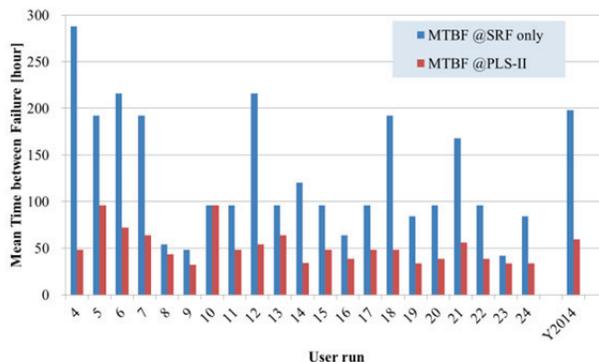
Figure 6: MTBF with 3 SRF systems in 2014.

Operation statistics of SRF system are reasonable compared to that of other light sources, for example MTBF in 2013 and 2014 were 186 hours and 197 hours as shown in Figure 6.
