### 3.9 GHZ SUPERCONDUCTING ACCELERATING 9-CELL CAVITY VERTICAL TEST RESULTS

Timergali Khabiboulline, Charles Cooper, Nandhini Dhanaraj, Helen Edwards, Mike Foley, Elvin Harms, Donald Mitchell, Allan Rowe, Nikolay Solyak. FNAL, Batavia, IL 60510, U.S.A  
 Wolf-Dietrich Moeller, DESY, Notkestrasse 85, Hamburg, Germany.

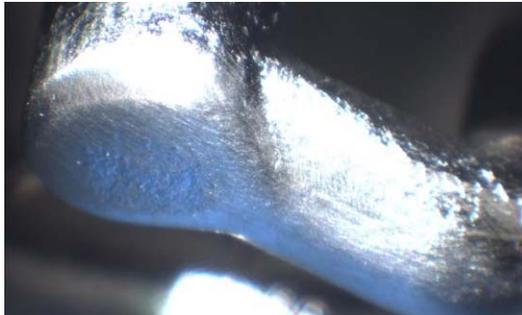
Figure 3: HOM formtile tip after trimming.

The trimming of the HOM tips was tested first with a spare HOM. The workmanship was inspected visually and carefully and after achieving acceptable results, the trimming technique was implemented to two pairs of the end assemblies with HOM couplers (Figure 3). Then the assemblies were shipped to JLAB for welding with the rest of cavity #4. After successful tests of cavity #4, we made the same modifications to the end-assemblies of cavities No.5-6 and trim the HOM antennas on the already built and tested cavity #3.
